Xcel Energy, Inc.  
Sherburne County Generating Station  
13999 Industrial Blvd.  
Becker, MN, 55308

**Re: 2018 Annual Inspection of Bottom Ash Pond**

FIGURE 1  
BOTTOM ASH POND  
2018 ANNUAL INSPECTION  
POND LAYOUT

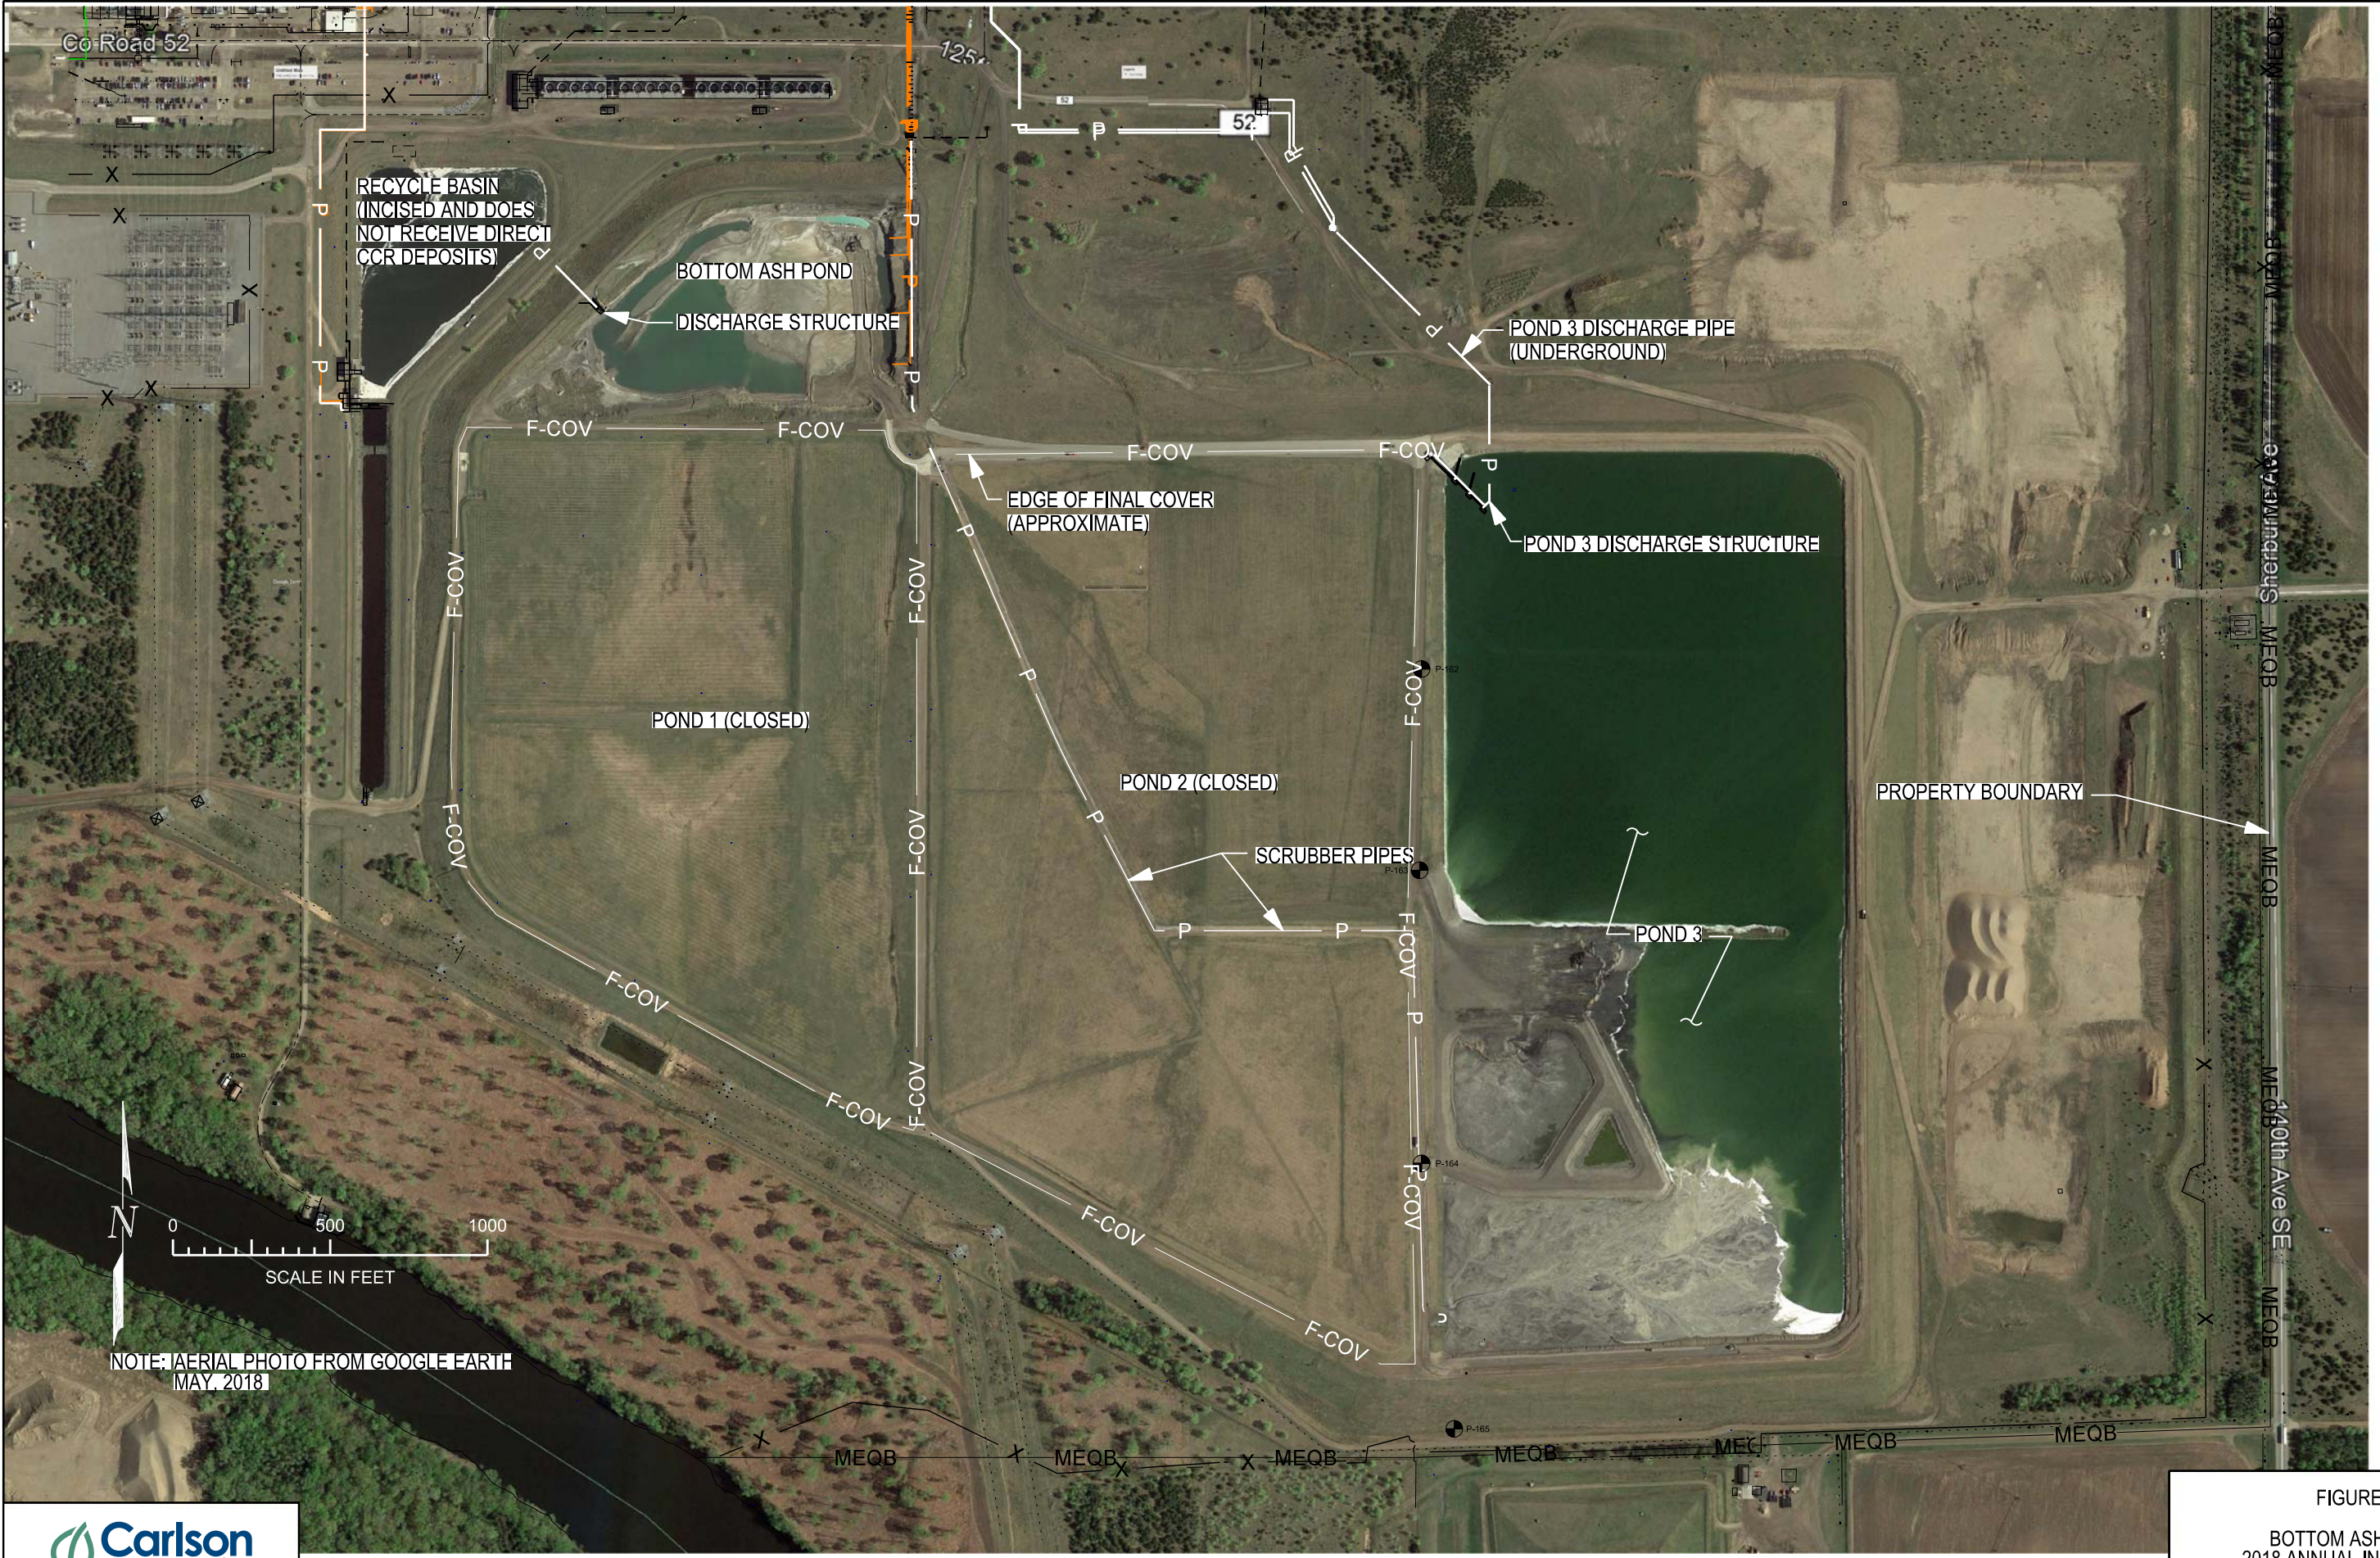
The discharge pipe corridor was inspected for signs of a leakage, such as saturated areas or sinkholes. No signs of leakage were observed along the pipe corridor between the BAP and the Recycle Basin.
