Xcel Energy, Inc.  
Sherburne County Generating Station  
13999 Industrial Blvd.  
Becker, MN, 55308

**Re: 2017 Annual Inspection of Bottom Ash Pond**

## Bottom Ash Pond Annual Inspection - November 2017

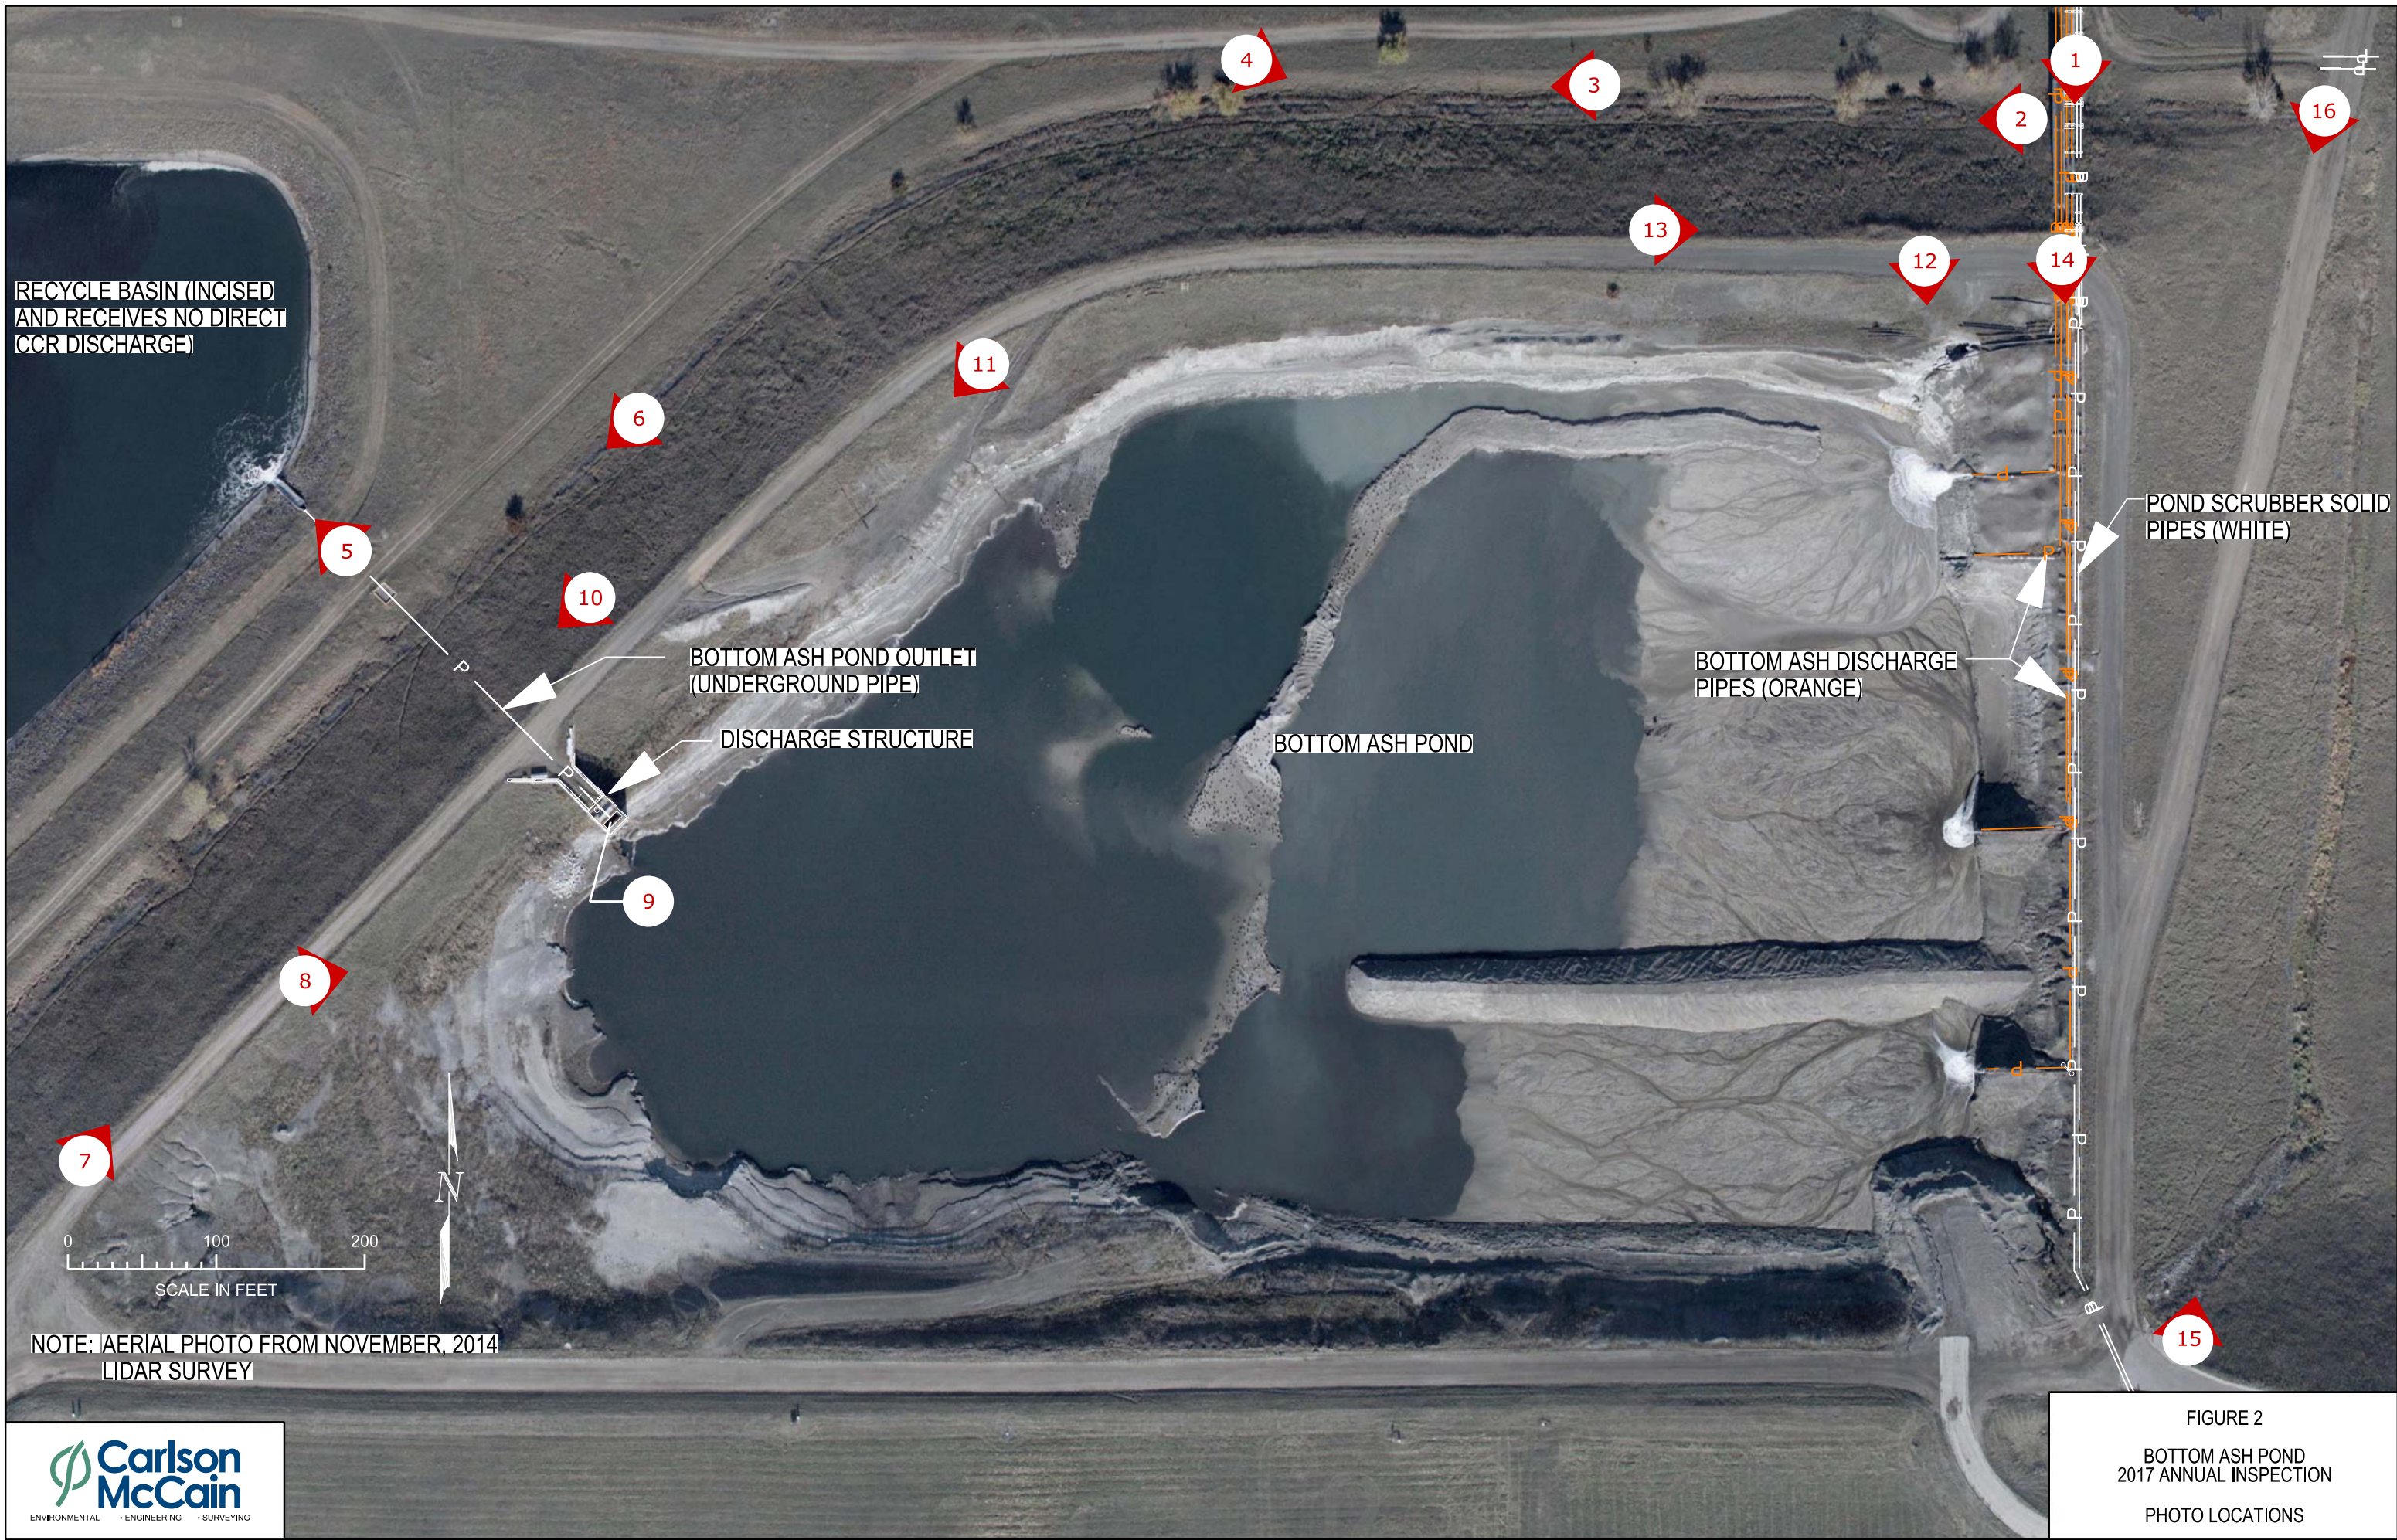
FIGURE 2  
BOTTOM ASH POND  
2017 ANNUAL INSPECTION  
PHOTO LOCATIONS

| Photo 1 | Bottom ash and scrubber pipes, looking south. |

| Photo 2 | North embankment and perimeter ditch, looking west. |
