January 10, 2018

Xcel Energy, Inc.  
Sherburne County Generating Station  
13999 Industrial Blvd.  
Becker, MN, 55308

**Re: 2017 Annual Inspection of Scrubber Solids Pond No. 3**

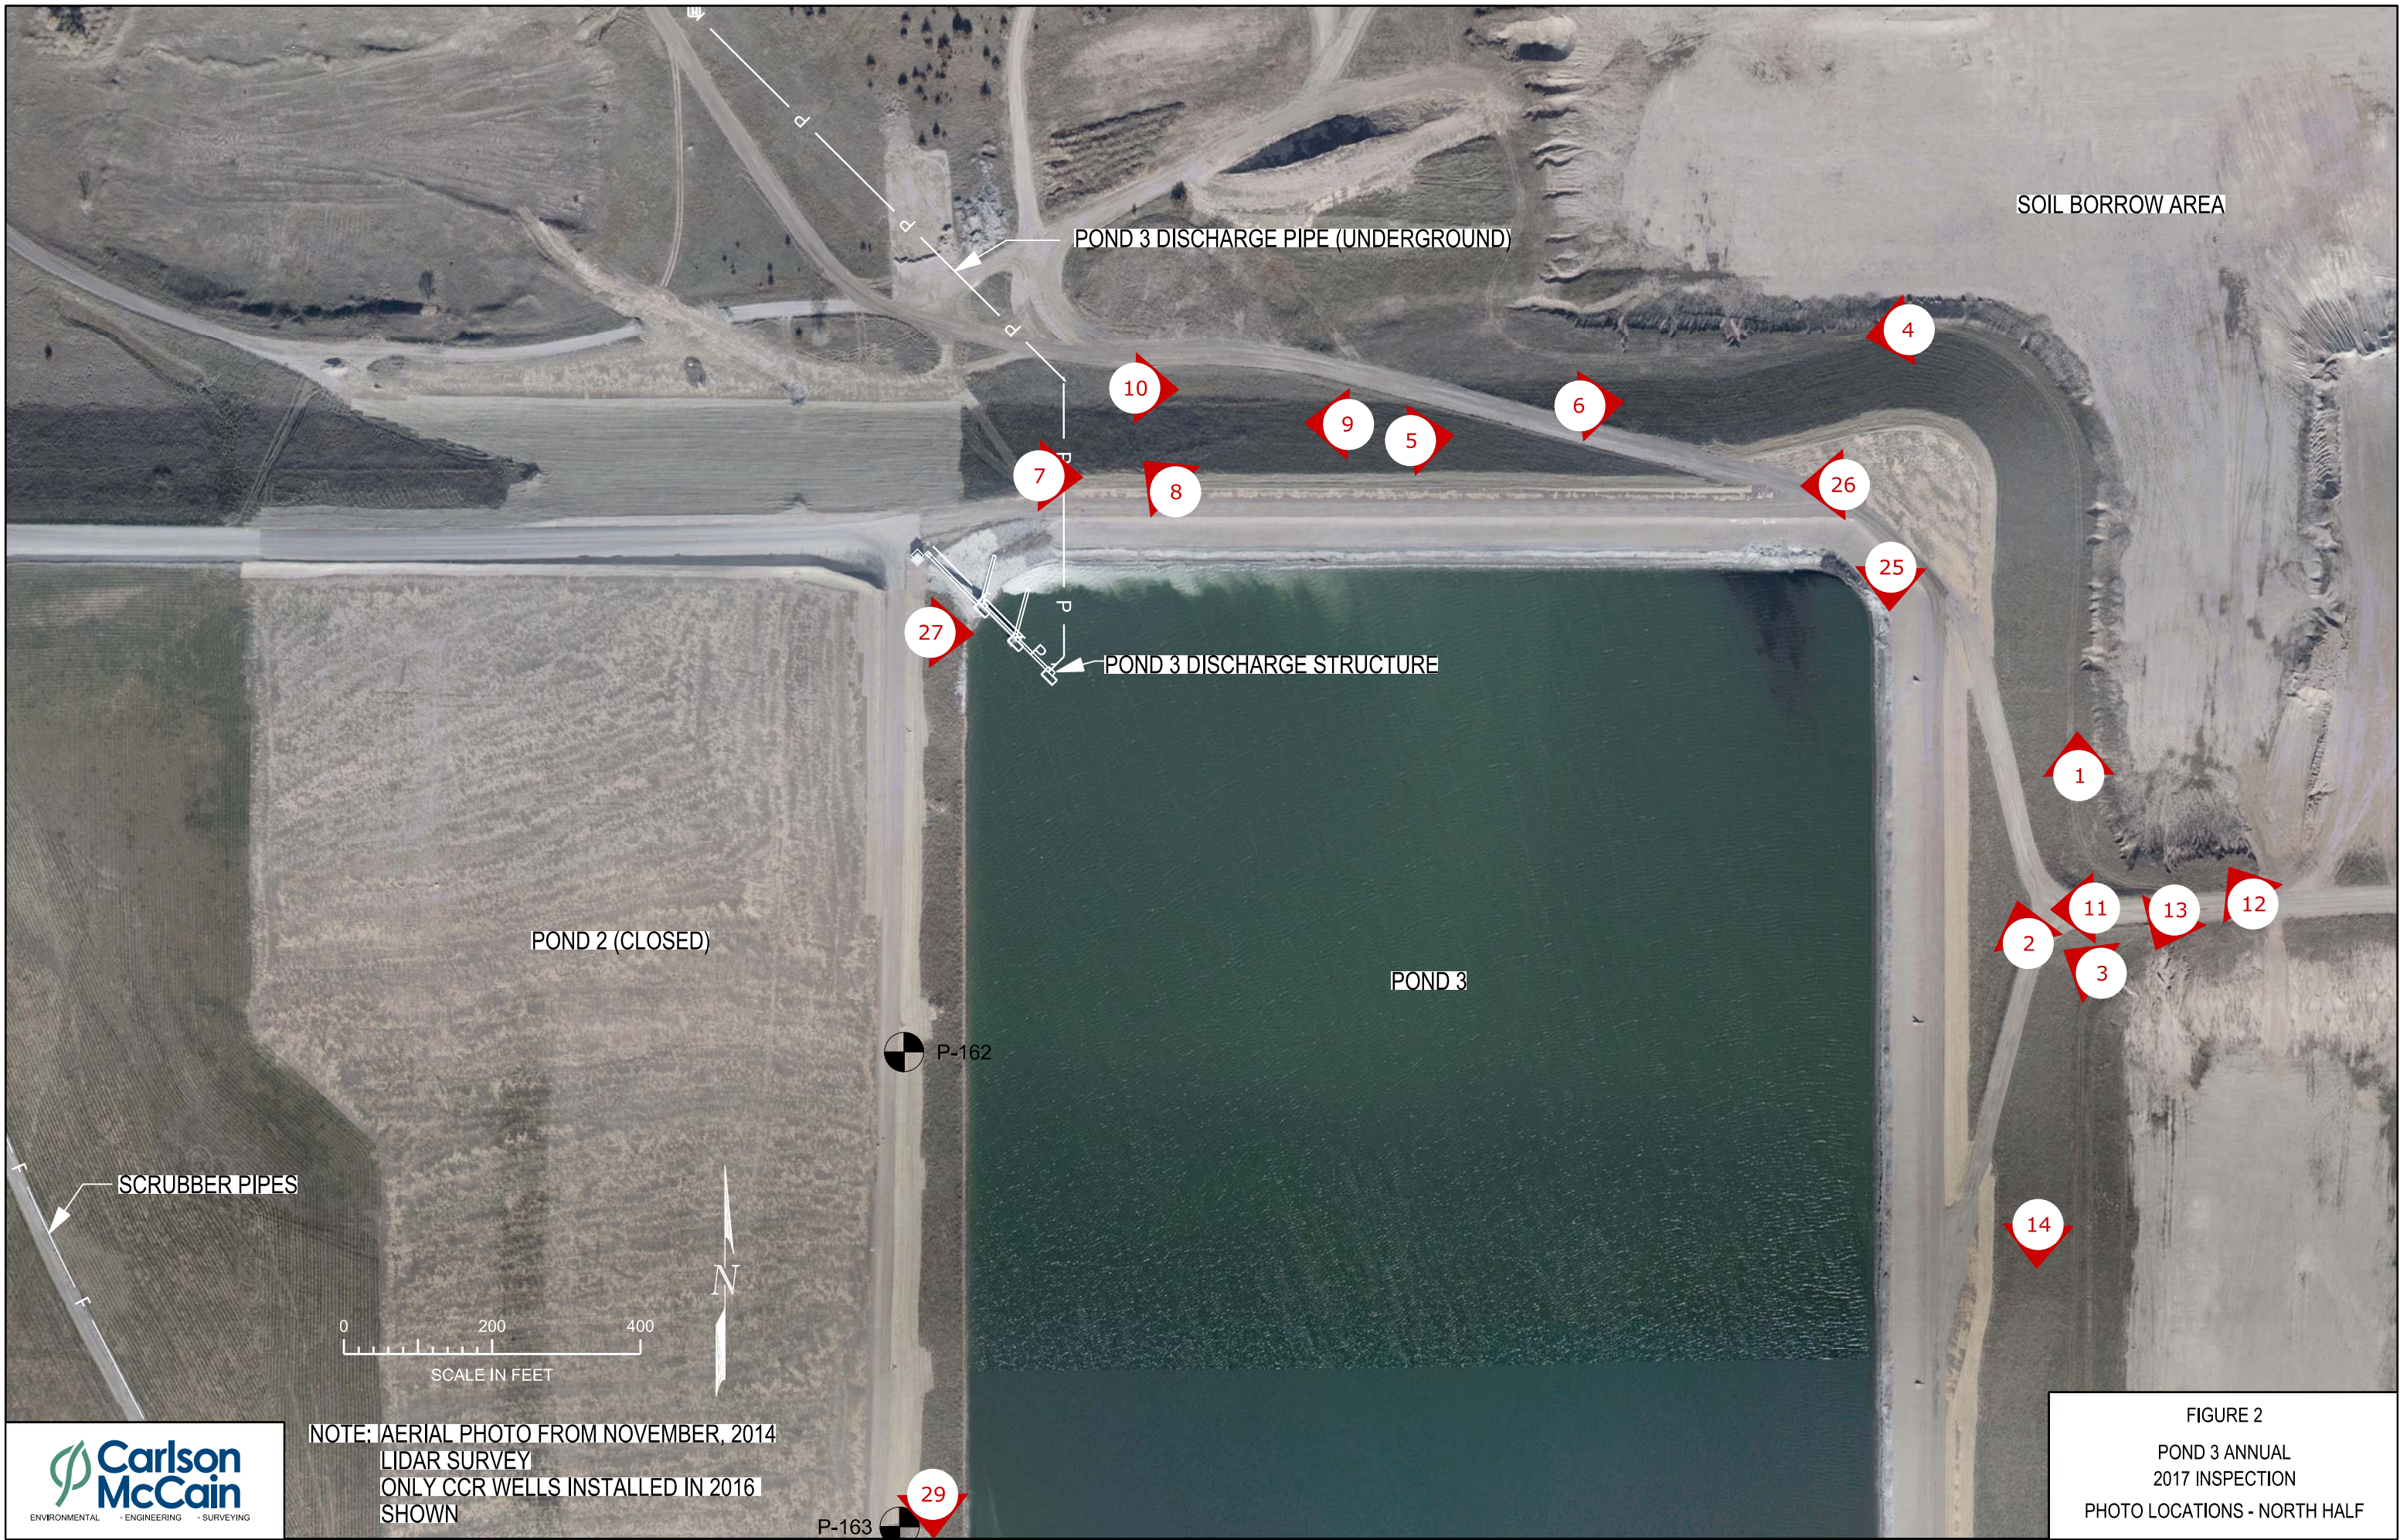
FIGURE 1  
POND 3 ANNUAL  
2017 INSPECTION  
POND LAYOUT

Two forms of CCR are deposited or placed in Pond 3. Solid bottom ash is excavated and hauled from the Bottom Ash Pond (see figure 1) and used above the water level in Pond 3 and compacted as a structural fill, or deposited in the pond, and not compacted. The highest elevation of bottom ash diked
