Periodic Safety Factor Assessment Scrubber Solids Pond No. 3 Sherburne County Generating Plant

Introduction

Safety Factor Assessment

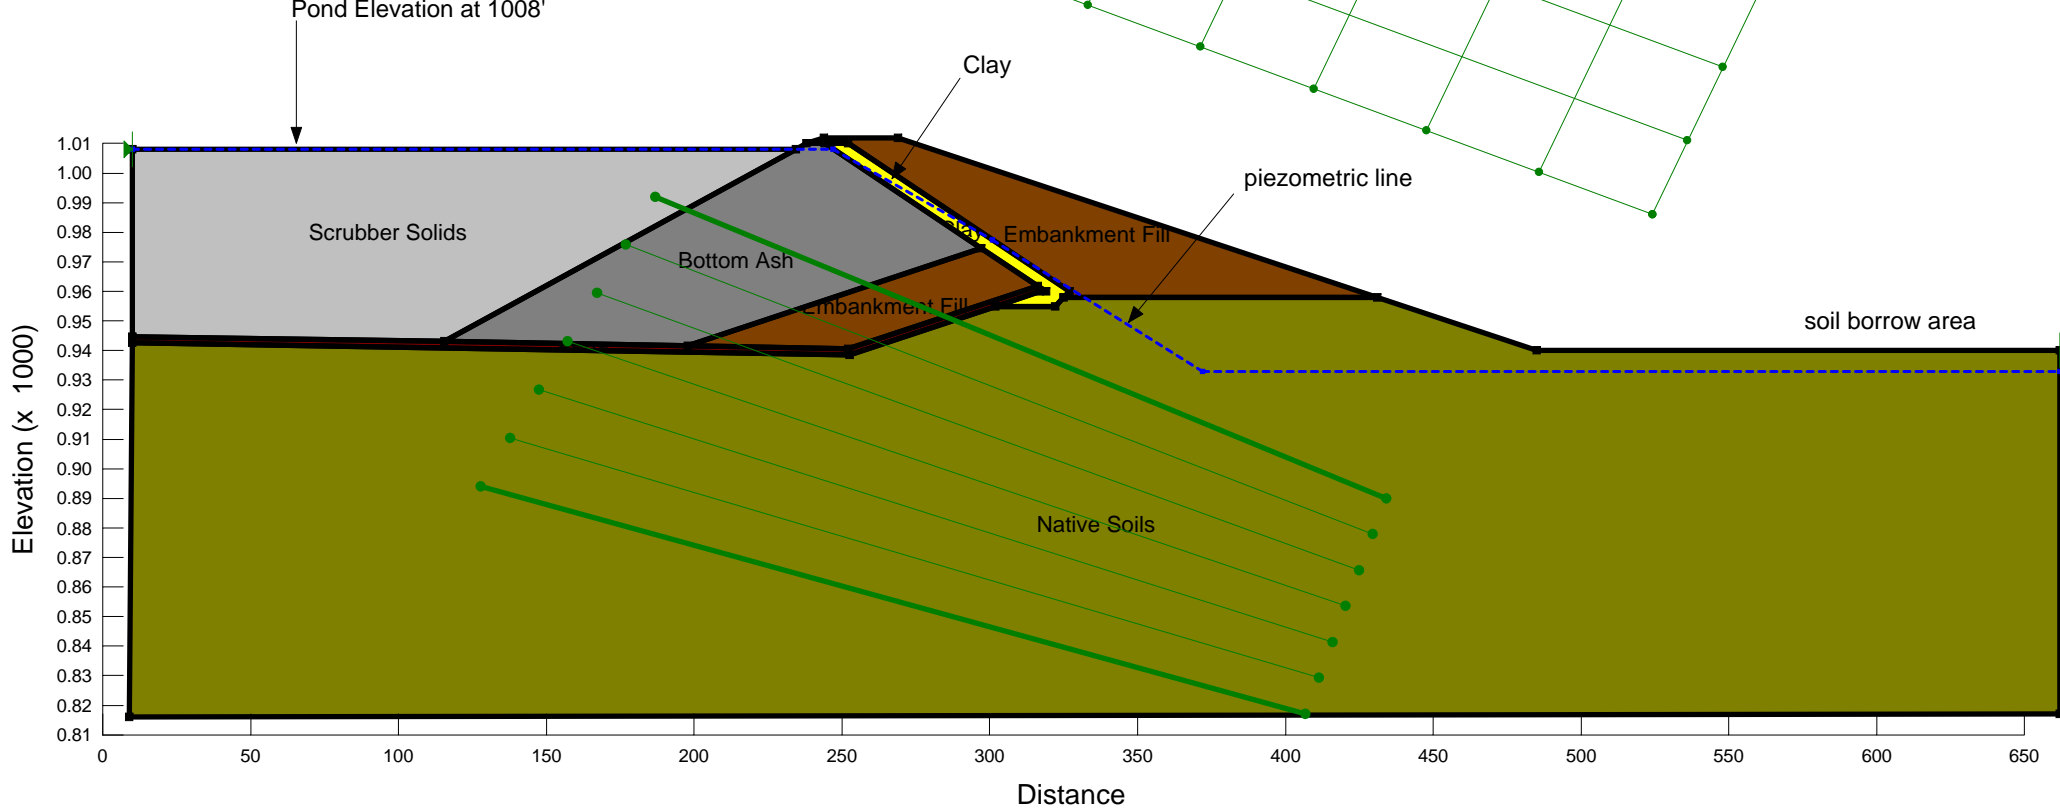
Pond 3N Condition 1: Maximum Storage Loading
Pond Elevation at 1008'
Deep Circular Failure
Pre-Analysis Diagram

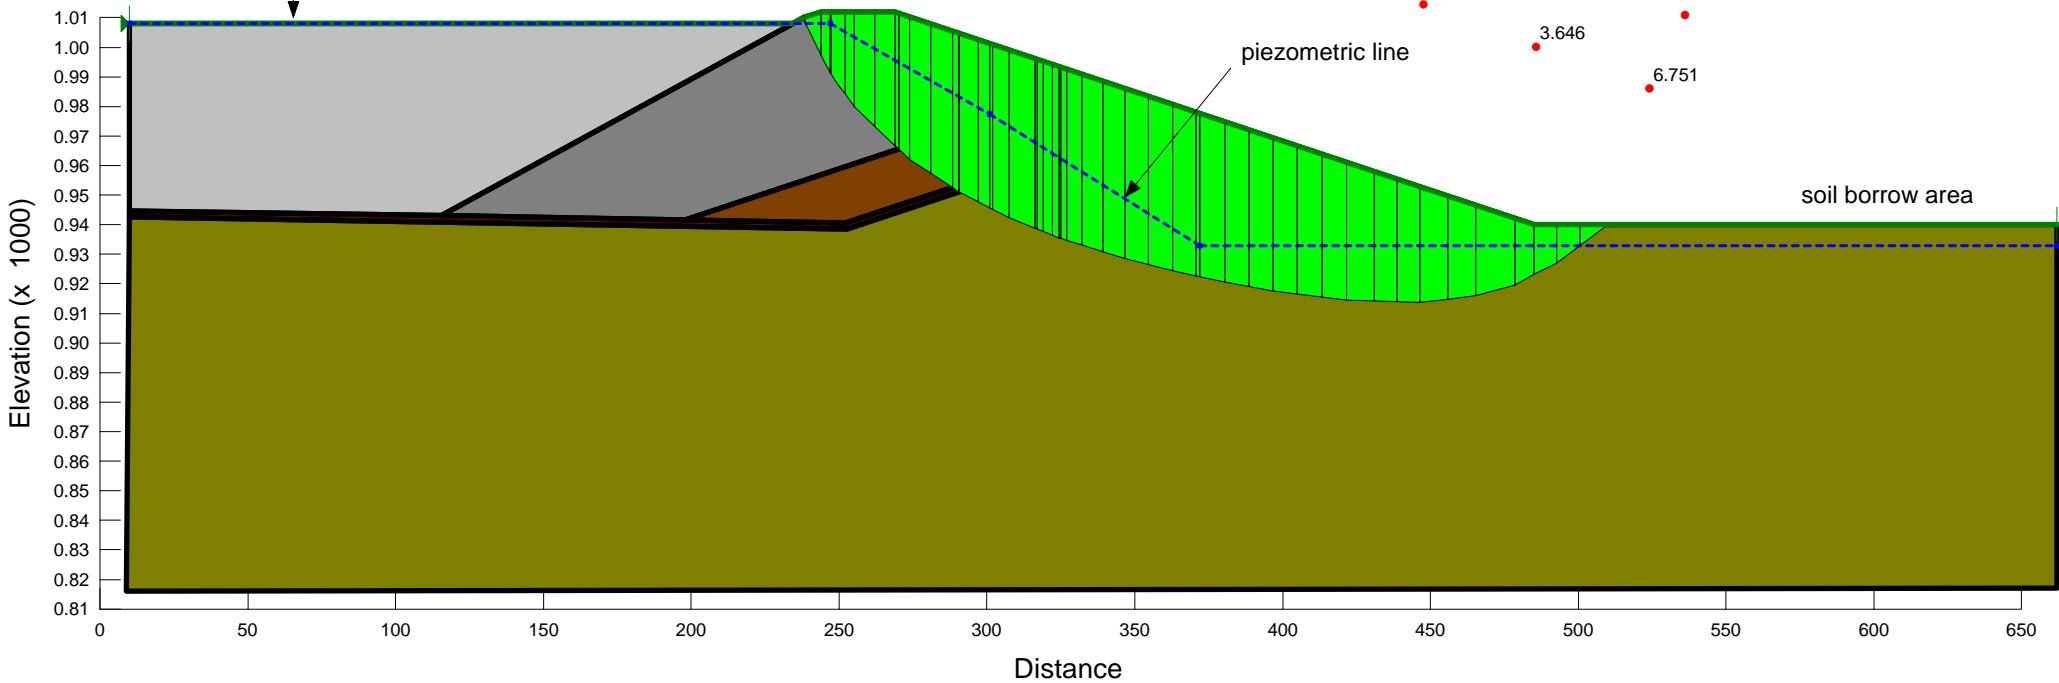
Pond 3N Condition 1: Maximum Storage Loading
Pond Elevation at 1008'
Deep Circular Failure

Pond Elevation at 1008'

The results of the static and seismic analyses are summarized below in Table 2. The full graphical results can be found in the Attachments.

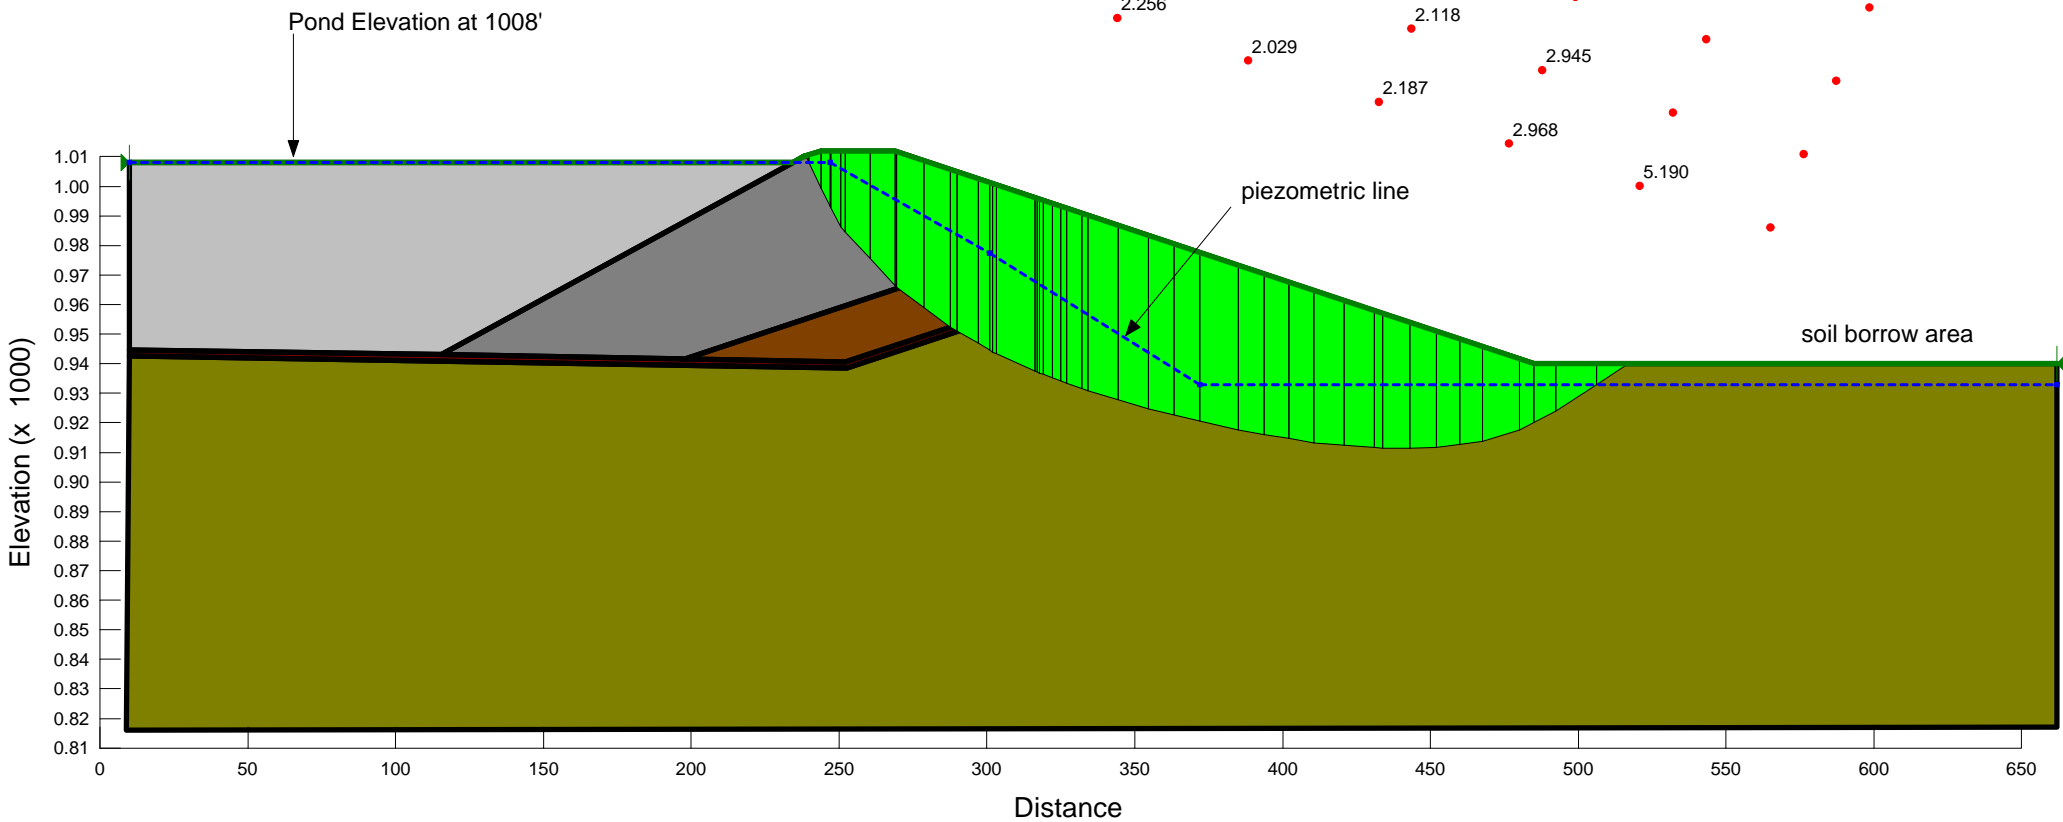
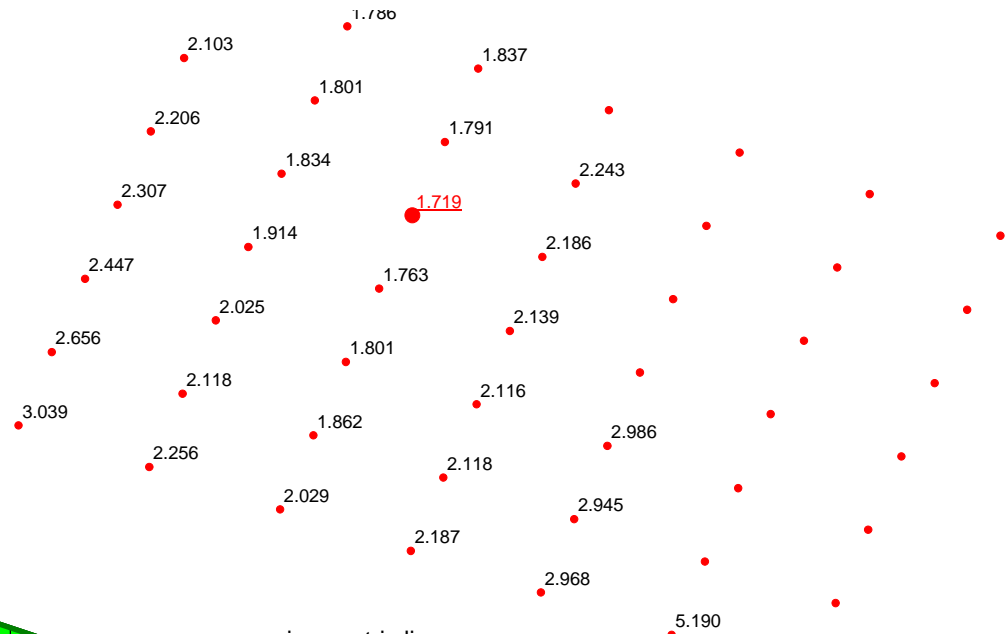
Pond 3N Condition 1: Maximum Storage Loading
Pond Elevation at 1008'
Deep Circular Failure
Seismic Analysis

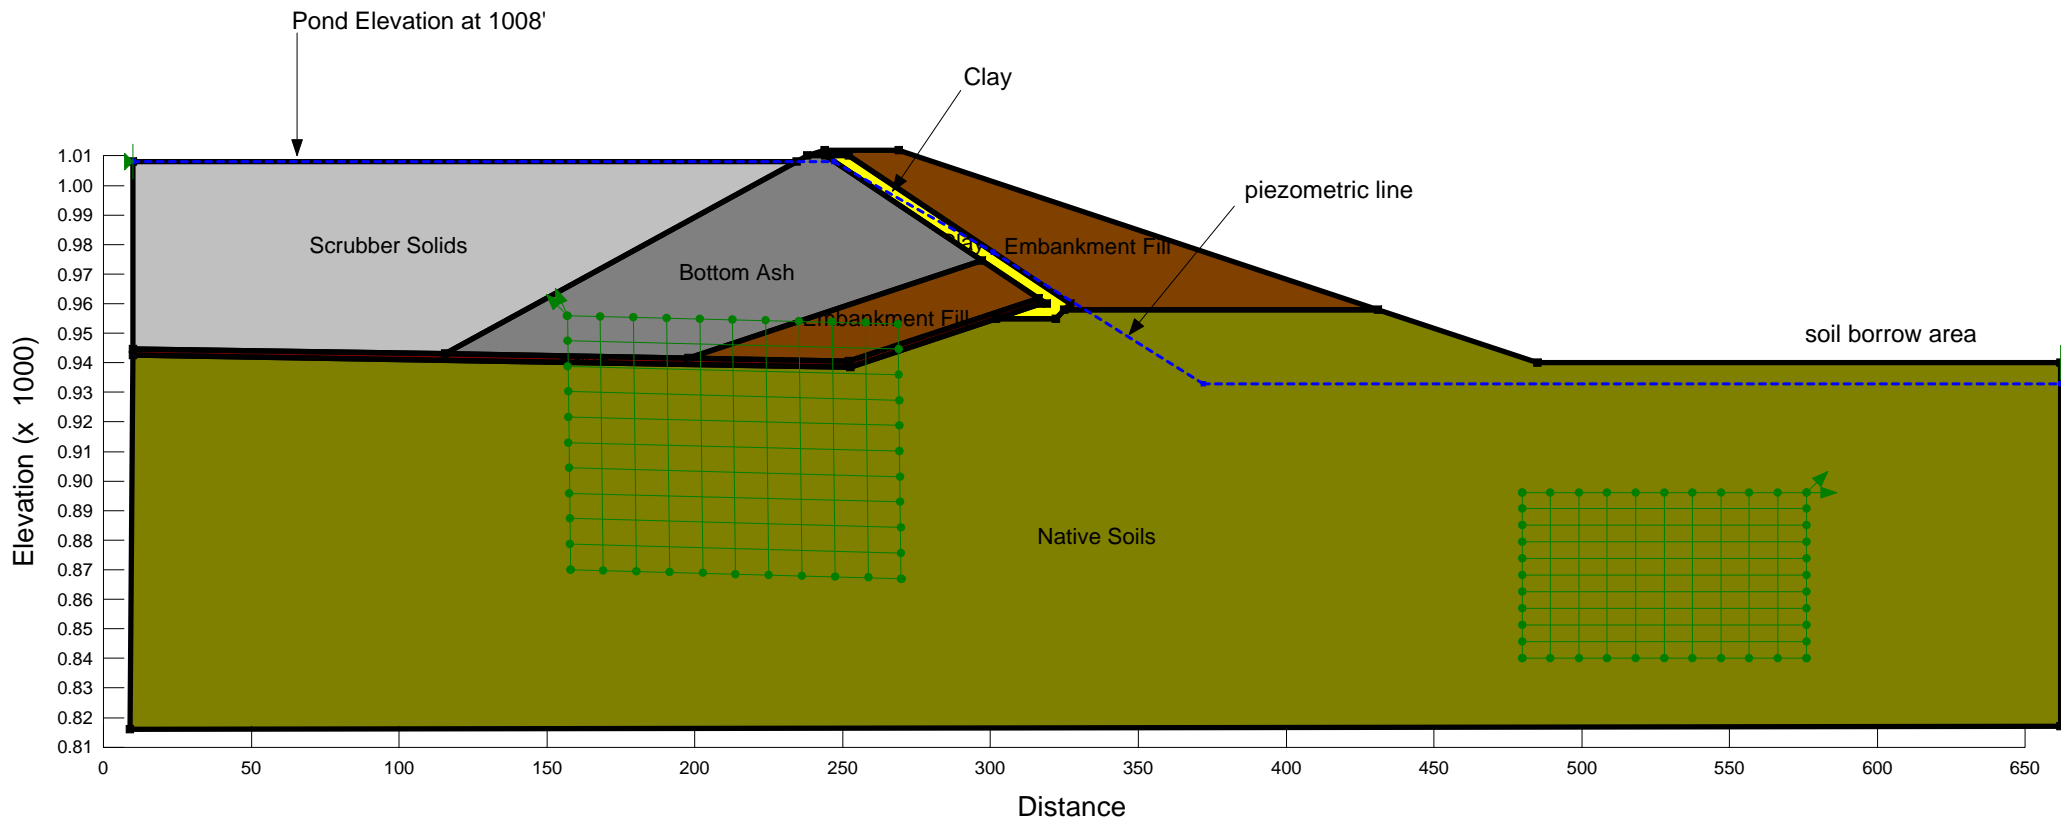
Pond 3N Condition 1: Maximum Storage Loading
Pond Elevation at 1008'
Block Failure
Pre-Analysis Diagram

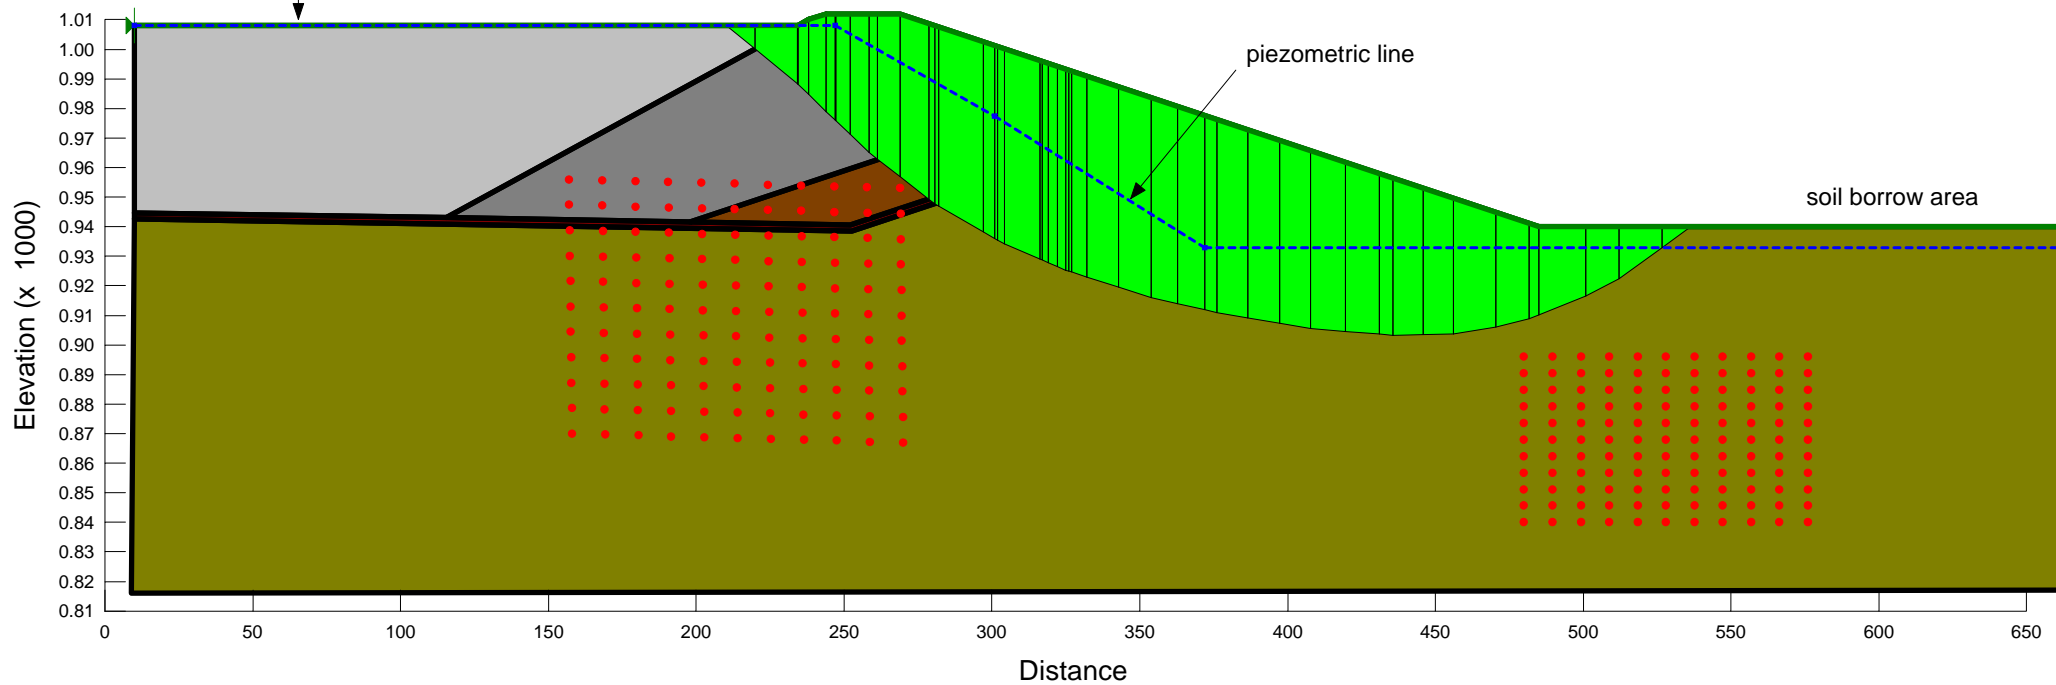
Pond 3N Condition 1: Maximum Storage Loading
Pond Elevation at 1008'
Block Failure

Pond Elevation at 1008'

1.812

piezometric line

soil borrow area

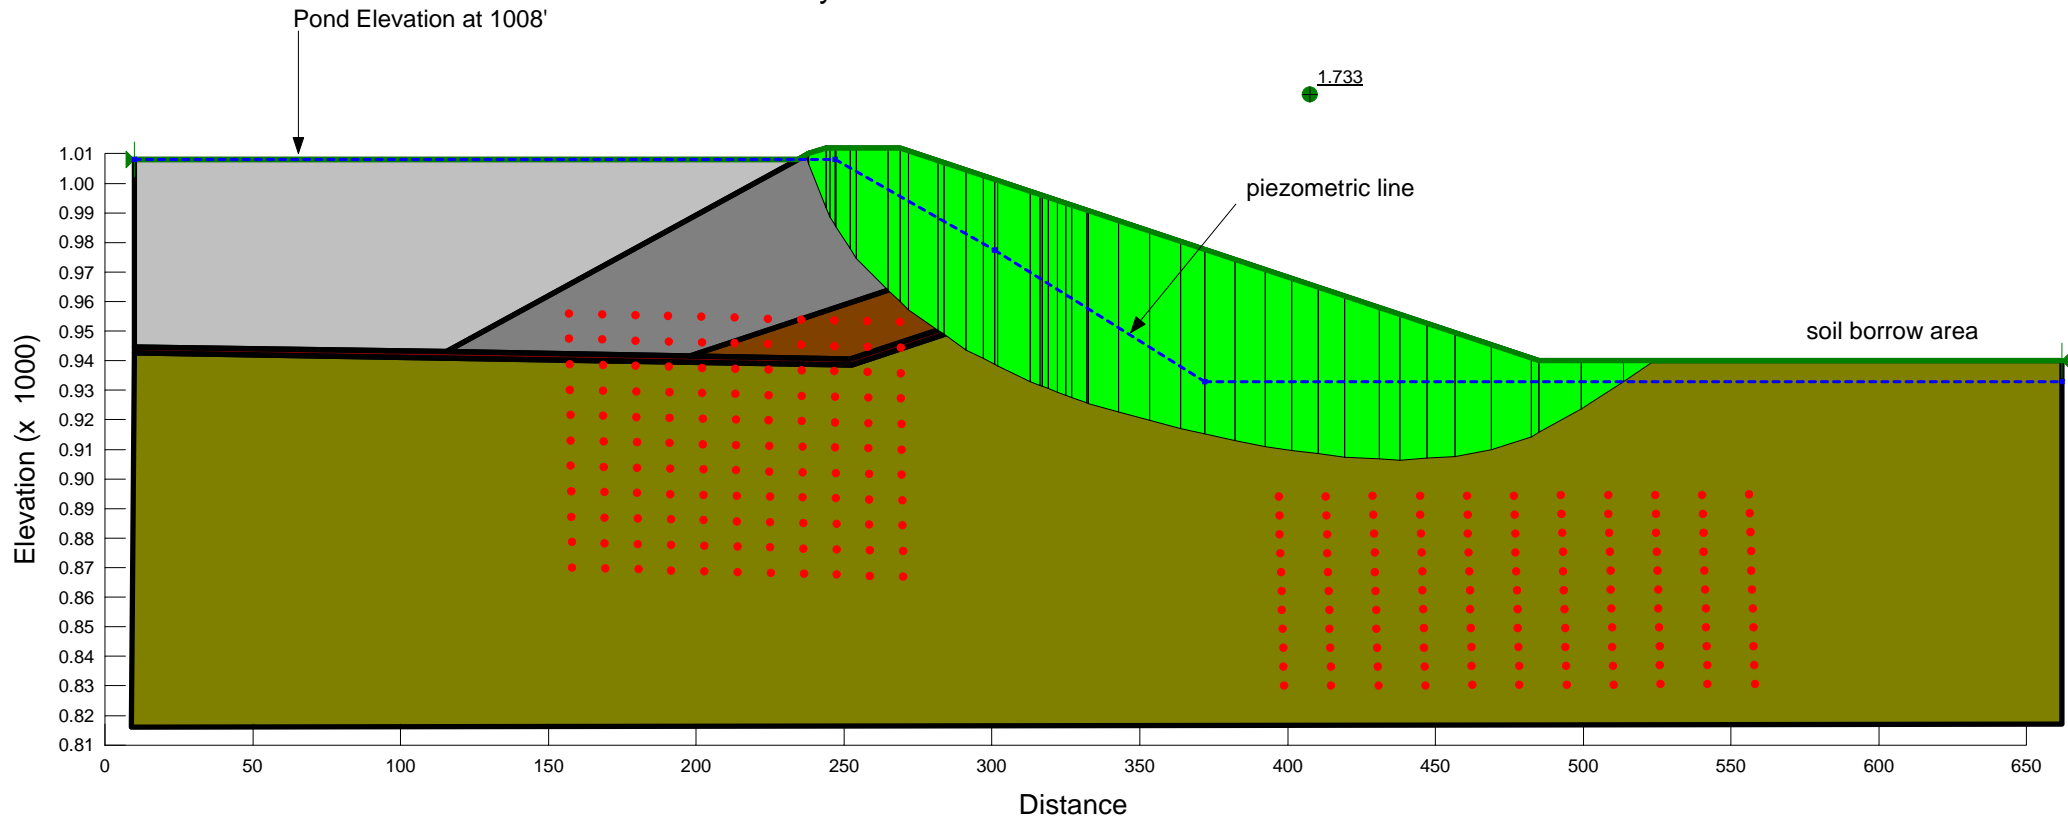
Pond 3N Condition 1: Maximum Storage Loading
Pond Elevation at 1008'
Block Failure
Seismic Analysis

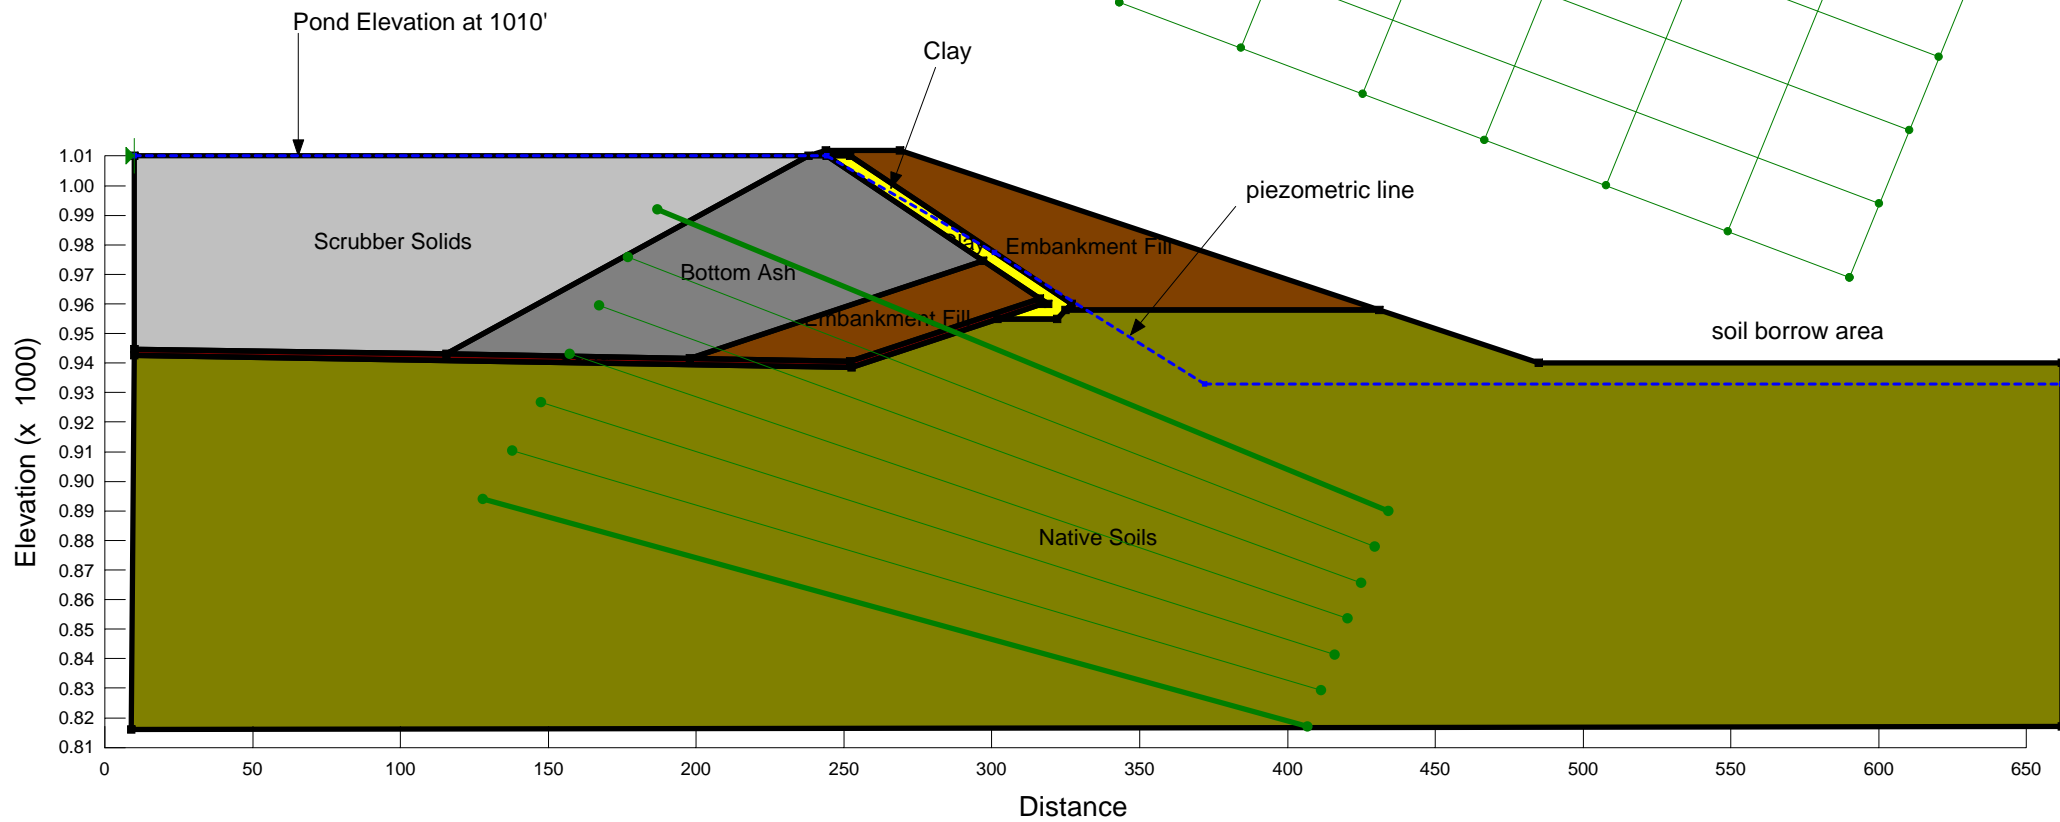
Pond 3N Condition 2: Maximum Surcharge Loading
Pond Elevation at 1010'
Deep Circular Failure
Pre-Analysis Diagram

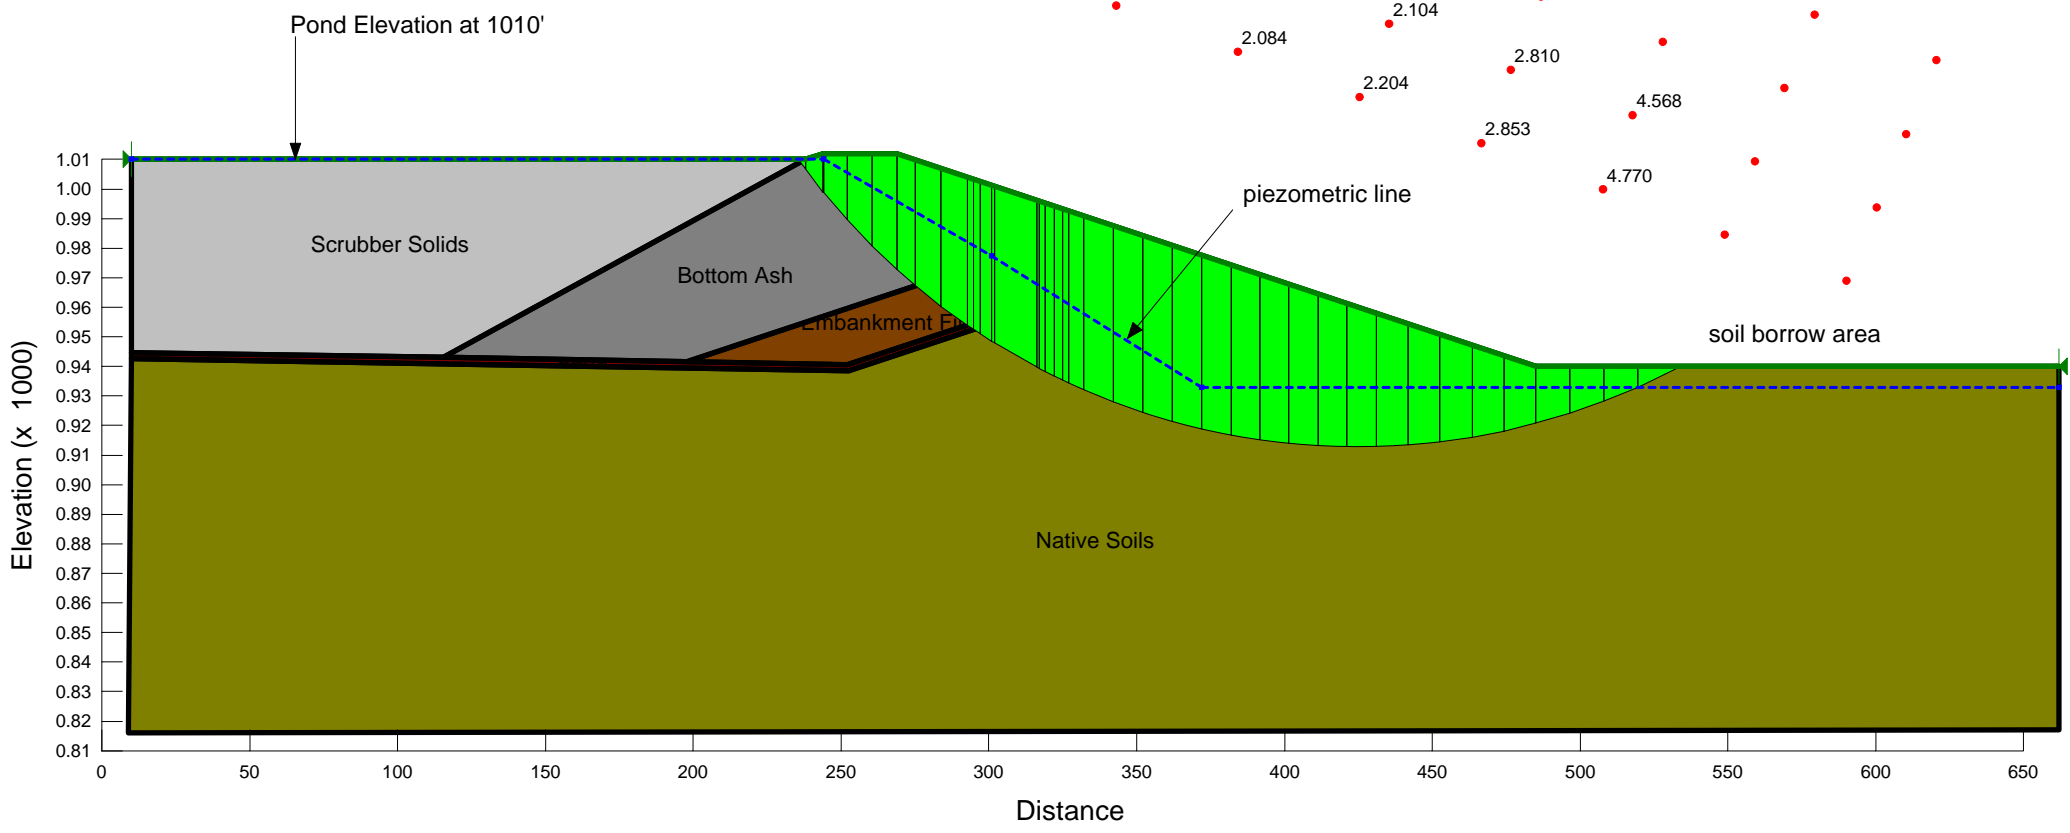
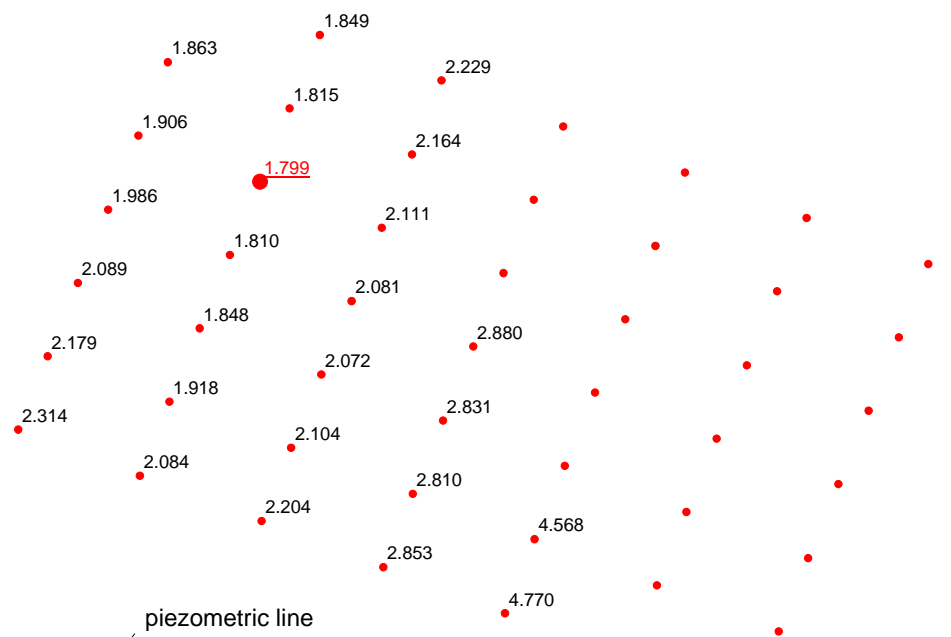
Pond 3N Condition 2: Maximum Surcharge Loading
Pond Elevation at 1010'
Deep Circular Failure

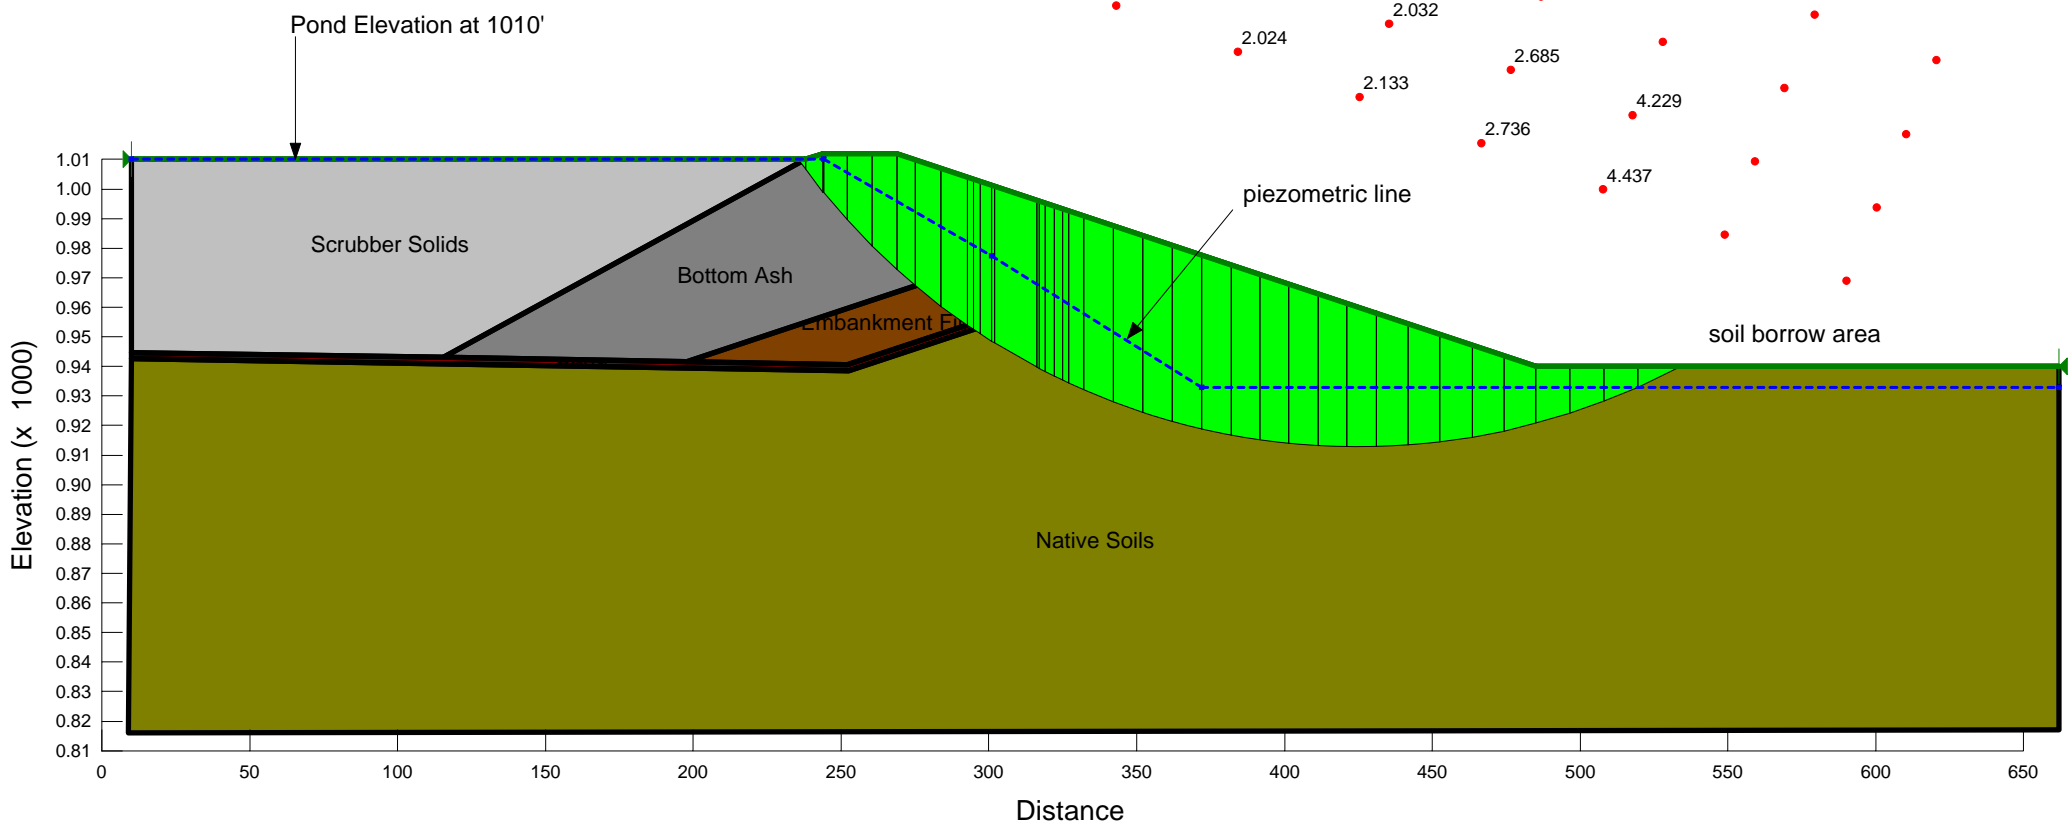
Pond 3N Condition 2: Maximum Surcharge Loading
Pond Elevation at 1010'
Deep Circular Failure
Seismic Analysis

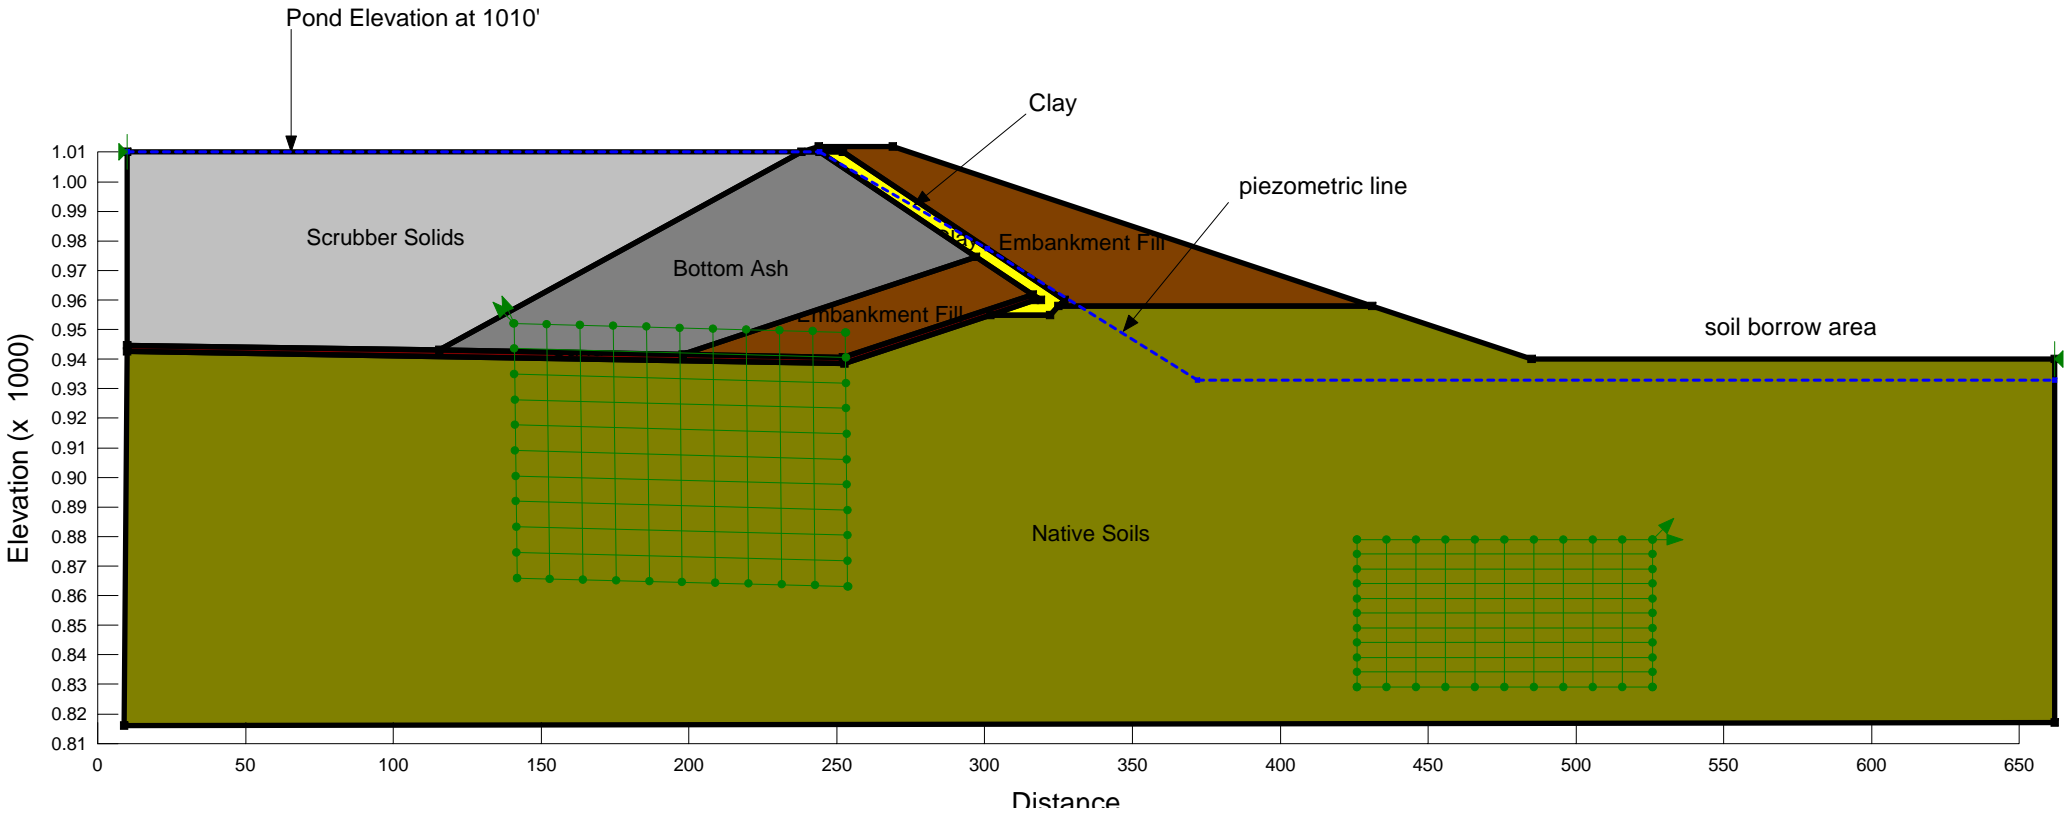
Pond 3N Condition 2: Maximum Surcharge Loading
Pond Elevation at 1010'
Block Failure
Pre-Analysis Diagram

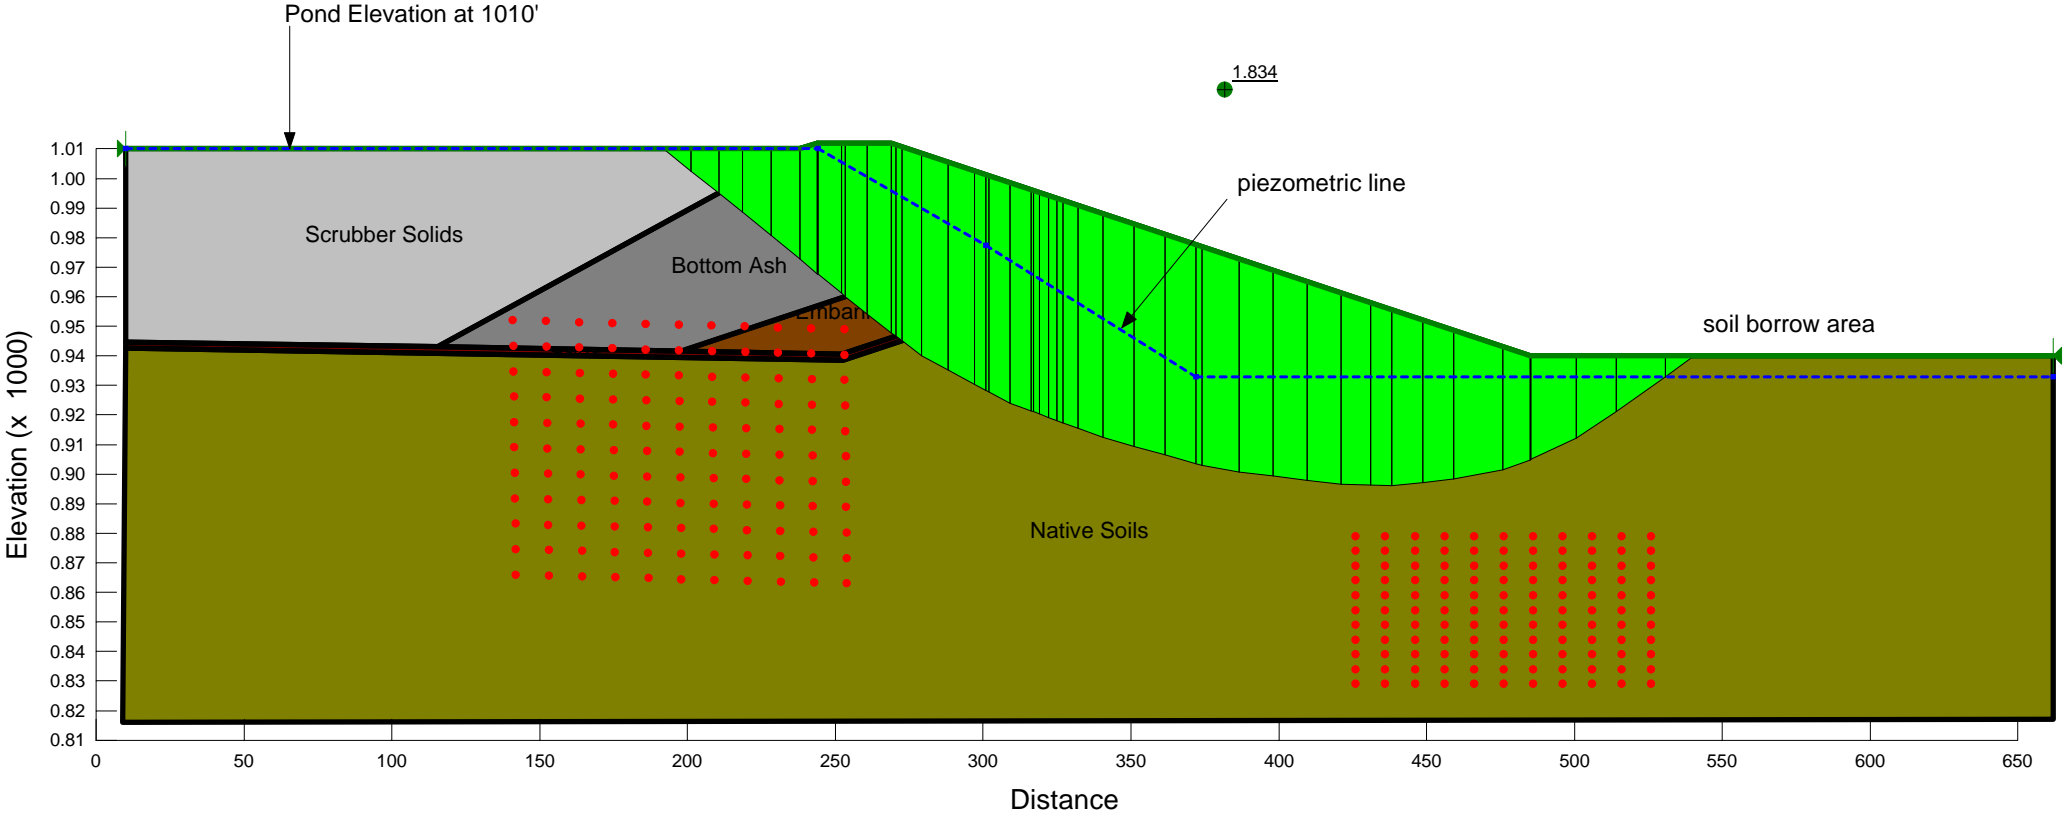
Pond 3N Condition 2: Maximum Surcharge Loading
Pond Elevation at 1010'
Block Failure

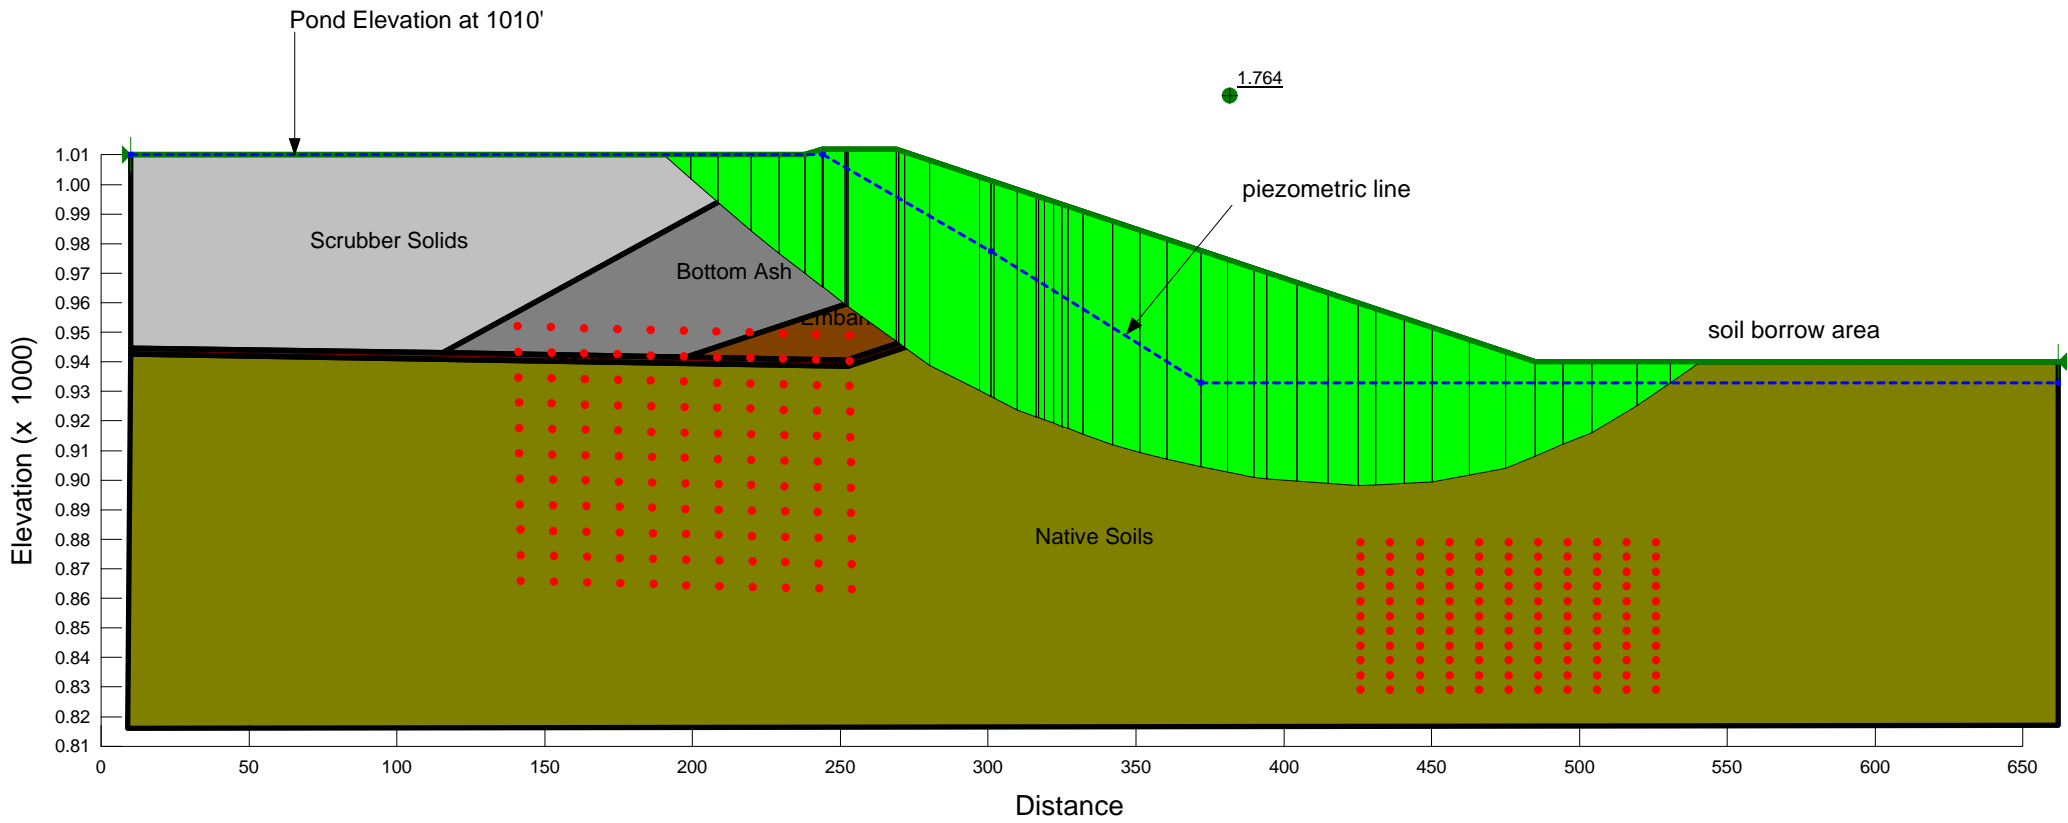
Pond 3N Condition 2: Maximum Surcharge Loading
Pond Elevation at 1010'
Block Failure
Seismic Analysis

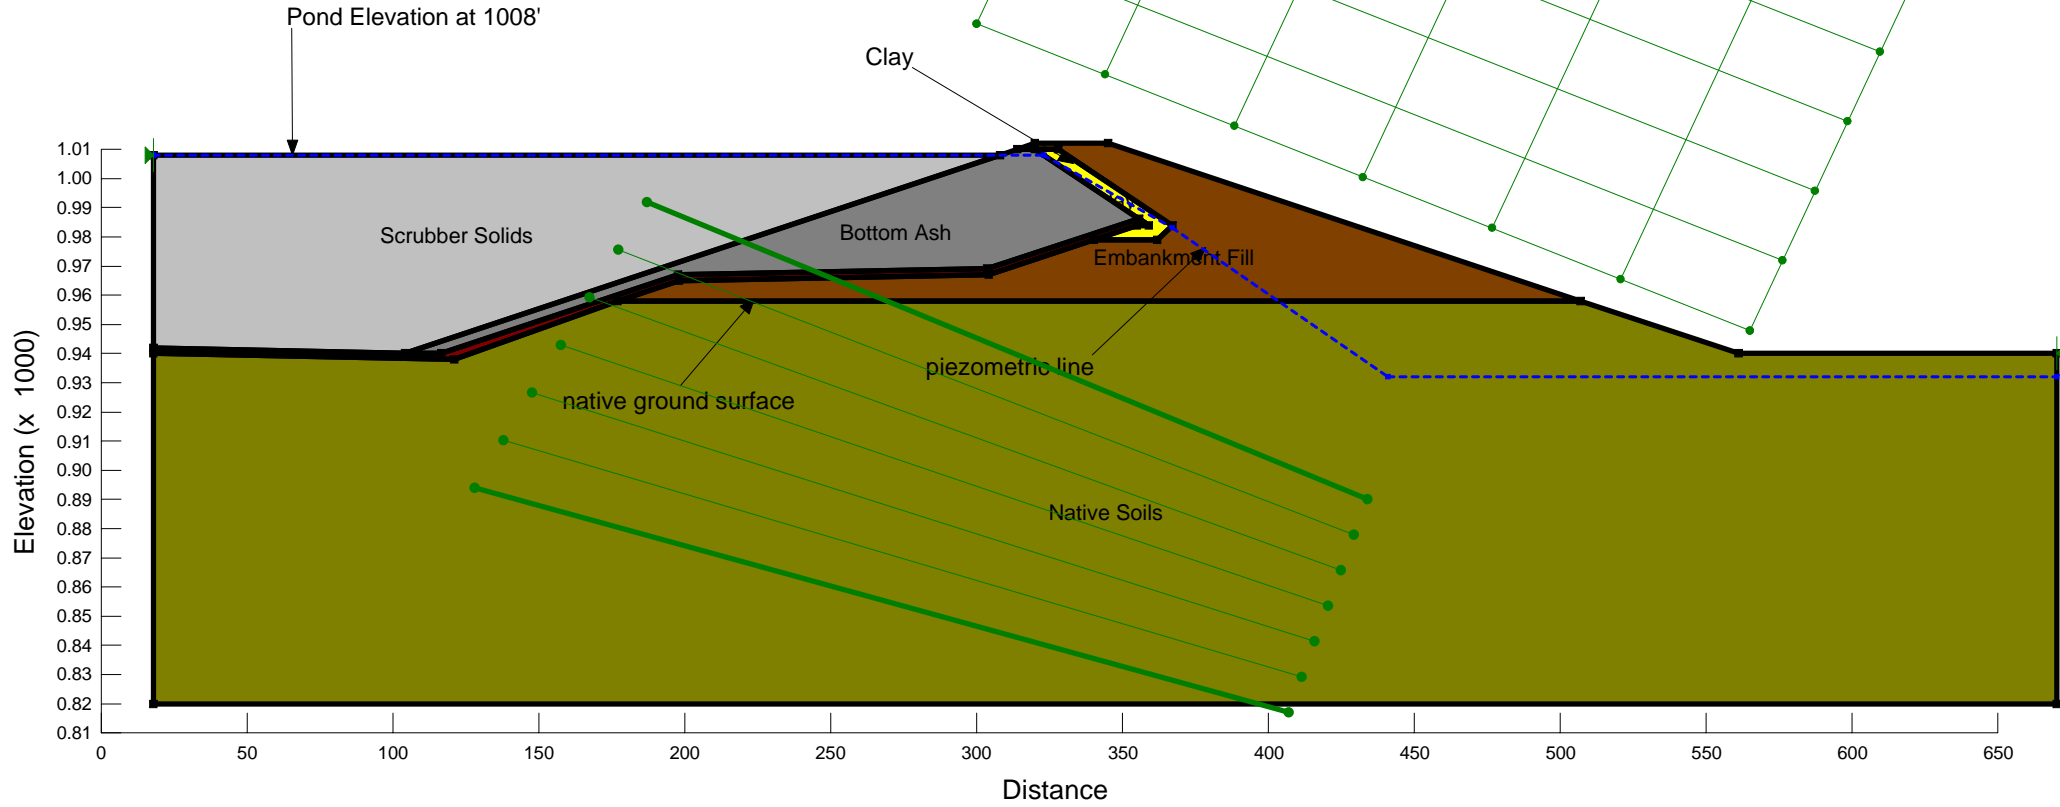
Pond 3S Condition 1: Long Term, Storage Loading
Pond Elevation at 1008'
Deep Circular Failure
Pre-Analysis Diagram
