Periodic Safety Factor Assessment Scrubber Solids Pond No. 3 Sherburne County Generating Plant

Introduction

Safety Factor Assessment

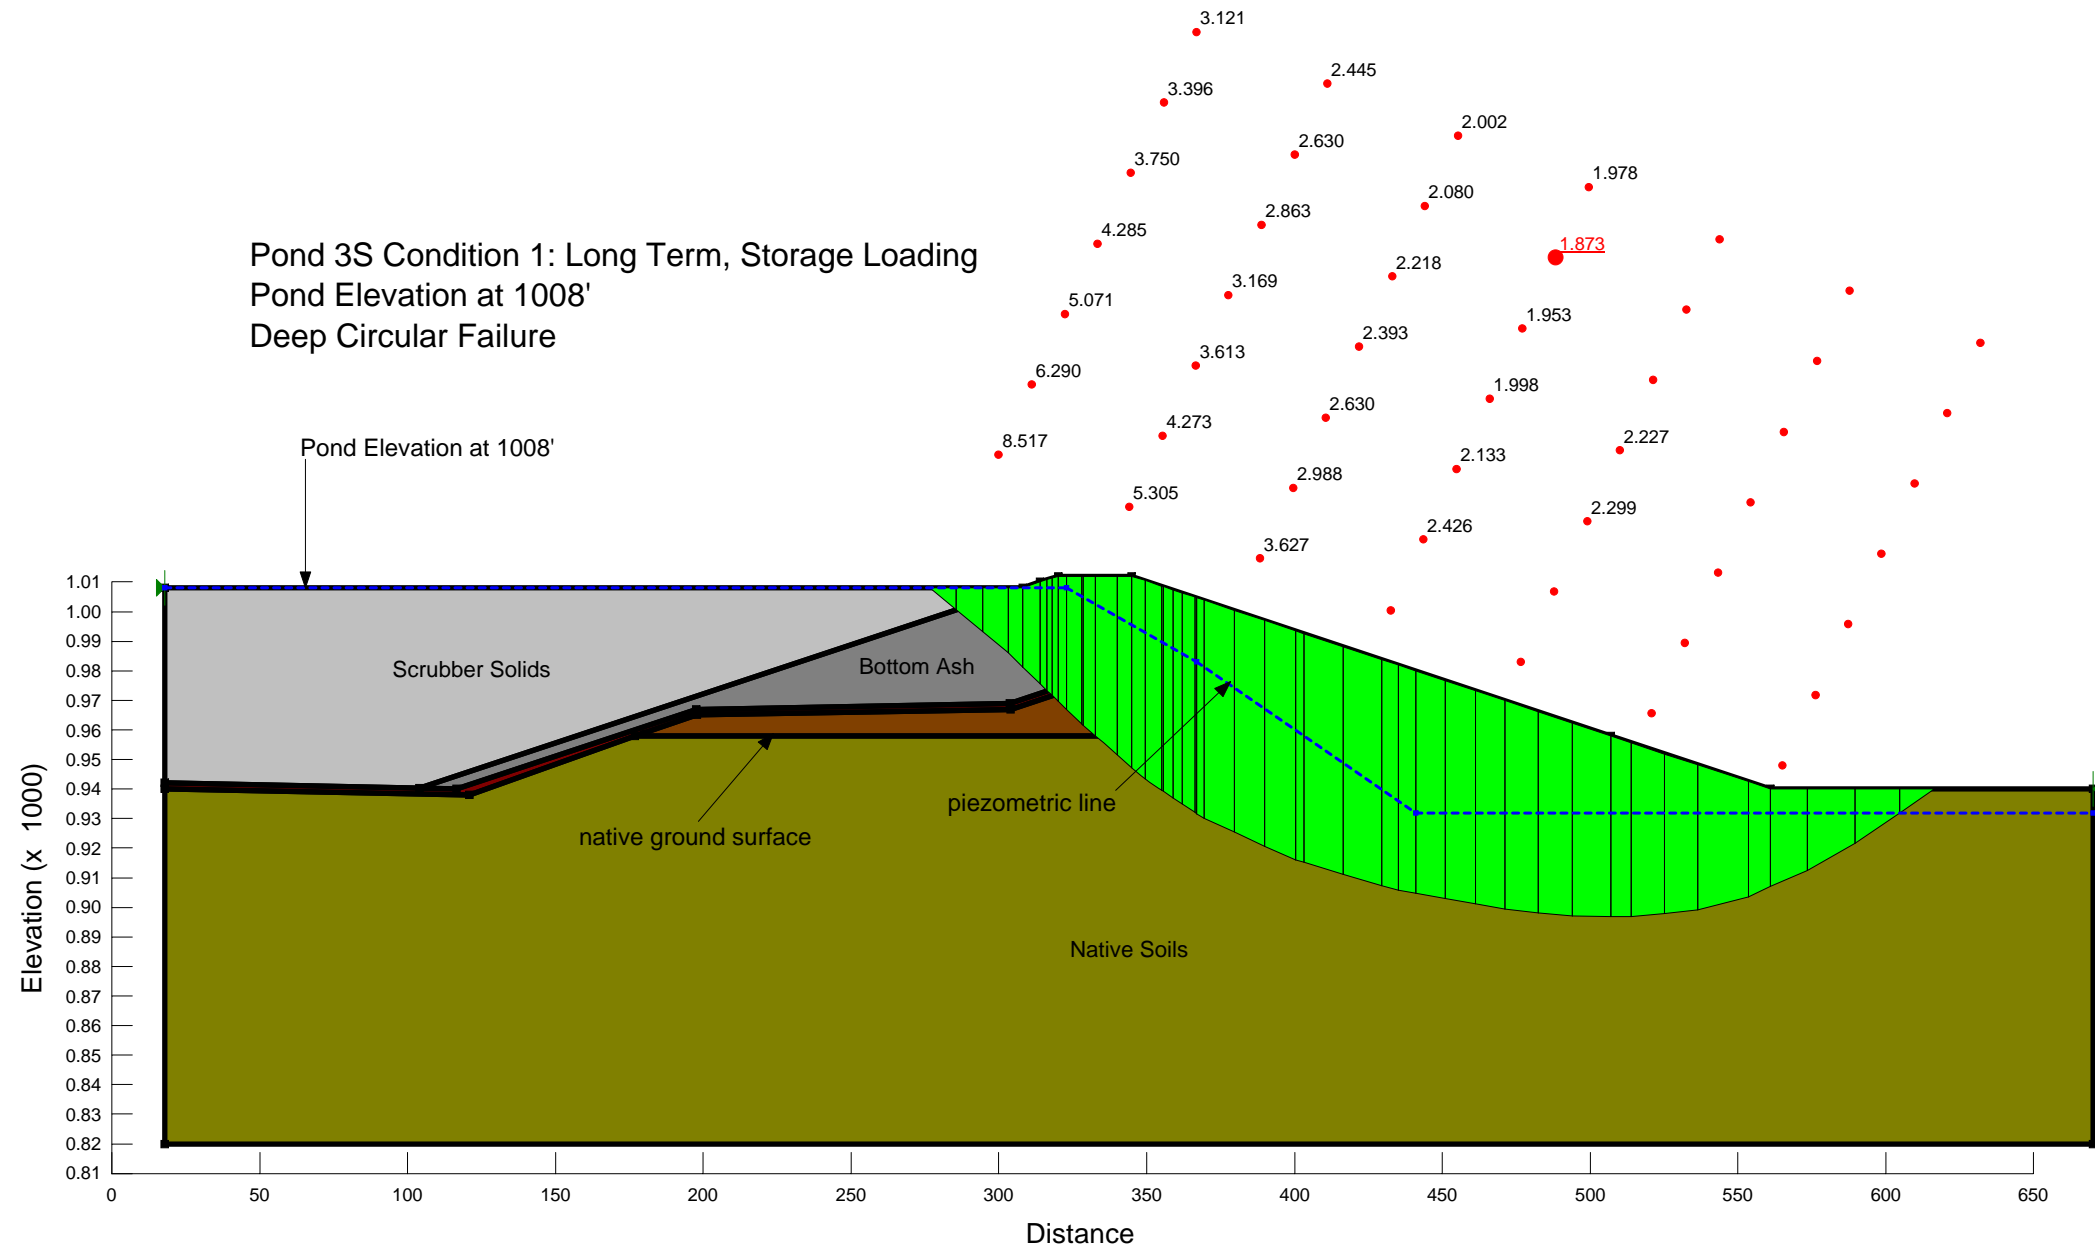
Pond 3S Condition 1: Long Term, Storage Loading
Pond Elevation at 1008'
Deep Circular Failure

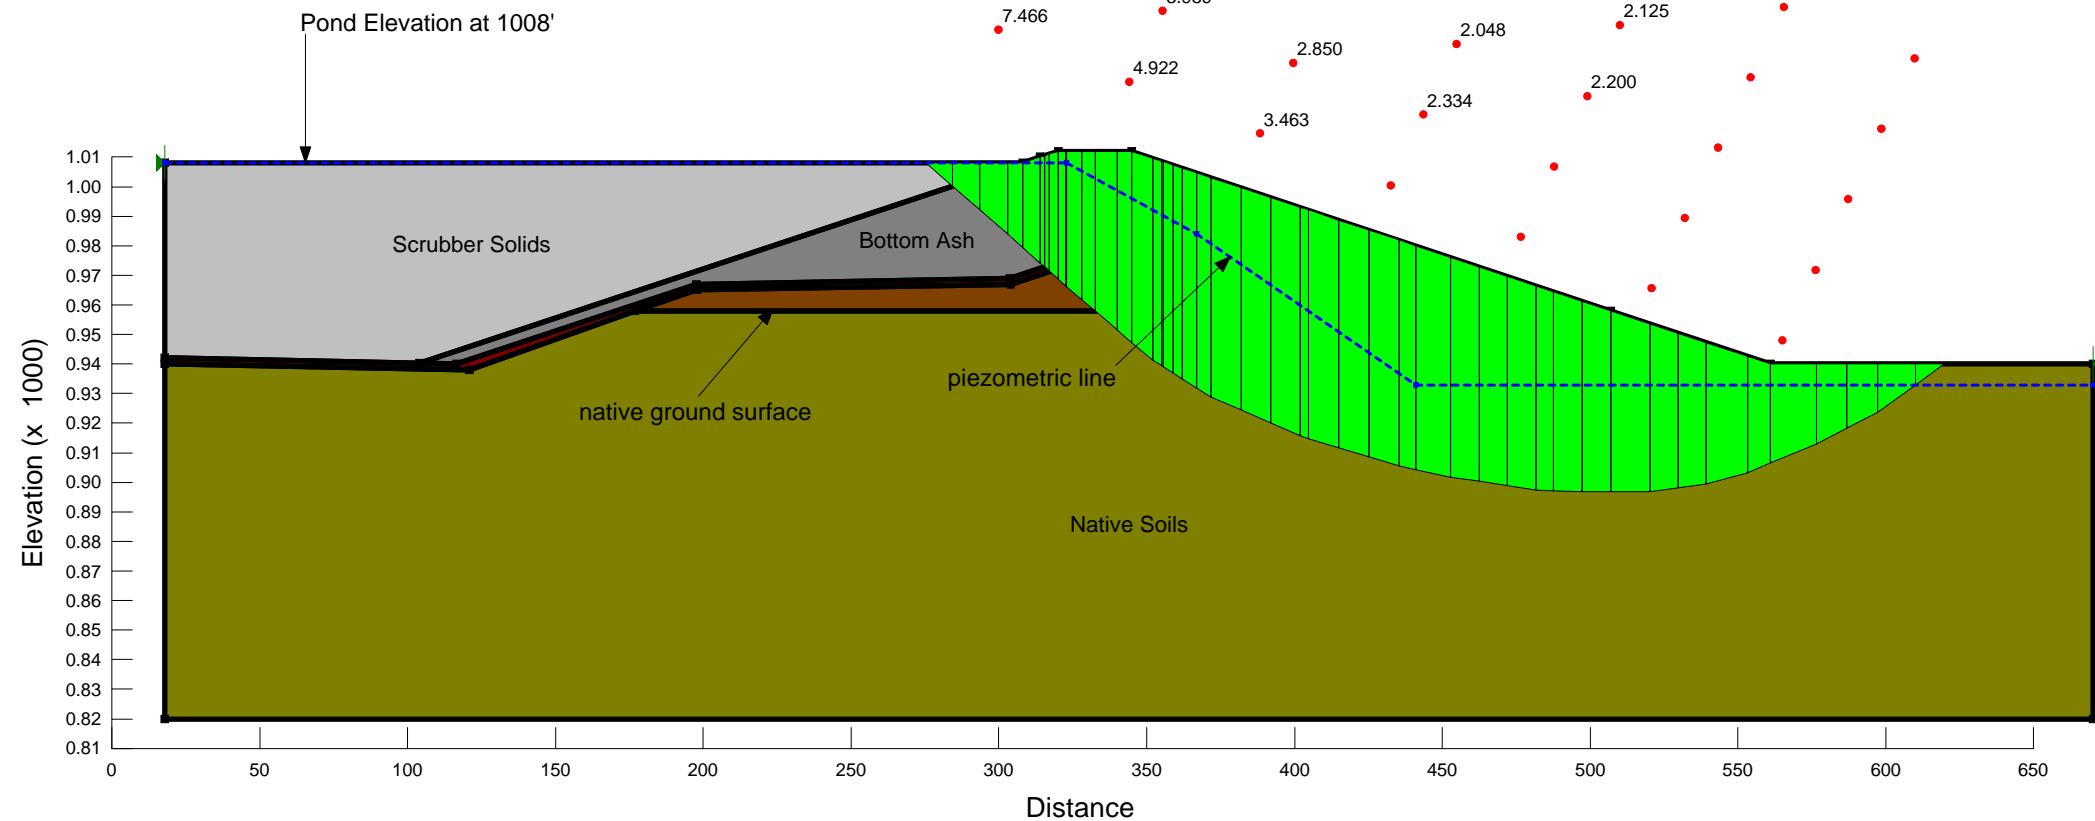
Pond 3S Condition 1: Long Term, Maximum Storage Loading
Pond Elevation at 1008'
Deep Circular Failure
Seismic Analysis

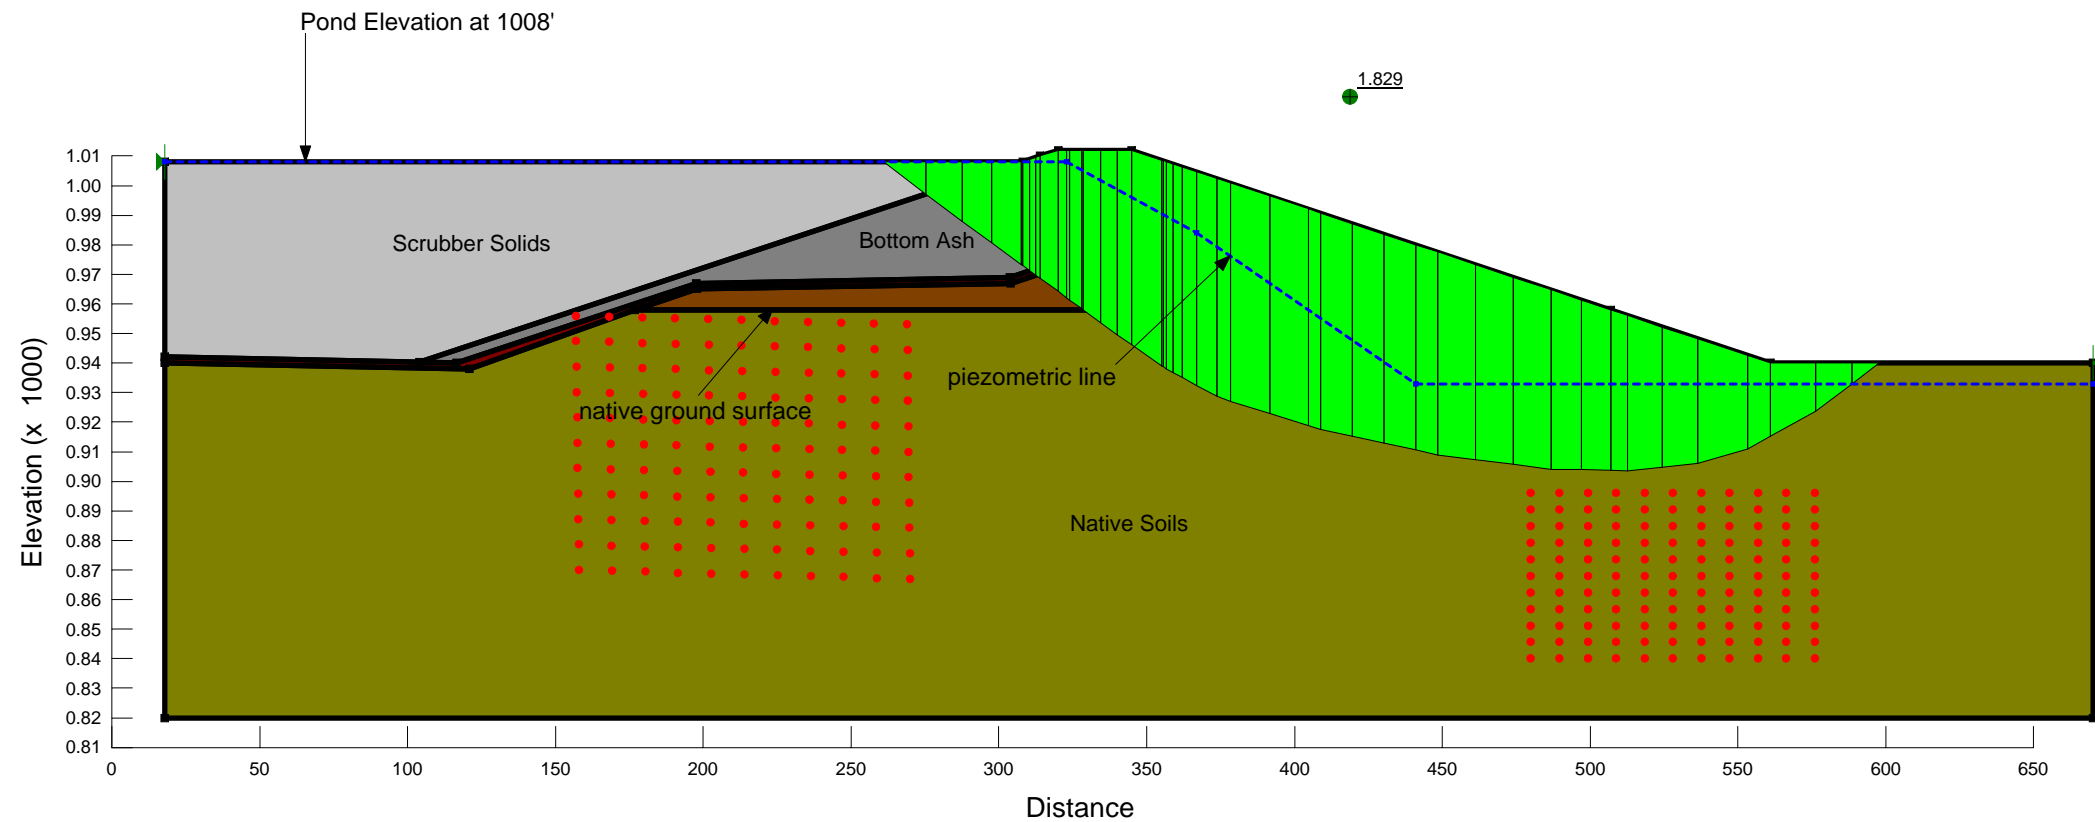
Pond 3S Condition 1: Long Term, Maximum Storage Loading
Pond Elevation at 1008'
Block Failure

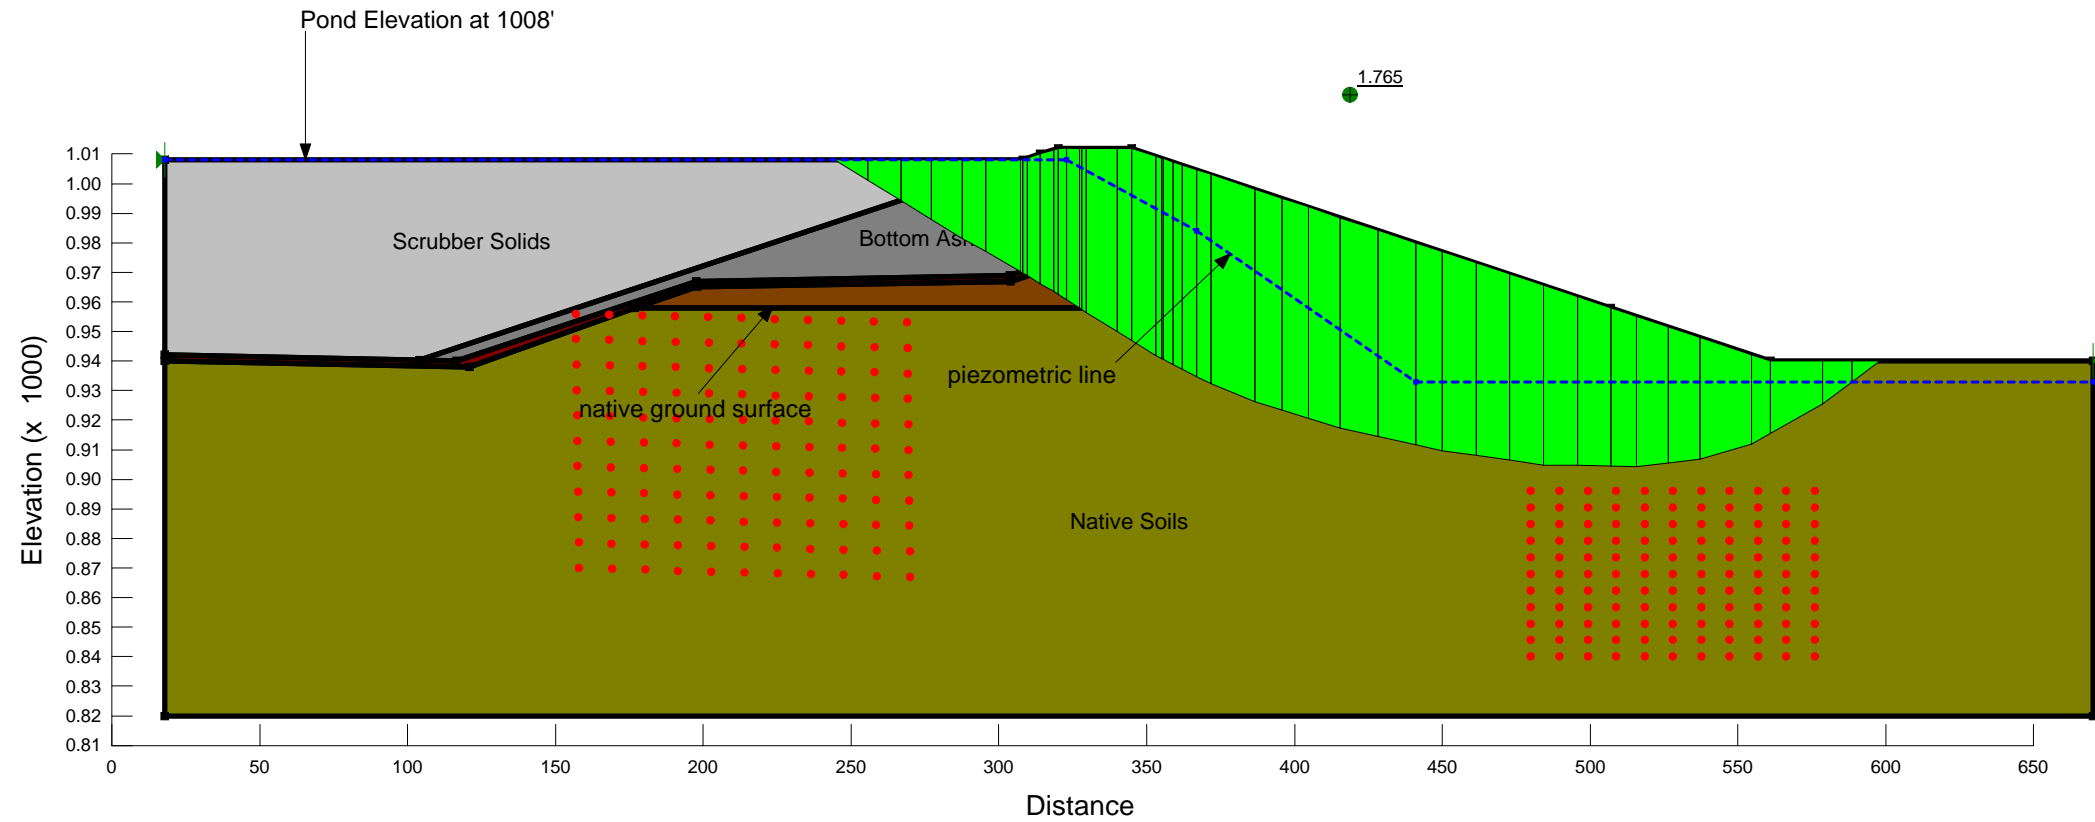
Pond 3S Condition 1: Long Term, Maximum Storage Loading
Pond Elevation at 1008'
Block Failure
Seismic Analysis

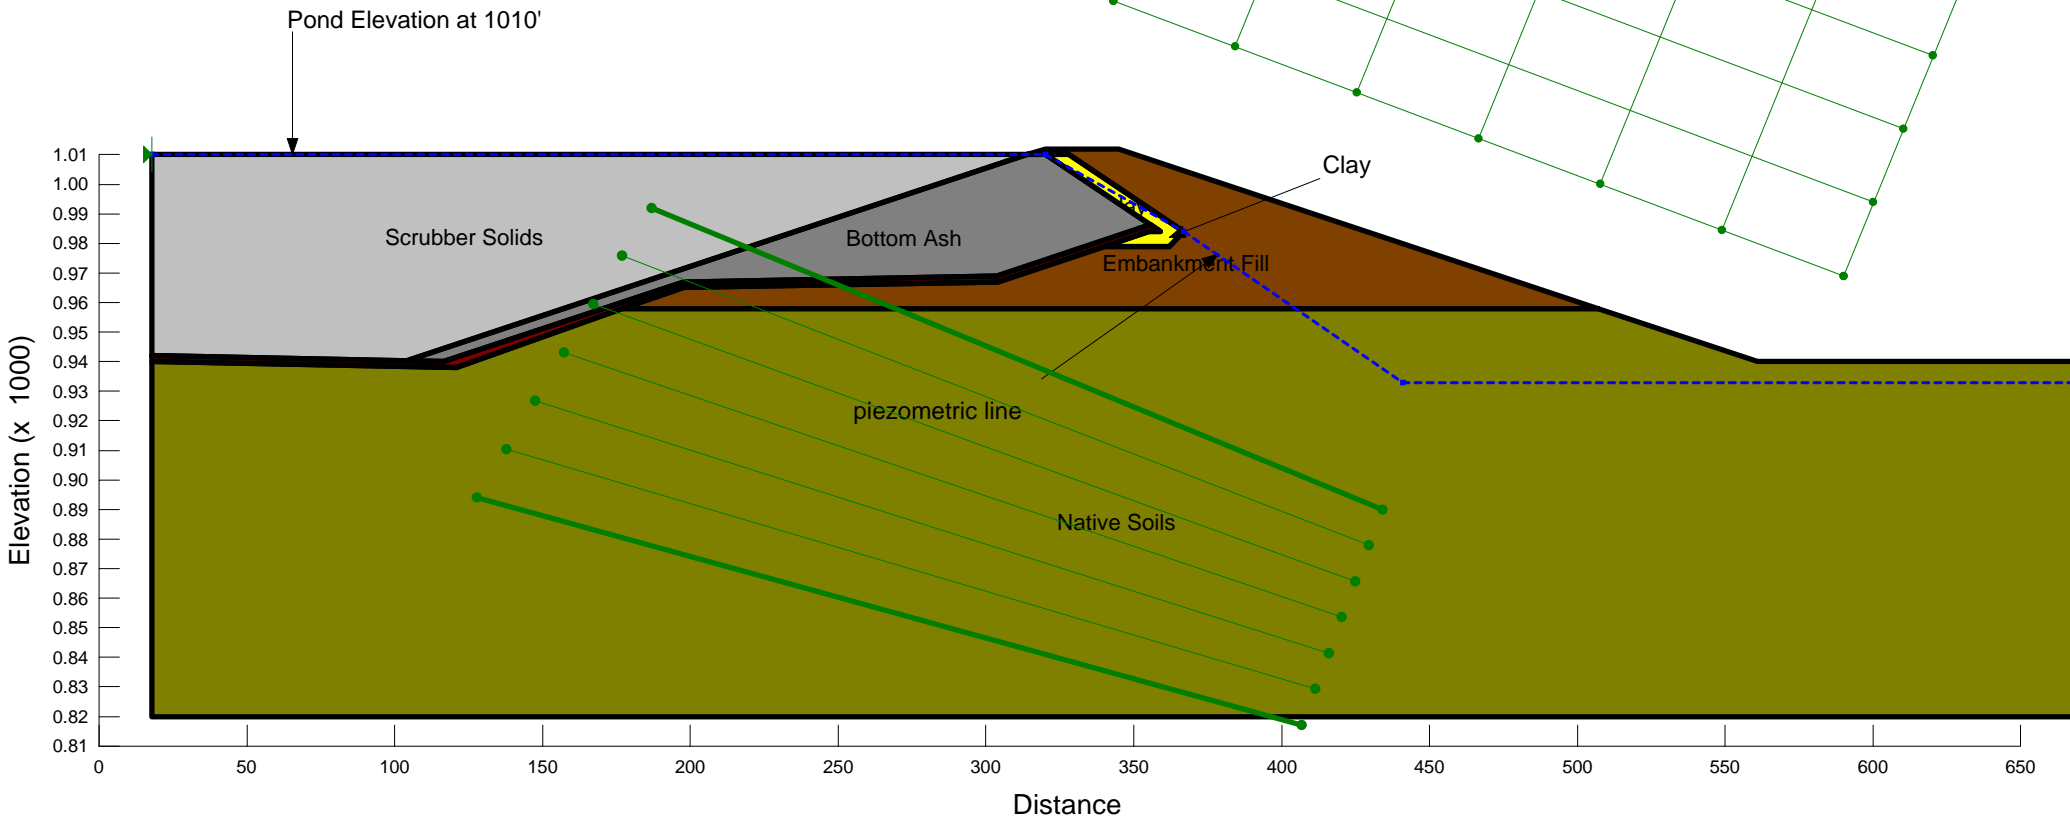
Pond 3S Condition 2: Maximum Surcharge Loading
Pond Elevation at 1010'
Deep Circular Failure
Pre-Analysis Diagram

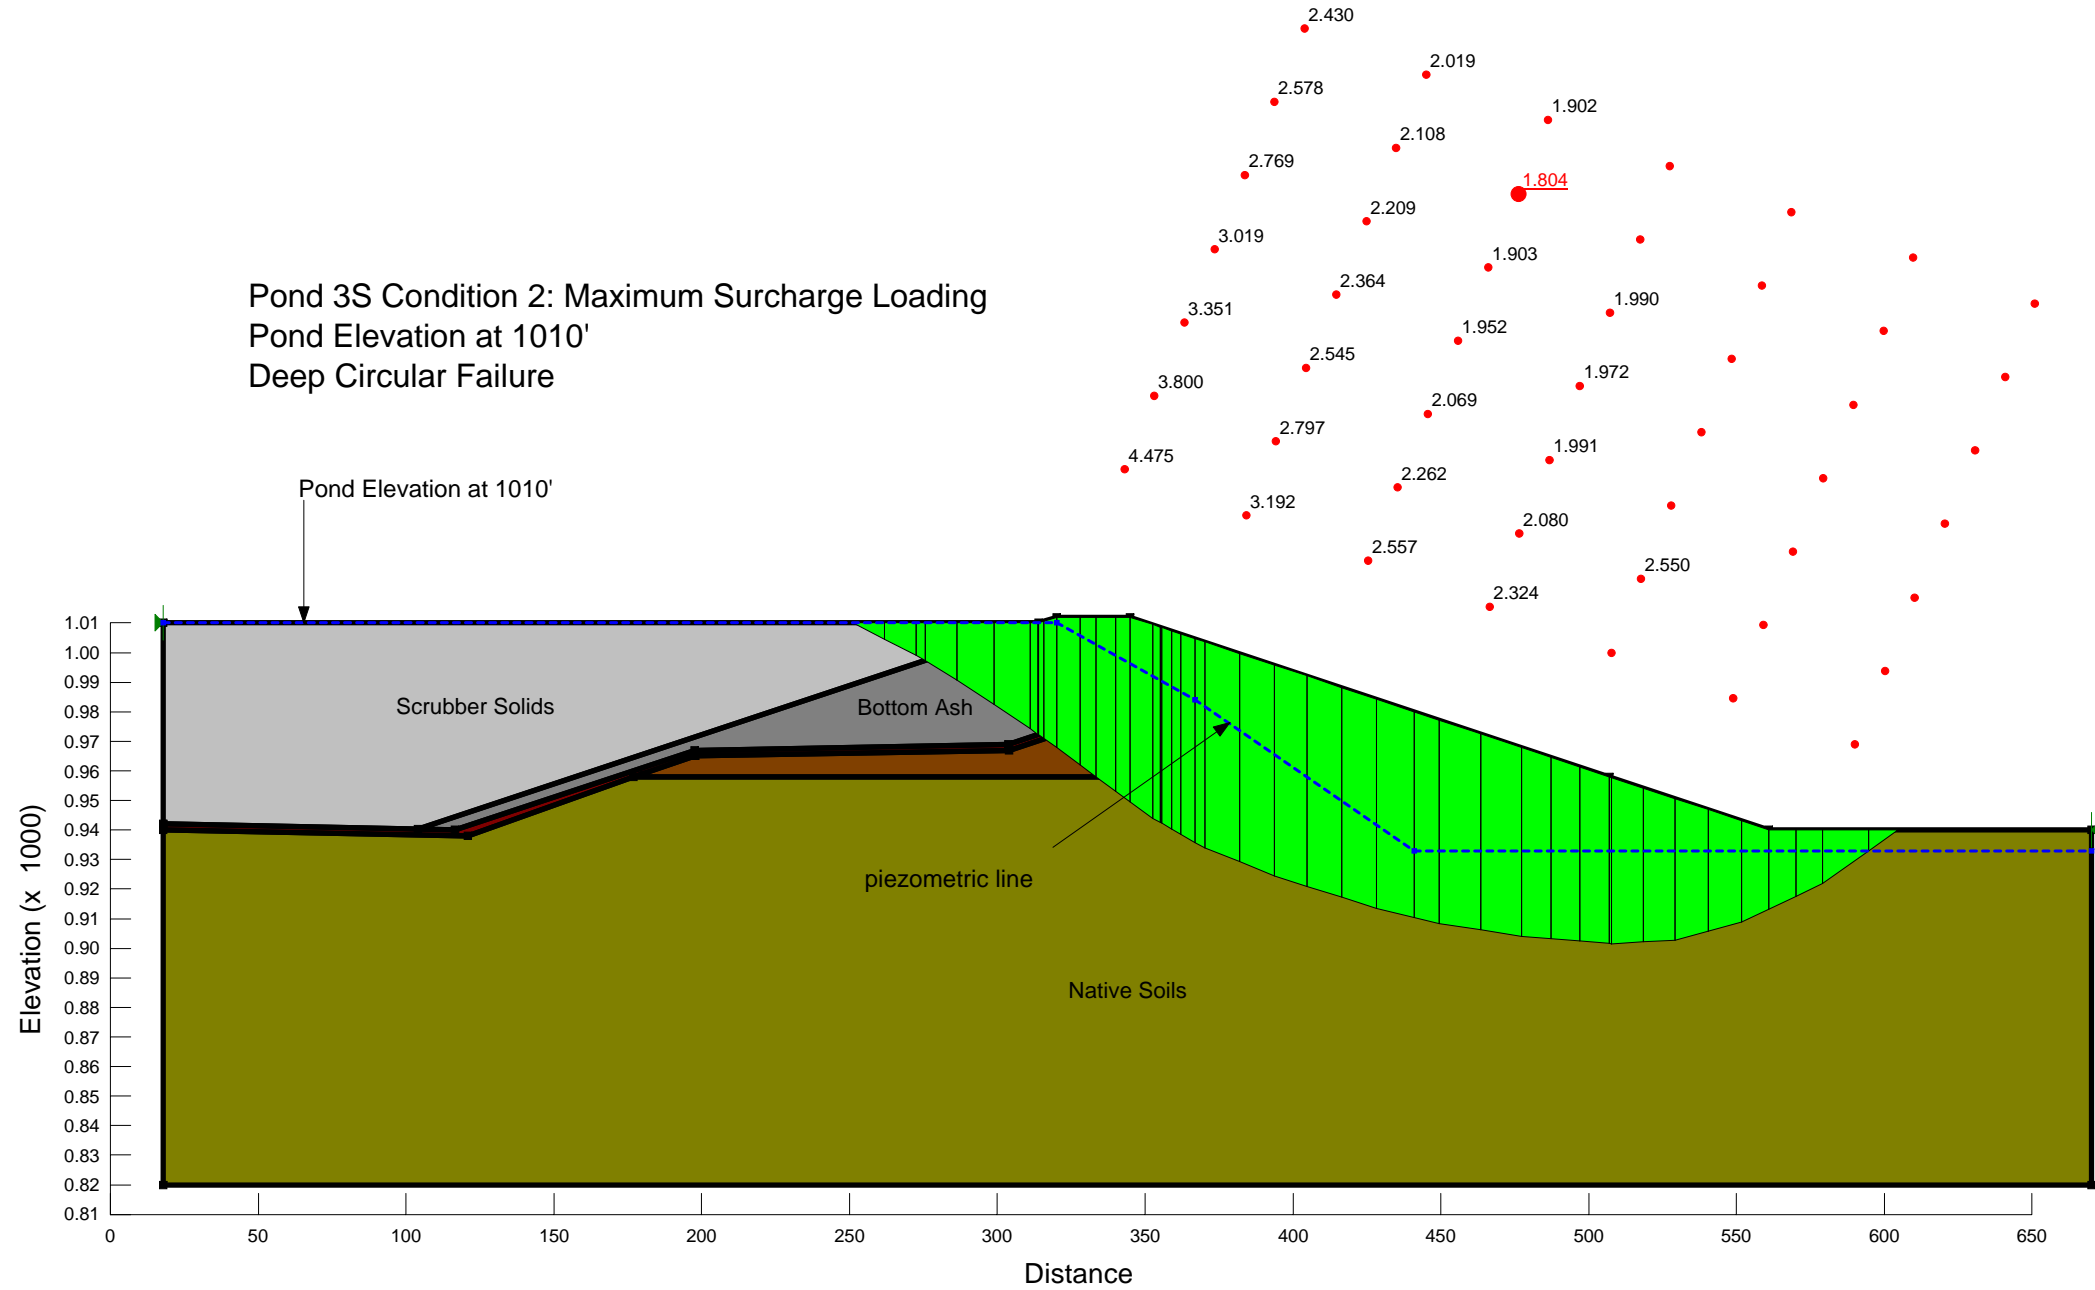
Pond 3S Condition 2: Maximum Surcharge Loading
Pond Elevation at 1010'
Deep Circular Failure

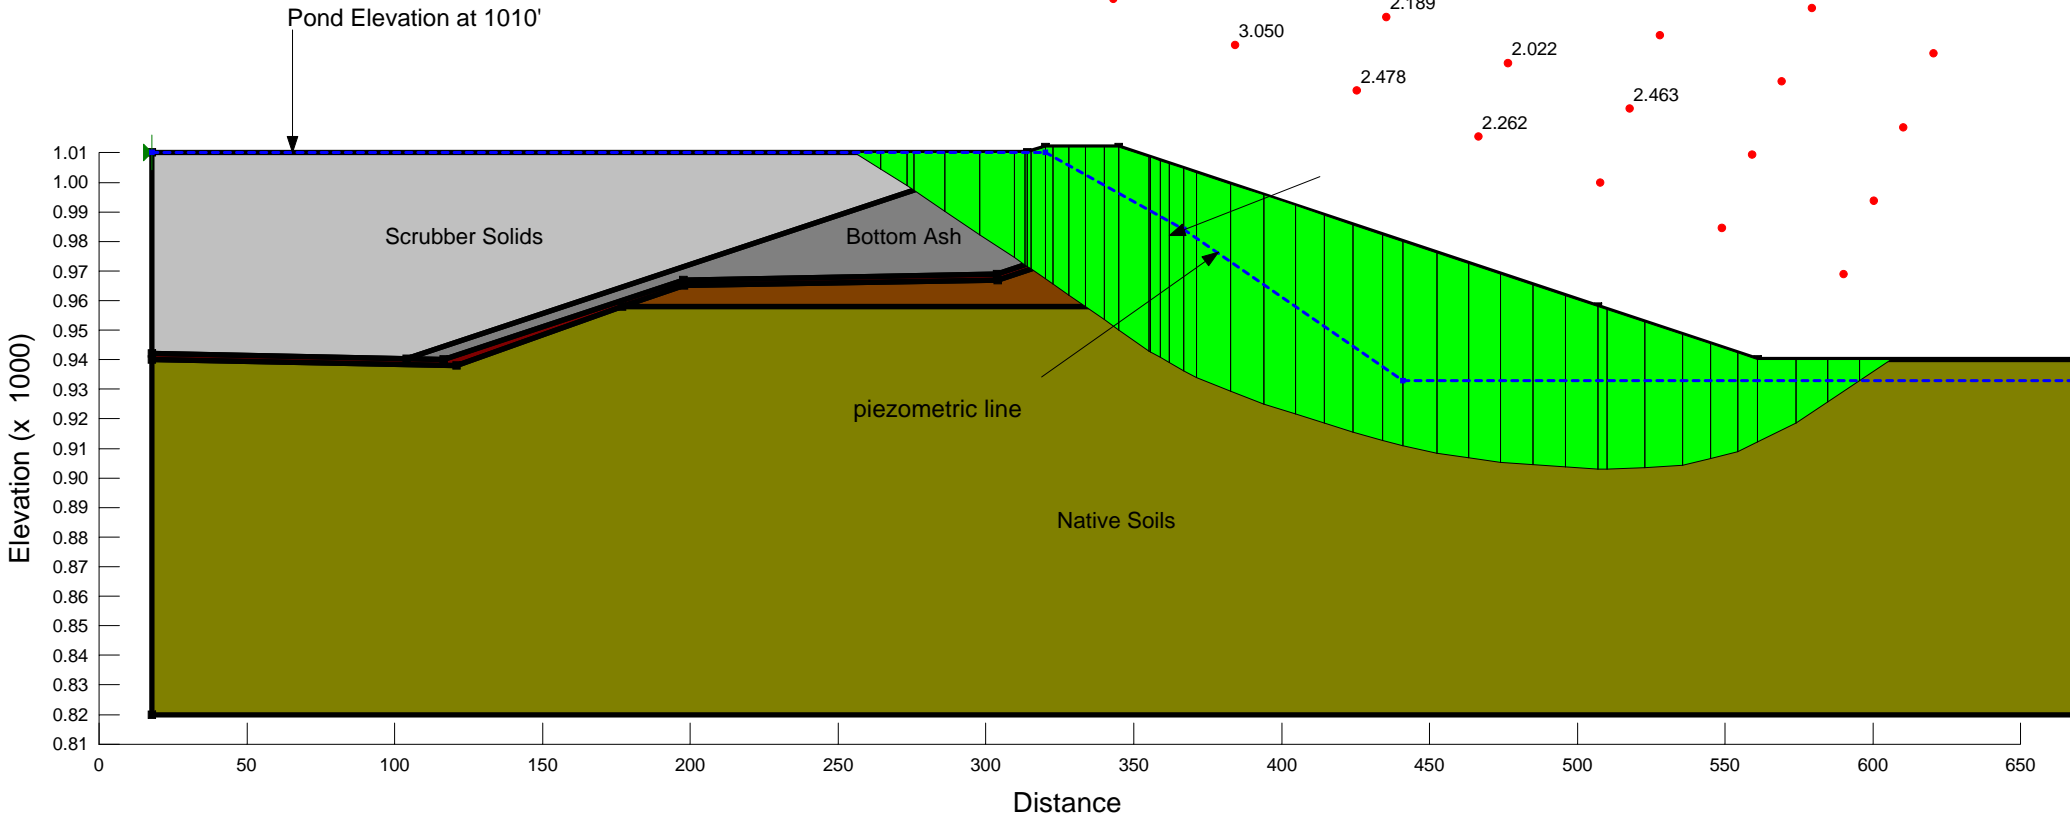
Pond 3S Condition 2: Maximum Surcharge Loading
Pond Elevation at 1010'
Deep Circular Failure
Seismic Analysis

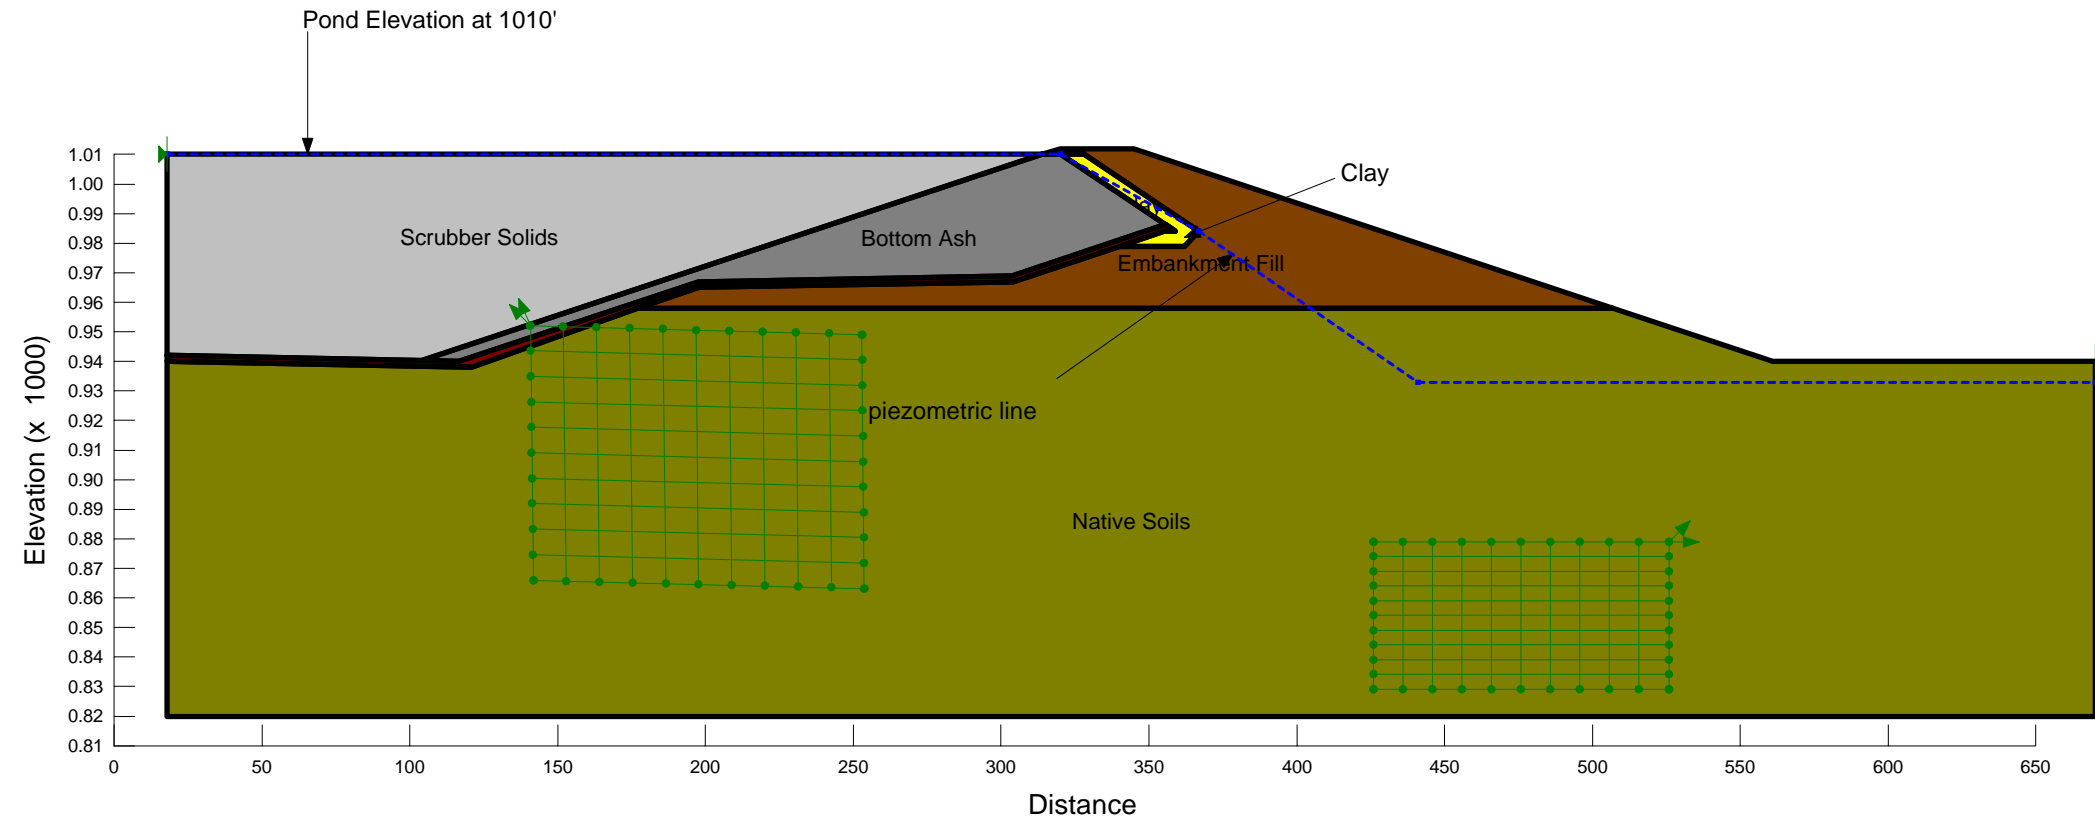
Pond 3S Condition 2: Maximum Surcharge Loading
Pond Elevation at 1010'
Block Failure
Pre-Analysis Diagram

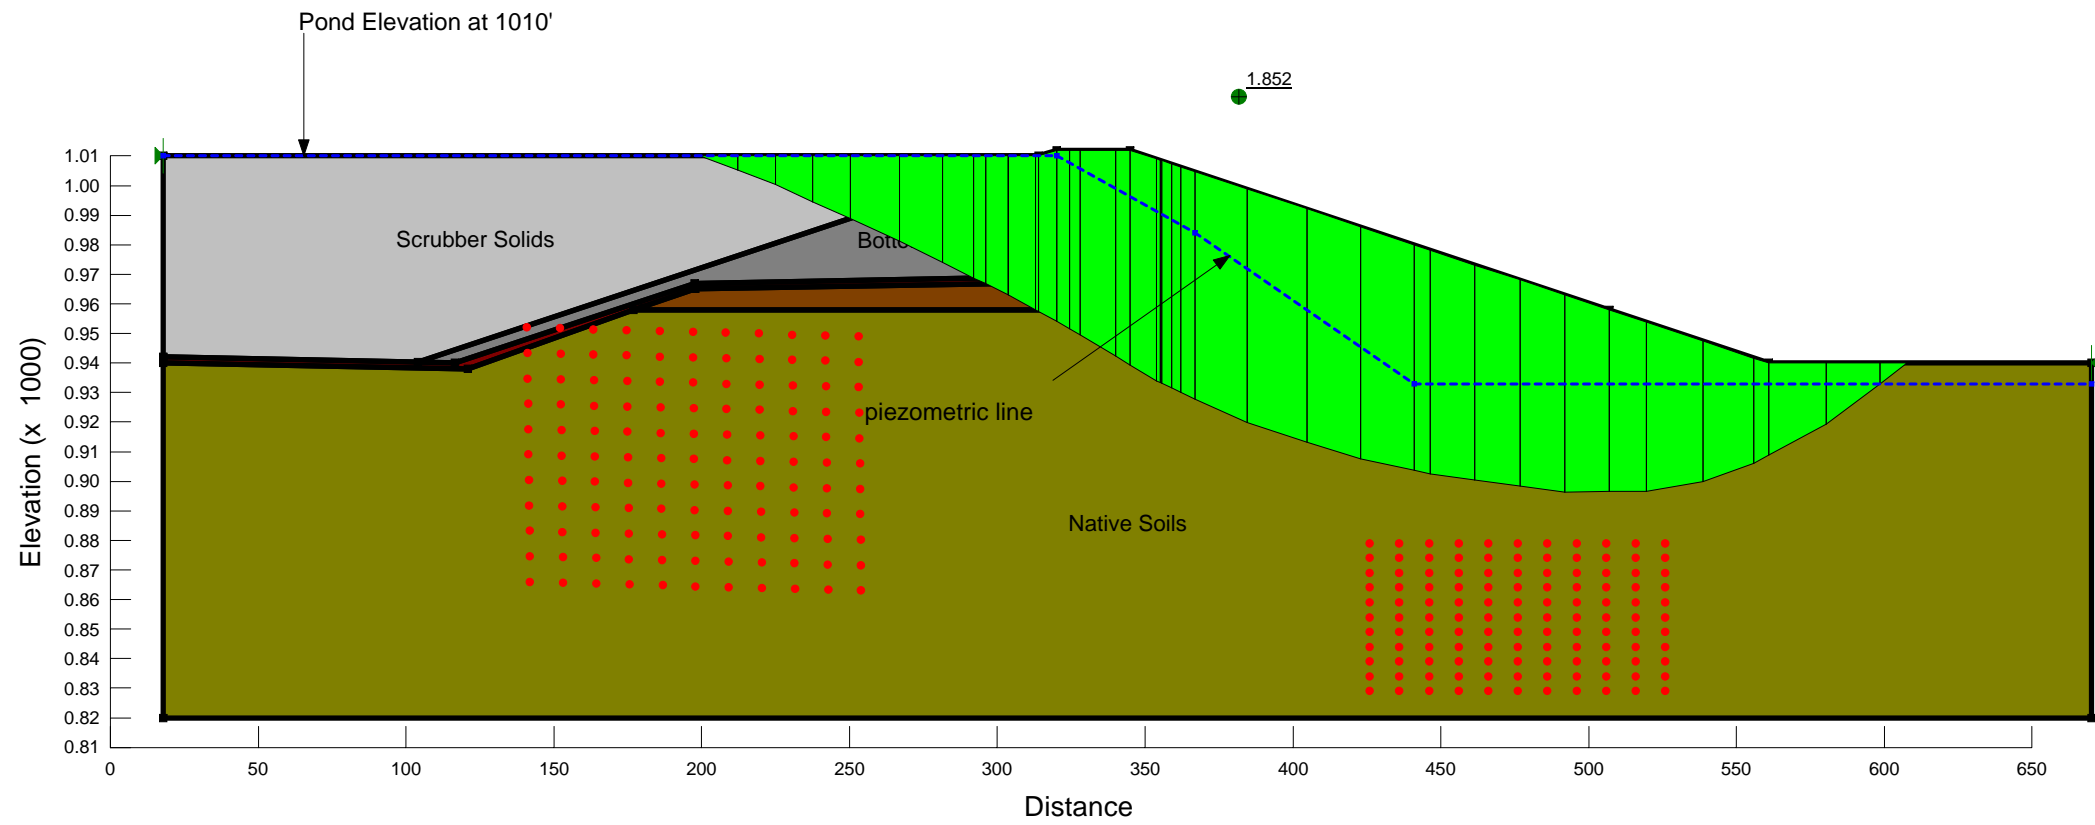
Pond 3S Condition 2: Maximum Surcharge Loading
Pond Elevation at 1010'
Block Failure

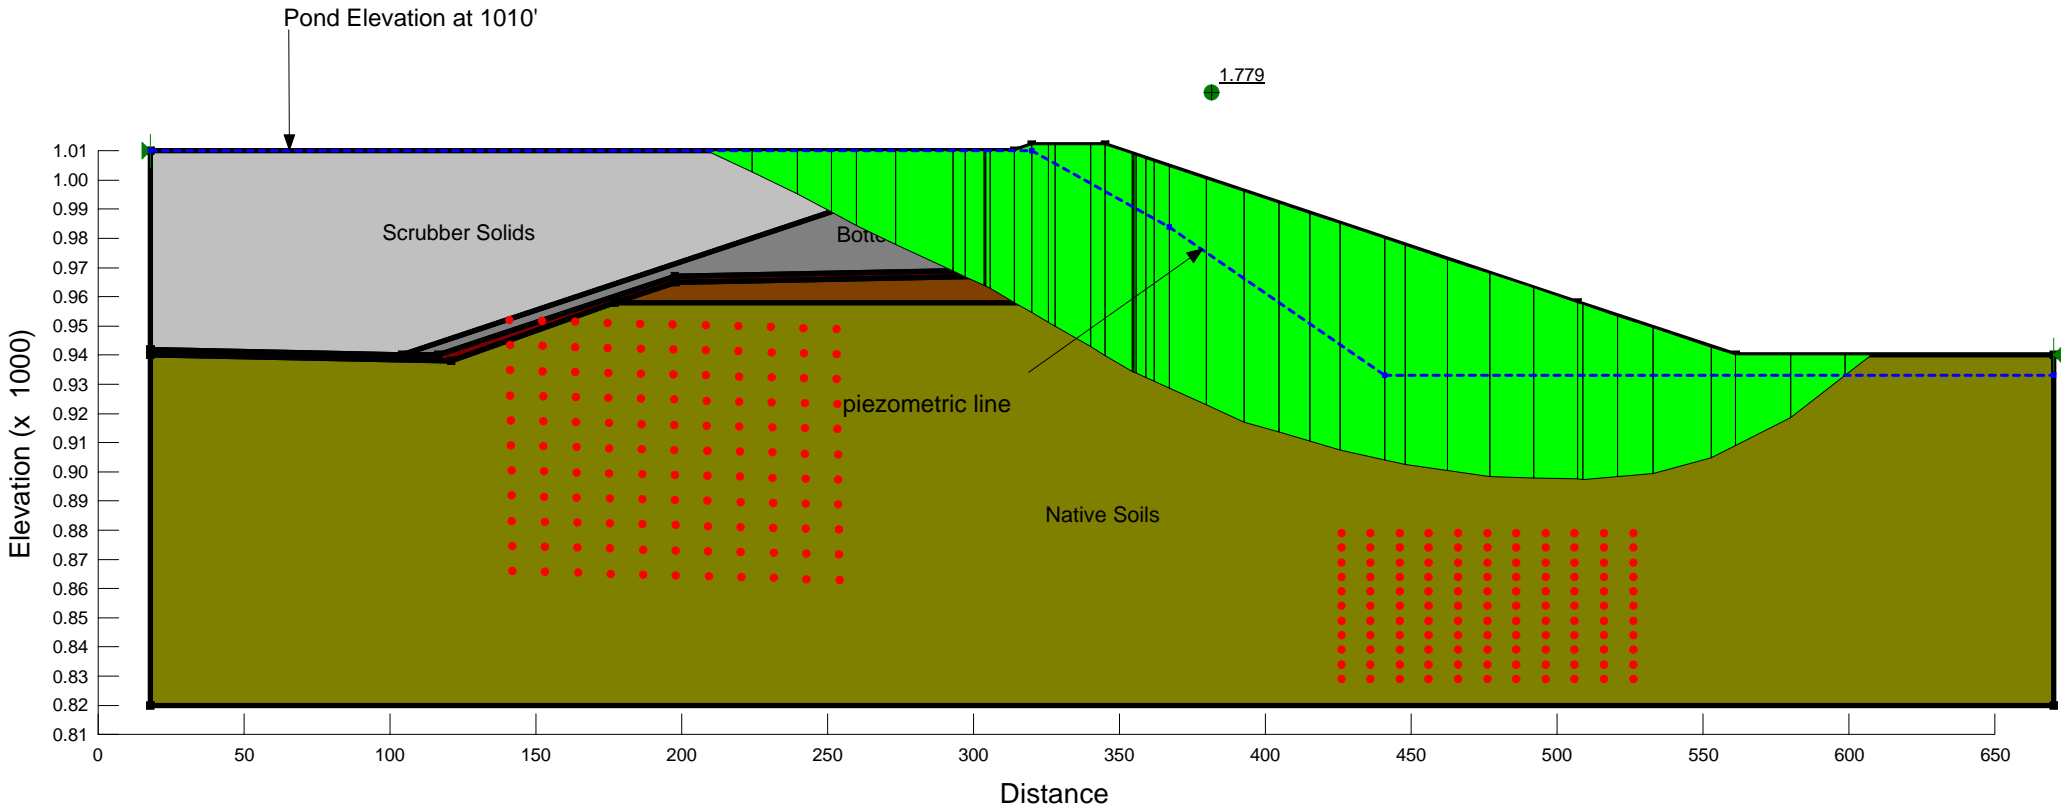
Pond 3S Condition 2: Maximum Surcharge Loading
Pond Elevation at 1010'
Block Failure
Seismic Analysis
