# Amended Written Post-Closure Plan

Comanche Station - Active CCR Landfill

*Public Service Company of Colorado  
Denver Colorado*

August 19, 2022 – Revision 1.1

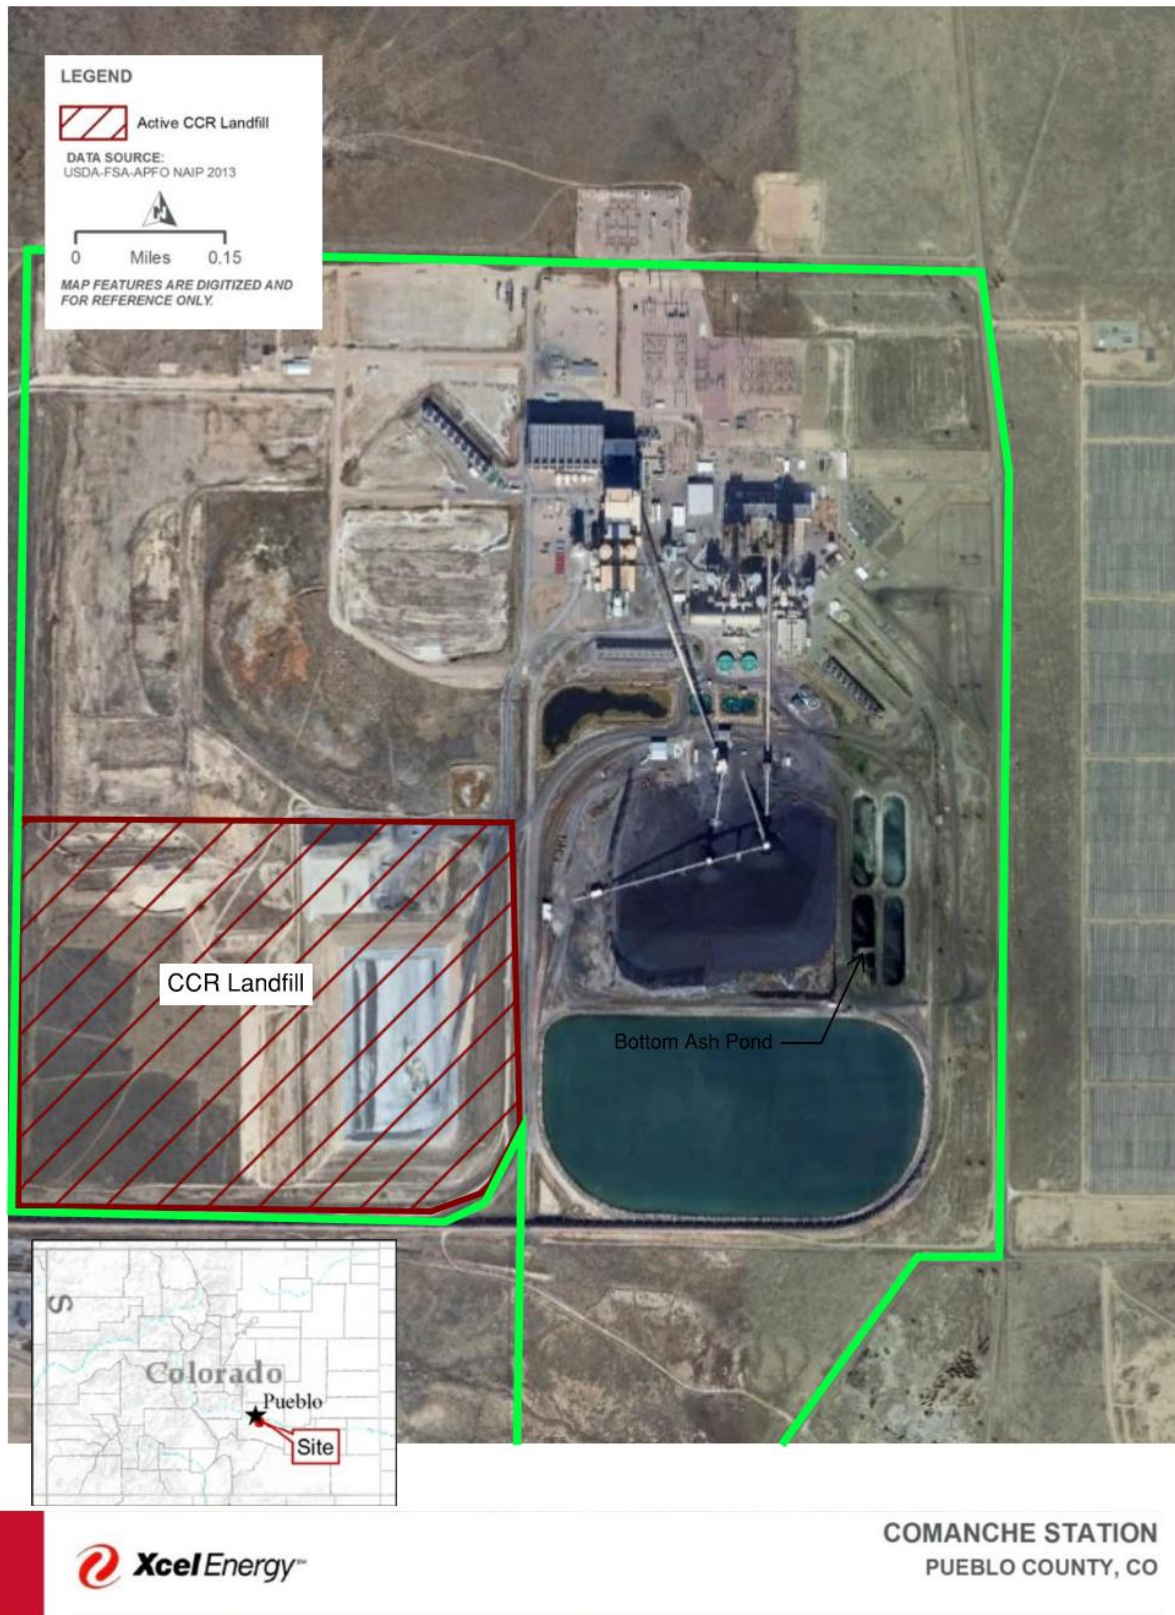
Figure 1. Comanche Power Station – CCR Landfill

The Station's Ash Disposal Facility (ADF) is located on the southwest corner of the Comanche property (see **Figure 1**). The land surface elevations range from approximately 4,830 feet above mean sea level (amsl) in the southwest and northwest corners of the Site to approximately 4,800 feet amsl in the southeast corner of the Site.
