2020 Annual Inspection Report

for Compliance with the Coal
Combustion Residuals Rule
(40 CFR Part 257)

Hayden Station

January 18, 2021

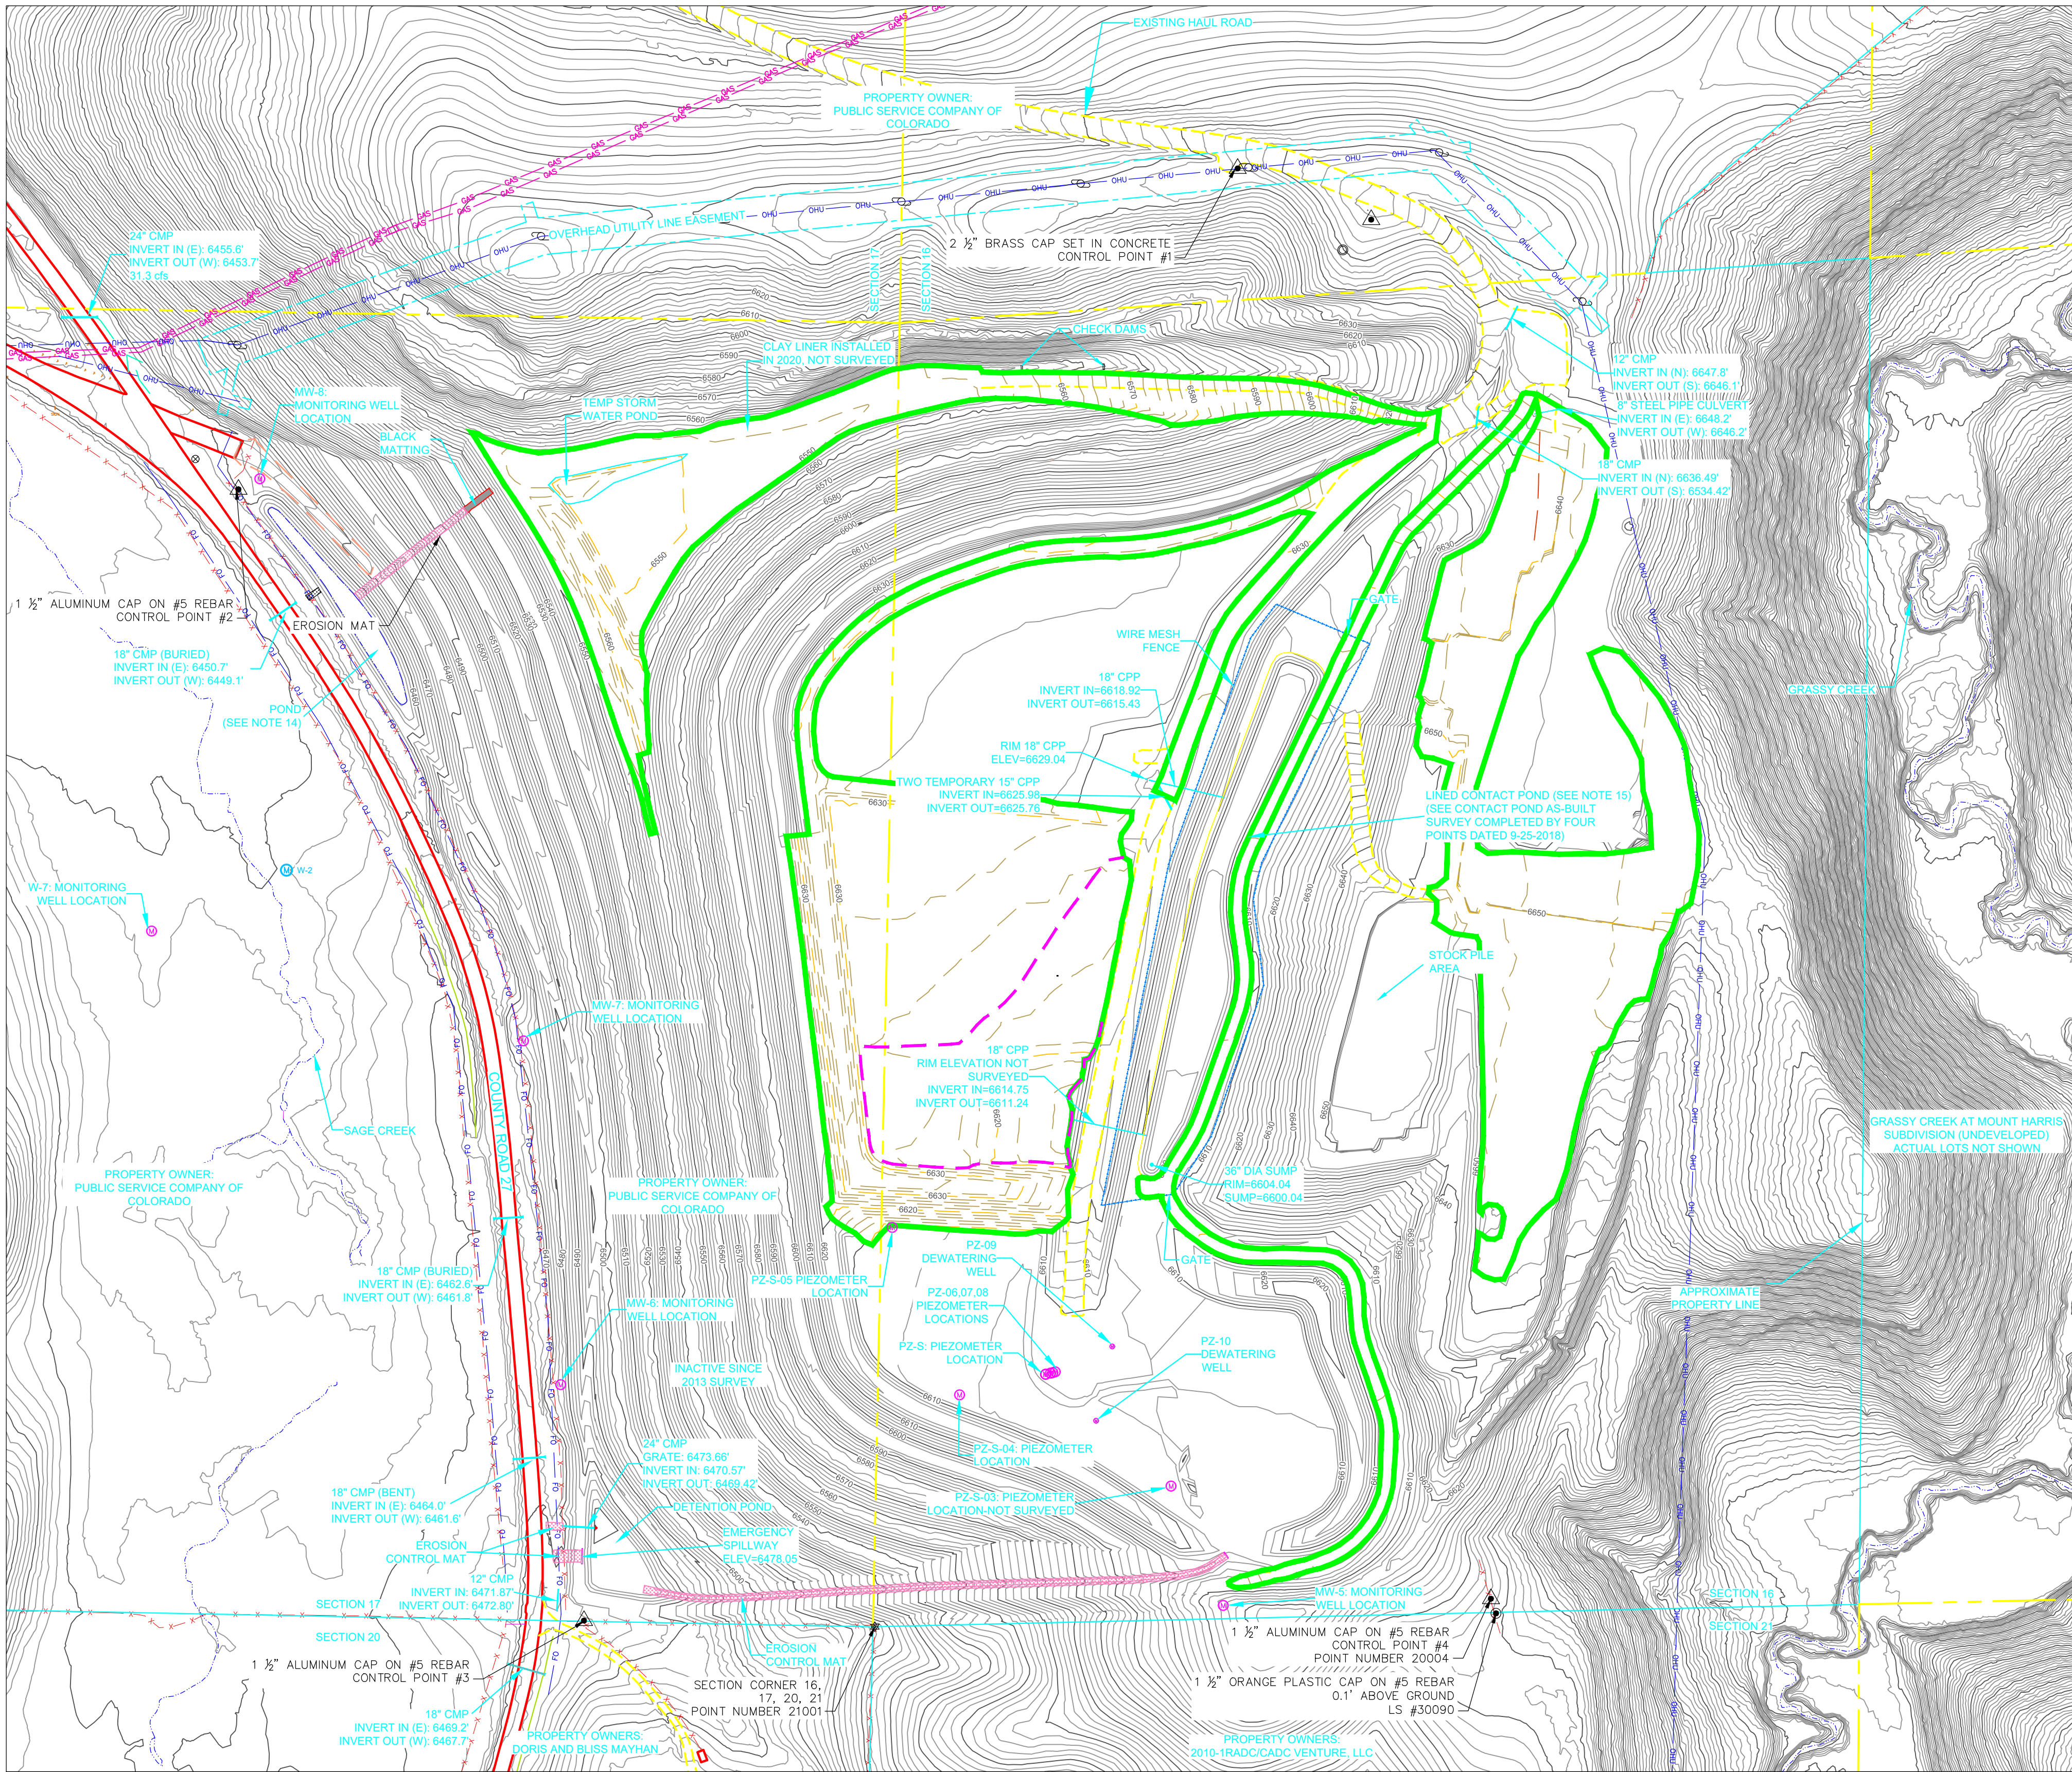
TOPOGRAPHIC EXHIBIT

LOCATED IN THE SOUTHEAST QUARTER OF SECTION 17 AND THE SOUTHWEST QUARTER OF
SECTION 16, TOWNSHIP 6 NORTH , RANGE 87 WEST OF THE 6TH P.M.,
COUNTY OF ROUTT , STATE OF COLORADO
SHEET 1 OF 1

Appendix A: Landfill Site Map

3. Weekly CCR Landfill Inspection Forms (per Section 257.84(a)).
4. October 2020 As-Built Survey with updated topography with the most recent field work dates of October 5 and October 6, 2019, performed by Four Points Surveying and Engineering.
