# 2021 Annual Inspection Report

for Compliance with the Coal  
Combustion Residuals Rule  
(40 CFR Part 257)

## **Pawnee Station - North Landfill**

***January 15, 2022***

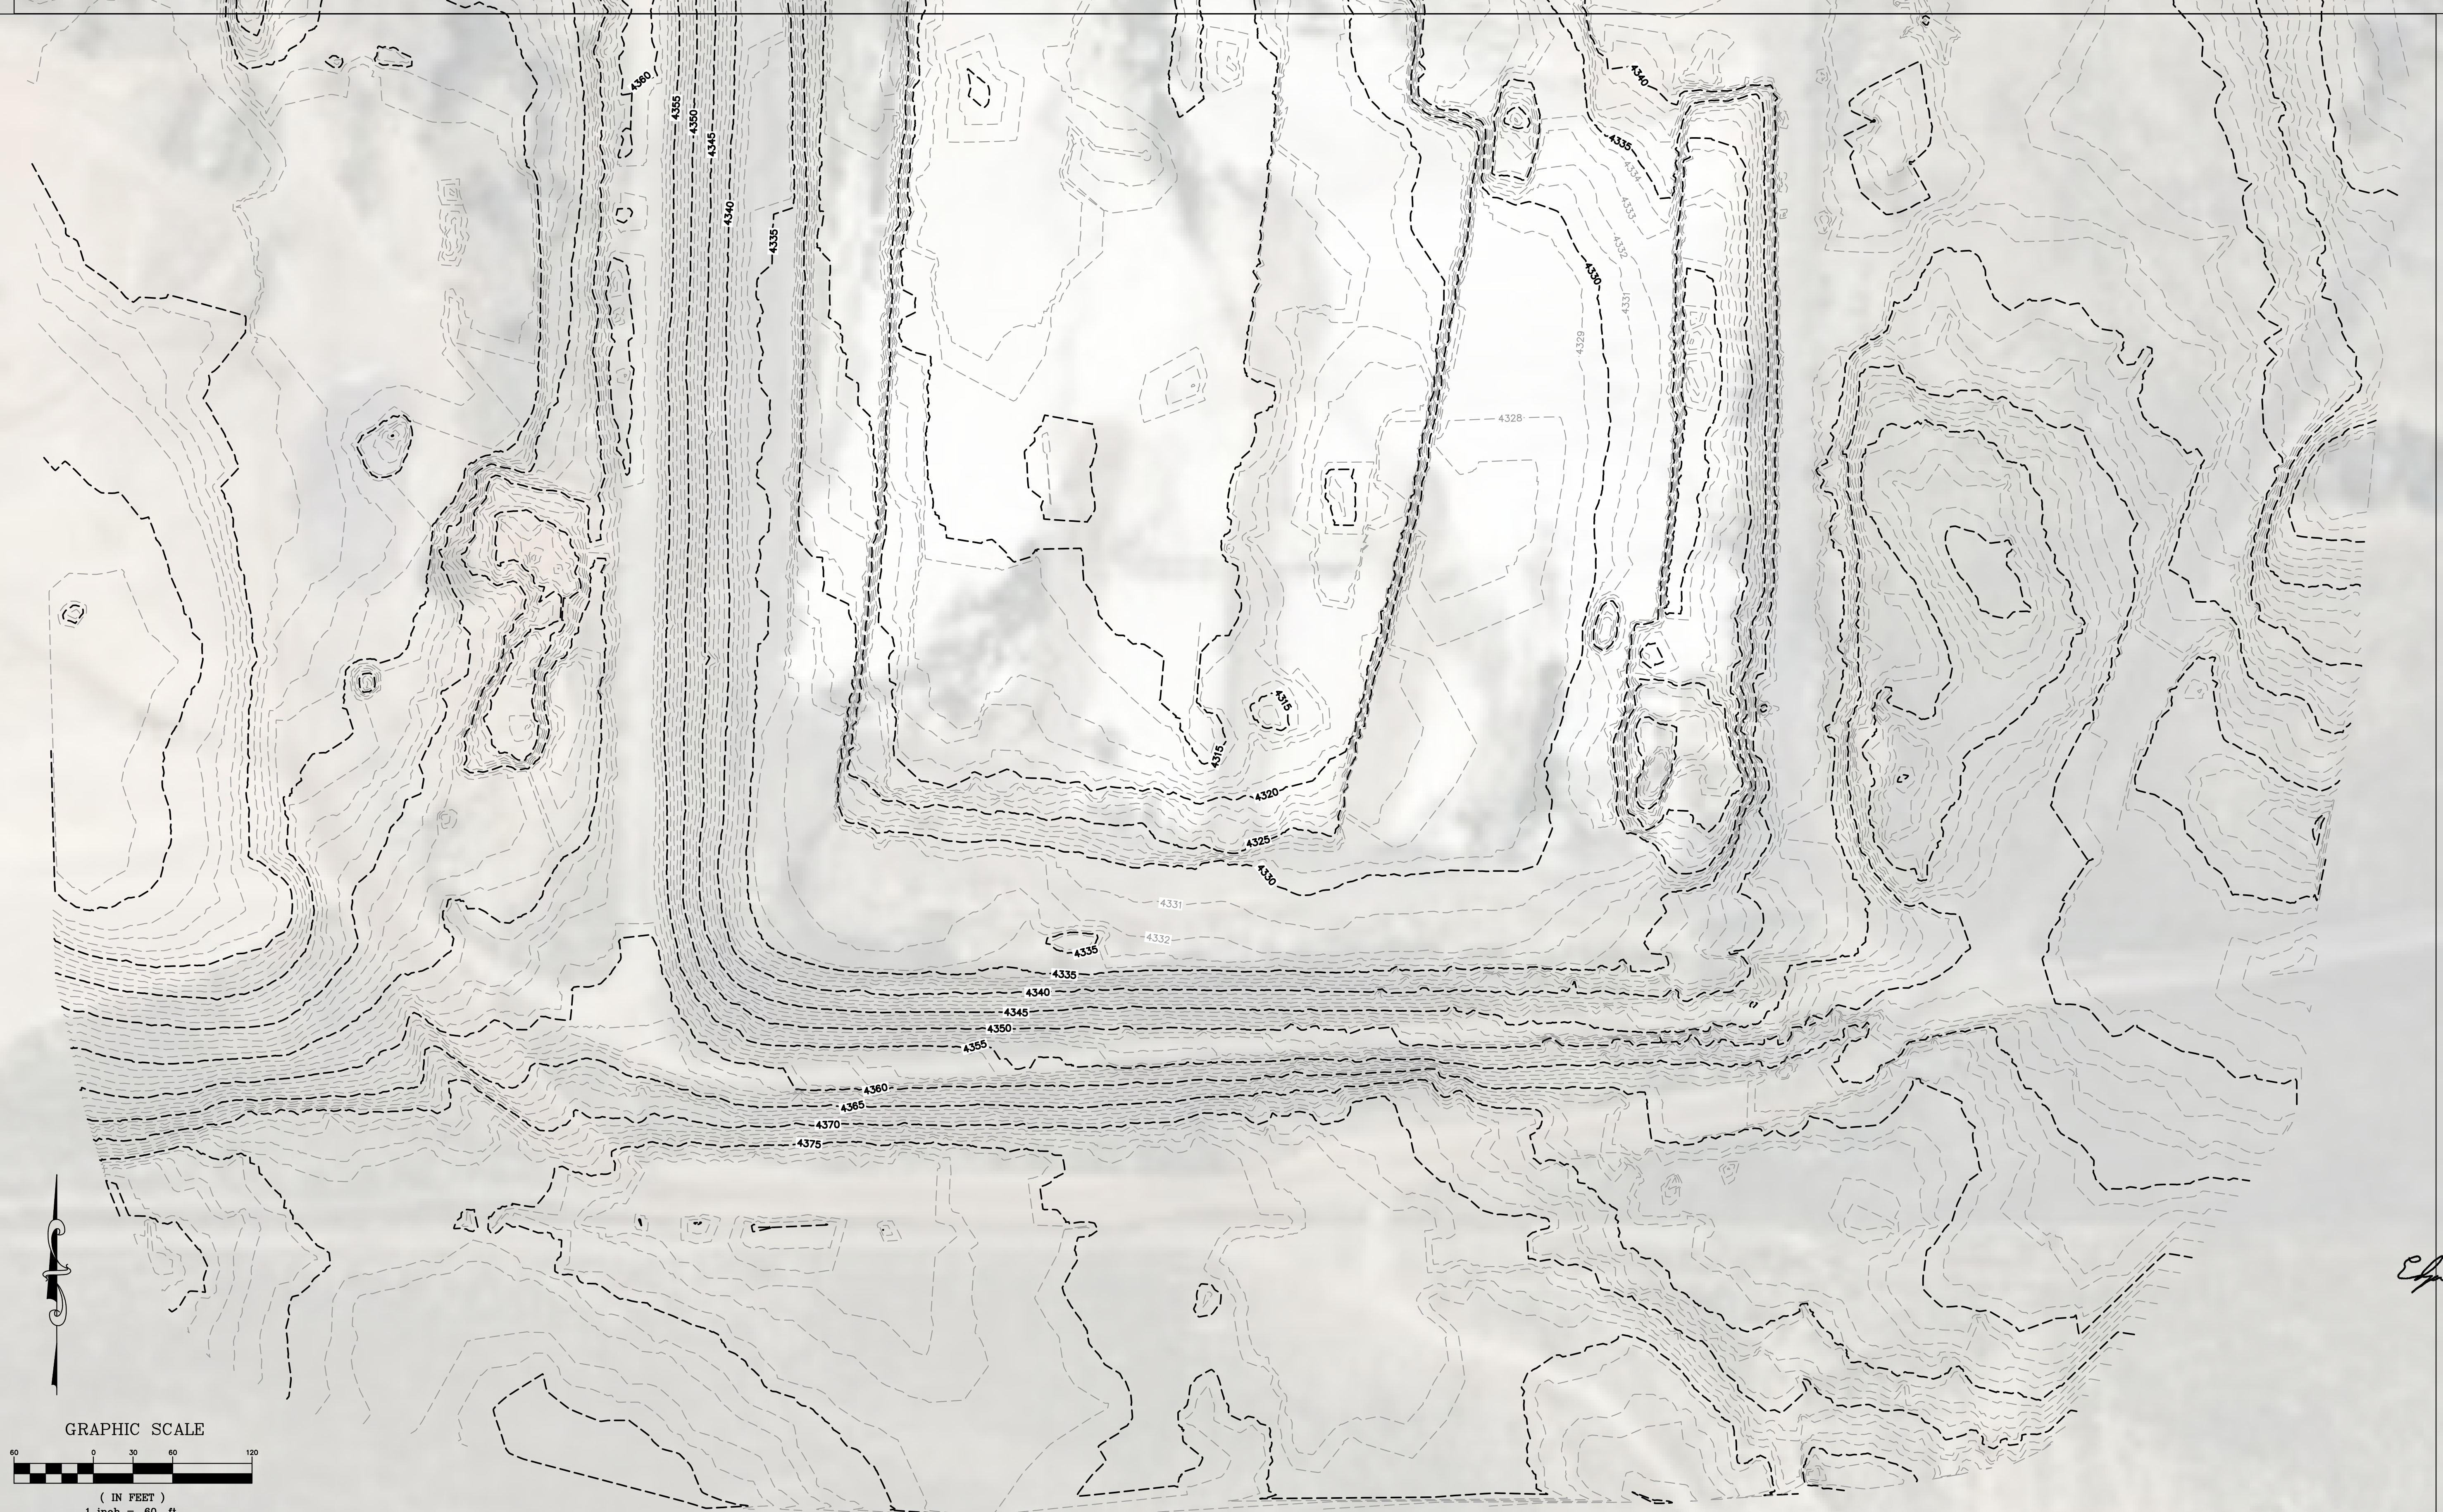
# TOPOGRAPHIC EXHIBIT

A PARCEL OF LAND LOCATED IN SECTIONS 19 & 20, TOWNSHIP 3 NORTH, RANGE  
56 WEST OF THE 6TH P.M.,  
COUNTY OF MORGAN, STATE OF COLORADO

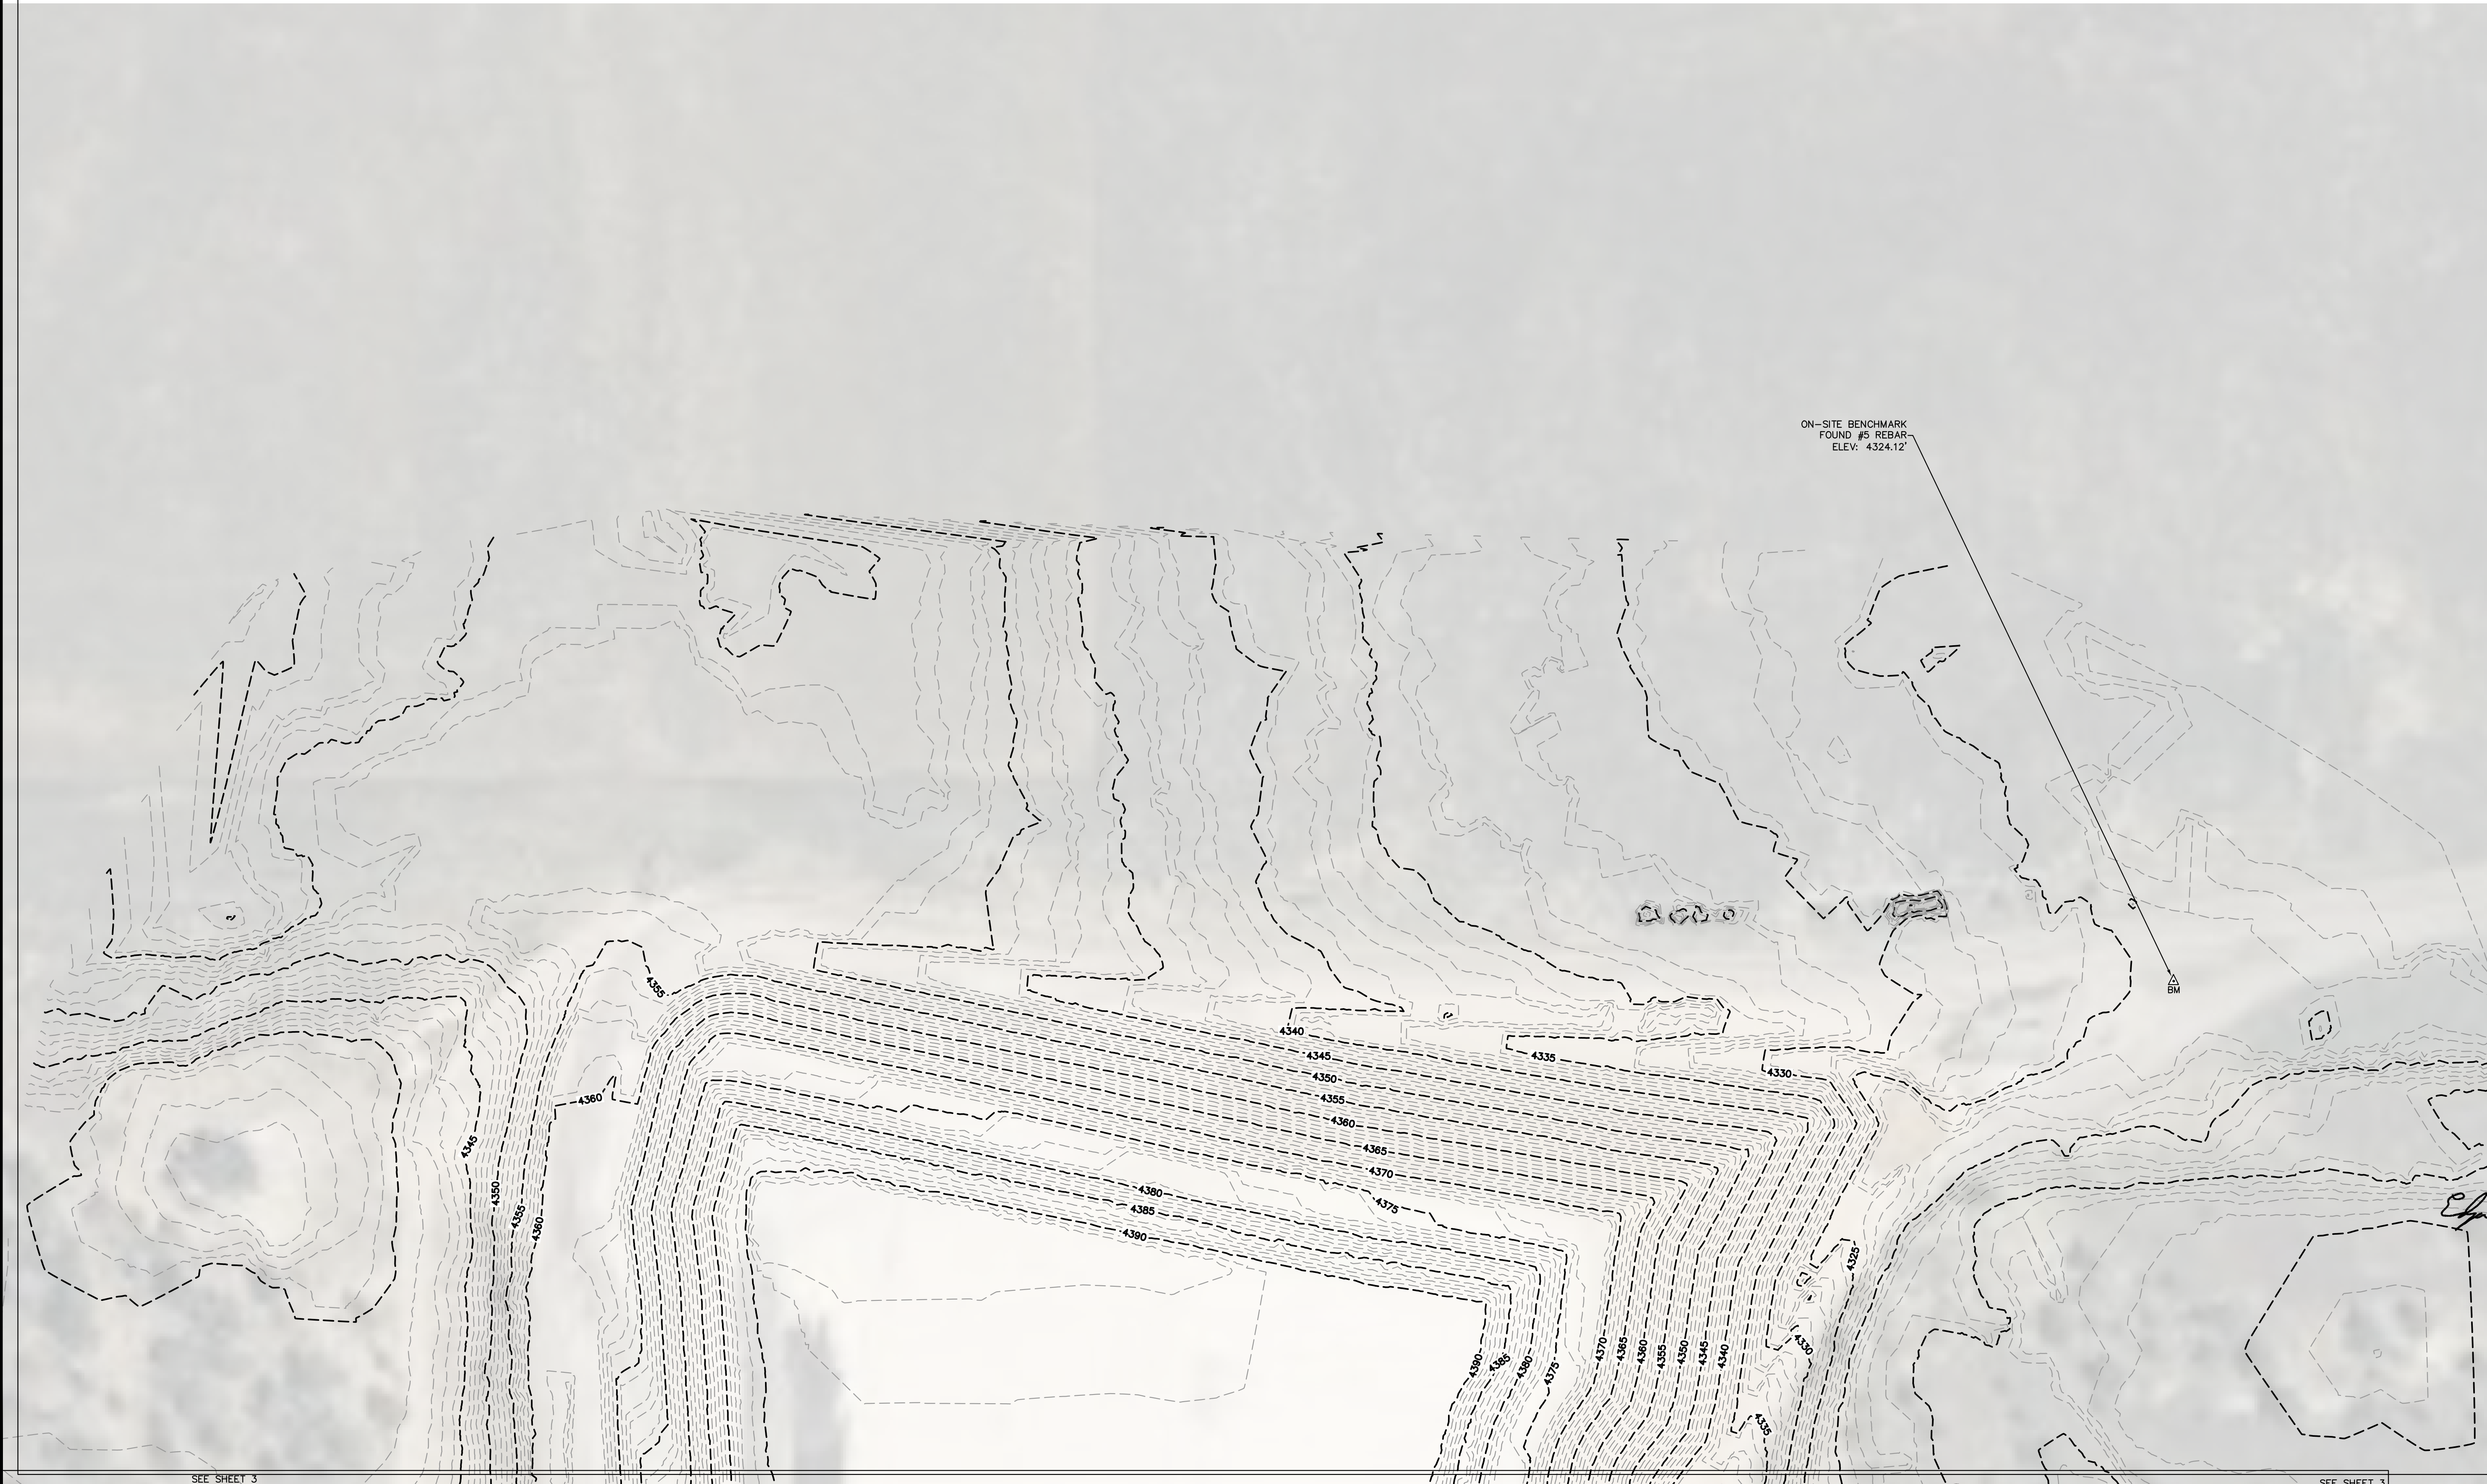
SHEET 4 OF 6

A PARCEL OF LAND LOCATED IN SECTIONS 19 & 20, TOWNSHIP 3 NORTH, RANGE  
56 WEST OF THE 6TH P.M.,  
COUNTY OF MORGAN, STATE OF COLORADO

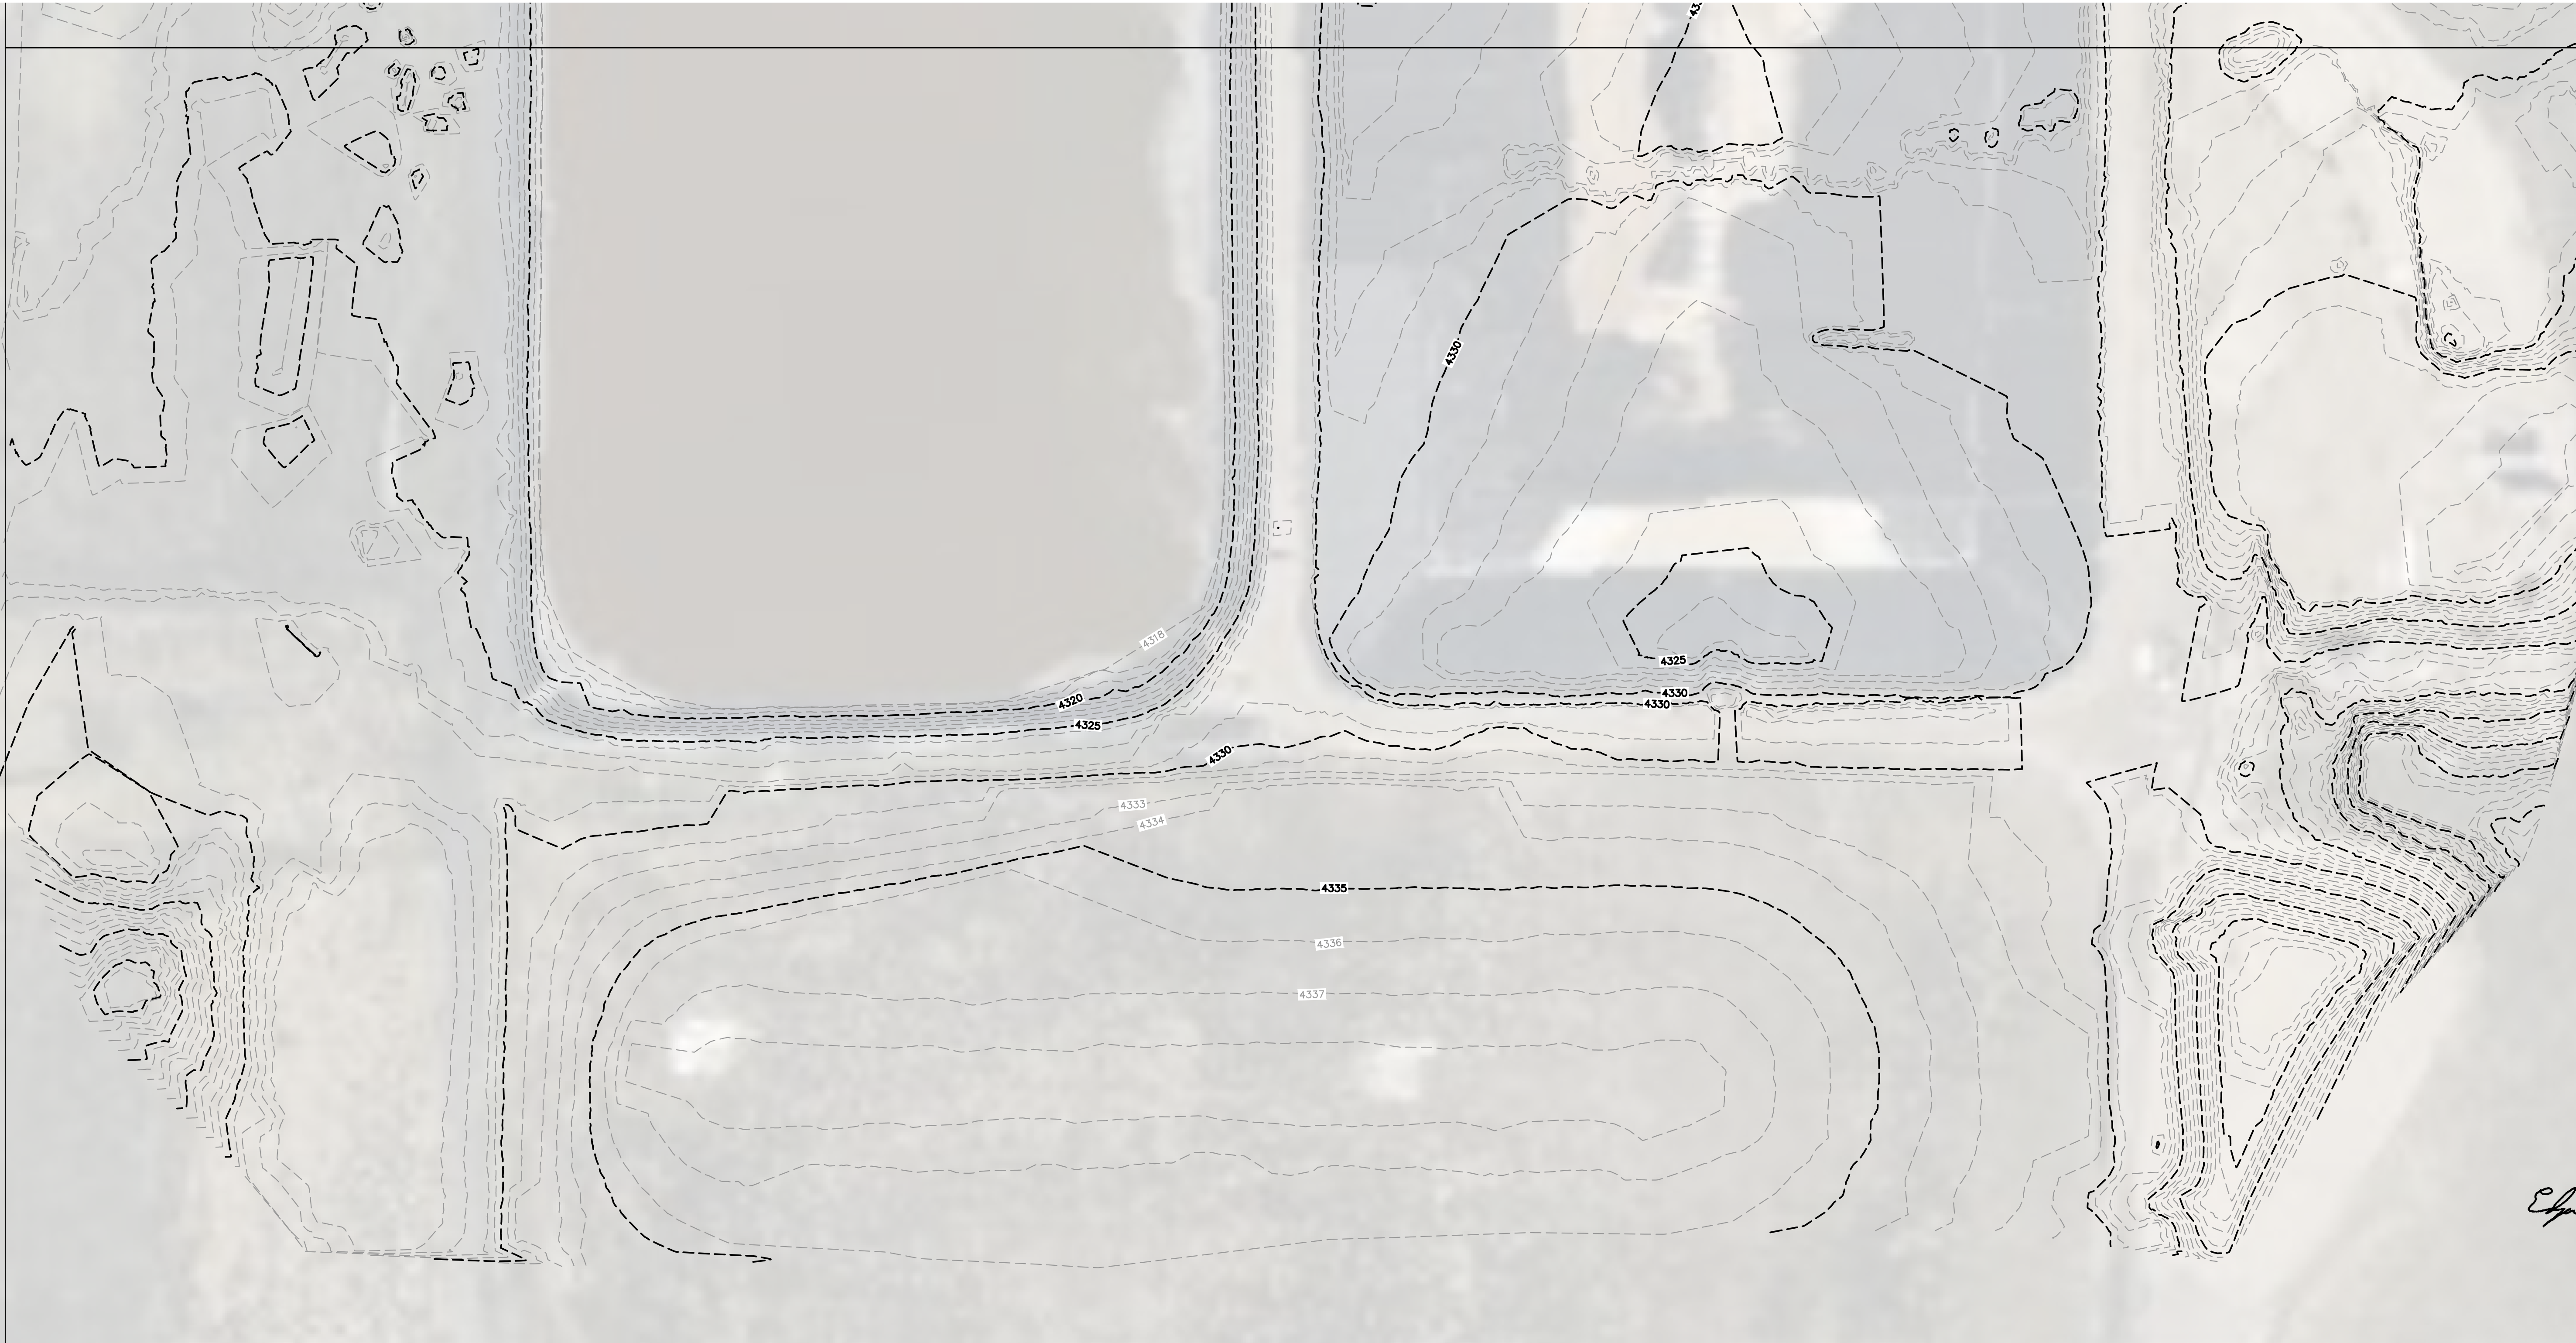
SHEET 5 OF 6

TOPOGRAPHIC EXHIBIT  
PREPARED FOR  
HDR  
COPYRIGHT 2021 FLATIRON, INC.

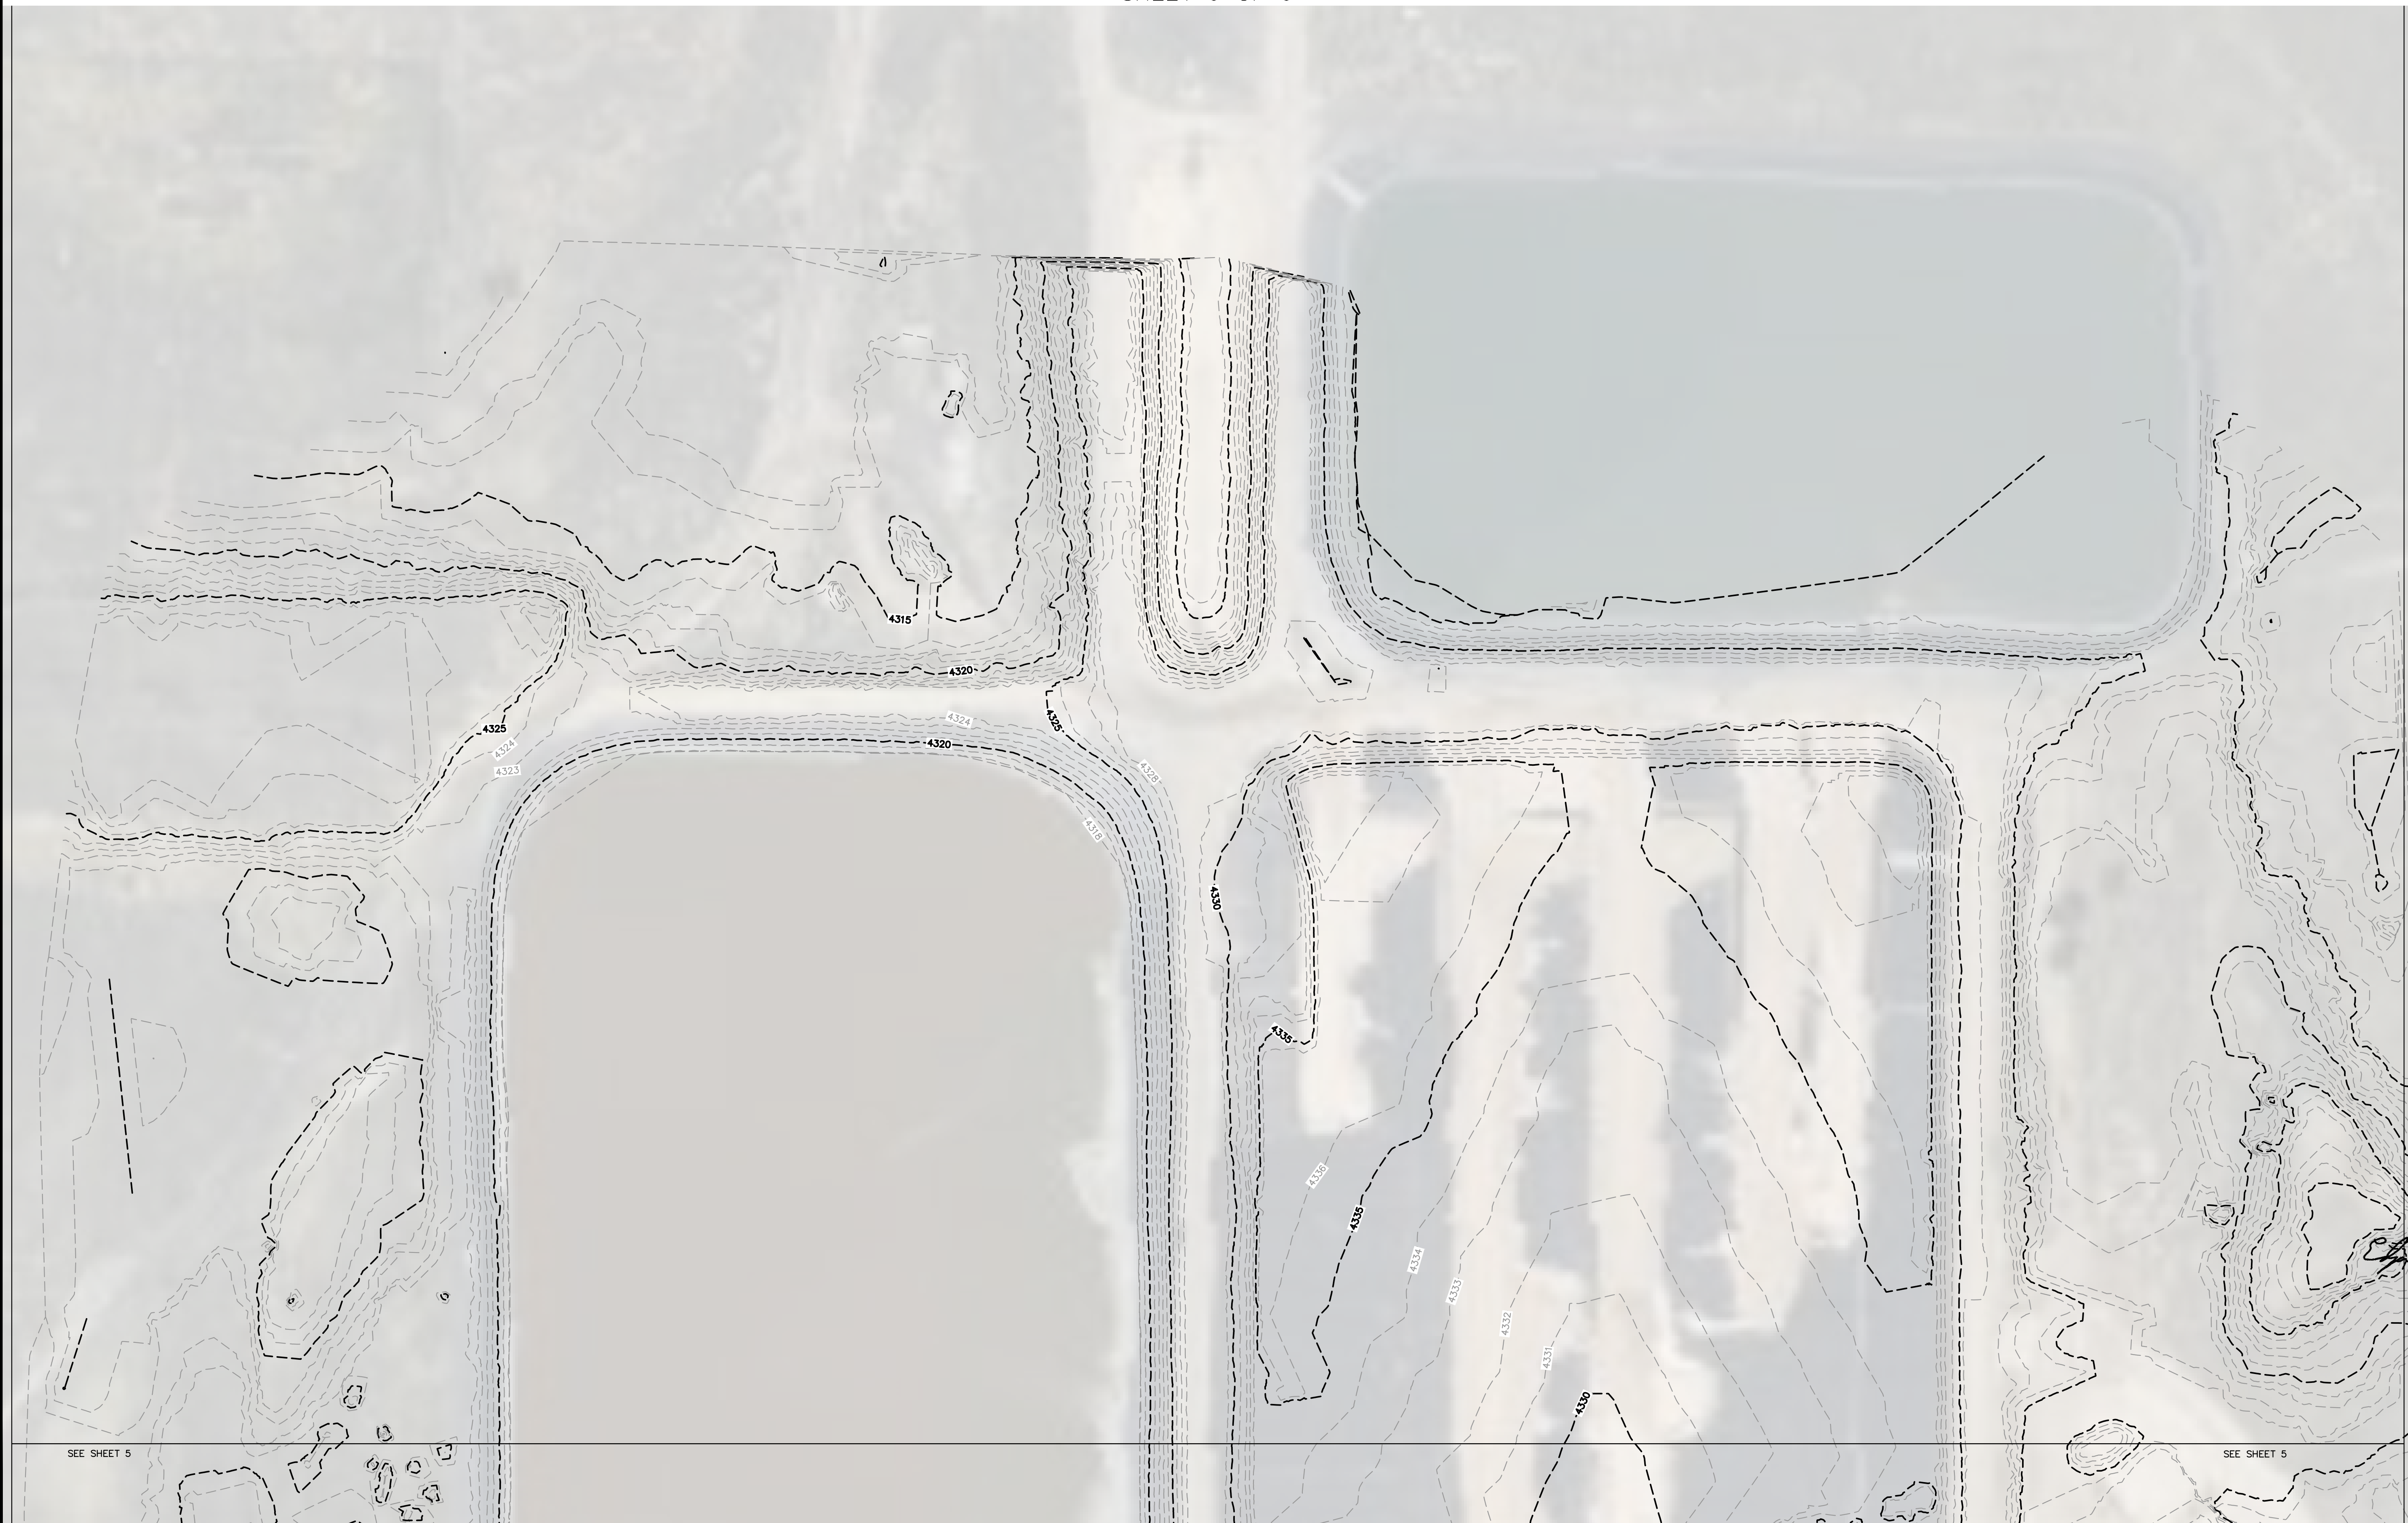
SHEET 6 OF 6

A PARCEL OF LAND LOCATED IN SECTIONS 19 & 20, TOWNSHIP 3 NORTH, RANGE  
56 WEST OF THE 6TH P.M.,  
COUNTY OF MORGAN, STATE OF COLORADO
