# 2019 Annual Inspection Report

for Compliance with the Coal  
Combustion Residuals Rule  
(40 CFR Part 257)

## **Valmont Station**

## Valmont Station CCR Unit 2019 Annual Inspection for Compliance with the Federal Coal Combustion Residuals Rule

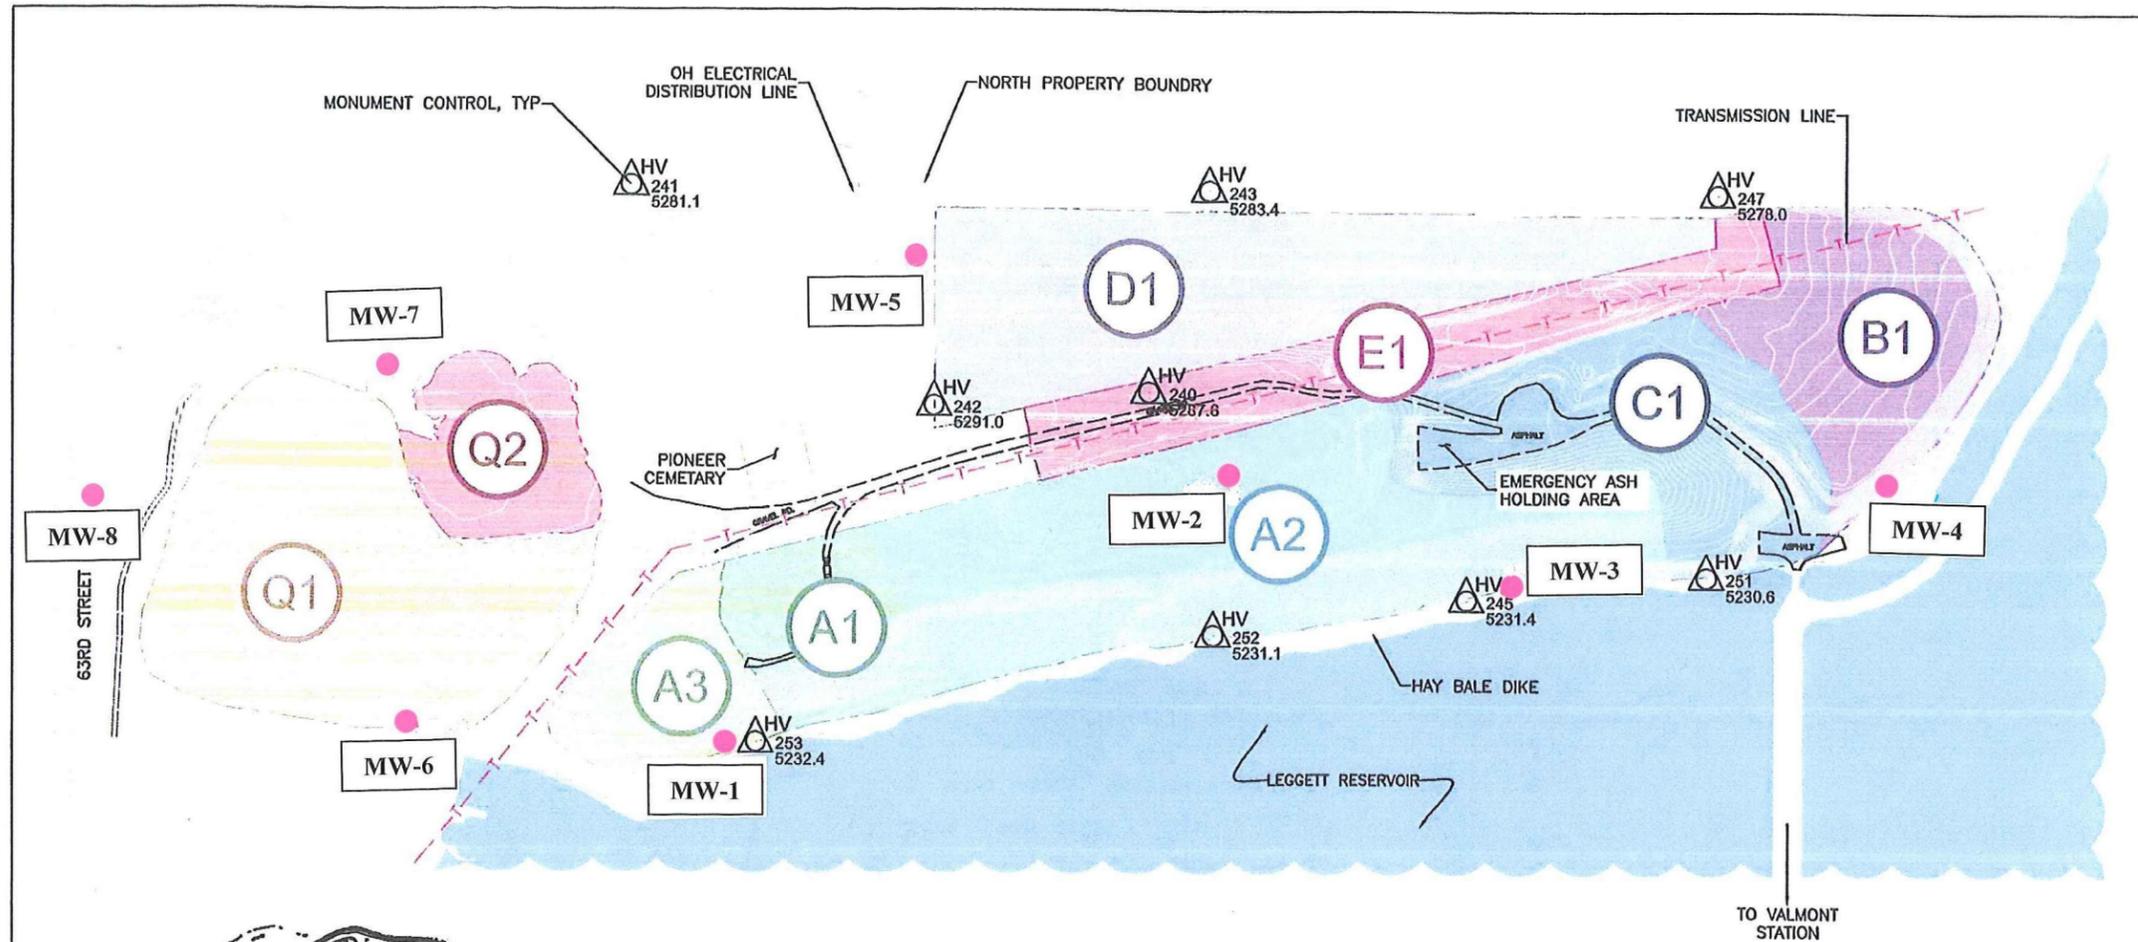
Red text box added by HDR for Jan 2020 CCR annual Report. CCR Jan 2020 Annual Report Figure 1

<b>VALMONT SEGS - COMMON</b> ASH DISPOSAL FACILITY AREA MAP  PUBLIC SERVICE COMPANY OF COLORADO <small>AN ISO 9001 CERTIFIED COMPANY</small>		FILENAME: 25-2.73 SH1 R-CODE: 1380029 SCALE: NTS	
		<b>FIG 0-1</b>	
DWN: TC	DATE: 07/27/08	SHEET 1    REV 0	
CHK: JH	DATE:		
ISSUE FOR CONSTRUCTION PER JULY, 2008 SURVEY - 1904293		NO    DATE    DR    JP    ISSUED FOR CONSTRUCTION PER	REVISION E    M    C    MF

Appendix A: Landfill Site Maps – Figure 1 and Figure 2

- There is a riprap run down on the east slope (Area B1) with no visible erosion or stability concerns.
  - The south slope is an area where sloughing and localized instability is visible about one quarter down from the top plateau (against a degraded line of straw bales). This area is heavily vegetated but should be monitored for future sloughing or movement. After a site visit, the consensus of HDR engineering staff was to continue monitoring the area. No additional movement, including surface tension cracks, or sloughing was observed since the prior annual inspection. Xcel is discussing ways to address what appears to be the inactive surface topsoil sloughing to ensure that the required topsoil cover is present. This work may be completed in 2020.

- The north facing landfill embankment of areas D1, E1 and B1 are graded to a uniform slope. This slope does not have benches but does have a dense cover of vegetation. No erosion or sloughing was noted.

- Area D1 impacted by construction in 2018 were seeded and at the time of inspection were covered with vegetation. Areas within D1, particularly to the east end of the cell, that were not disturbed by the 2018 construction were soil and vegetation covered. No erosion was noted during inspection.
