2017 Annual Inspection Report

for Compliance with the Coal
Combustion Residuals Rule
(40 CFR Part 257)

Valmont Station

January 18, 2018

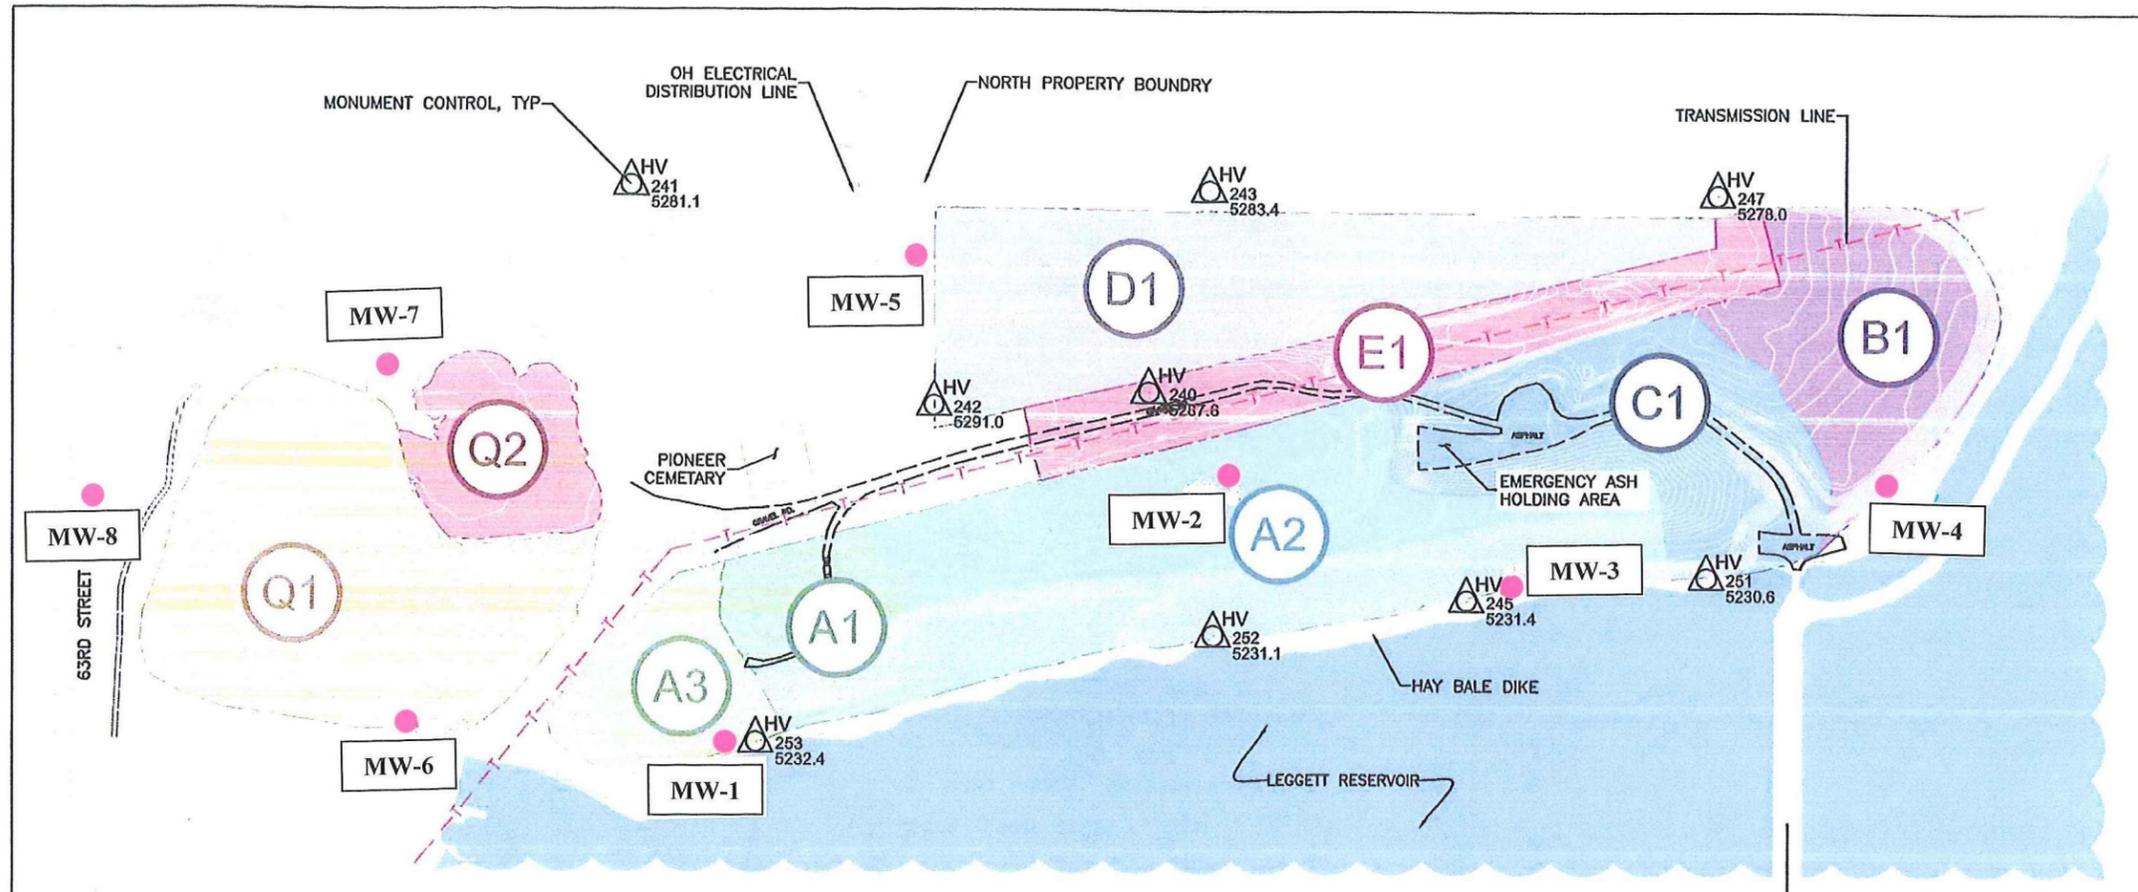
Appendix A – Landfill Site Map

ASH DISPOSAL FACILITY AREA MAP

1. landfill side slope toe of slope;
2. Landfill side slope benches;
3. Riprapped stormwater drainage conveyance channels on southwest side (Areas Q-1 and A-3) of landfill and east end (Area B-1) of landfill; and
4. Active CCR fill areas (CCR disposal, spreading, and compaction).

- The north facing landfill embankment of areas D1, E1 and B1 are graded to a uniform slope. This slope does not have benches but does have a dense cover of vegetation. No erosion or sloughing was noted.

- The active fill area (Area D-1) was observed to have minimal areas of exposed ash. The recently soil covered CCR landfill work areas on the western side of Area D-1 appeared to have adequate soil cover. Side slopes for the cell excavation between the two fill areas were steep but showed no signs of instability or erosion.
