## **Initial Safety Factor Assessment**

### **Bottom Ash Pond**

### **Sherburne County Generating Plant**

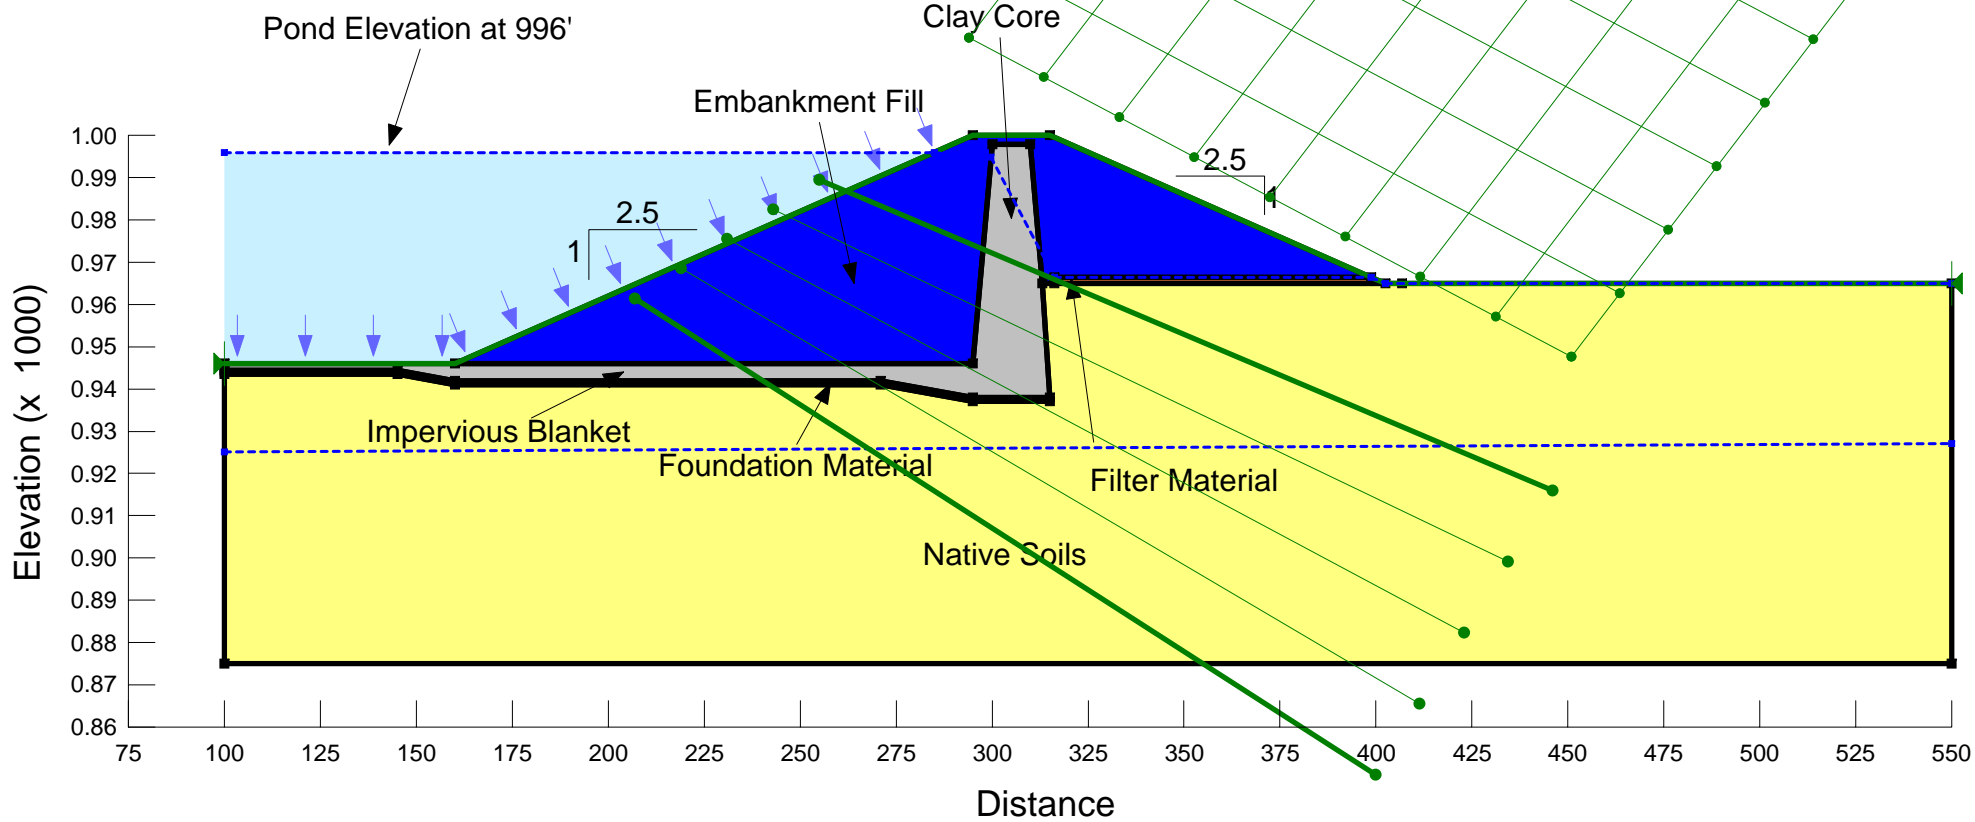
Condition 1: Maximum Storage Loading  
Pond Elevation at 996'  
Xcel Sherco Bottom Ash Pond  
Deep Circular Failure  
Pre-Analysis Diagram

The analyses for the Bottom Ash Pond were conducted through the critical cross section, located on the northern dike. The stability calculations for all Conditions were conducted using deep failure modes to determine the global stability of the dike, rather than localized sloughing that would not result in dike failure.

- The geometry of the Bottom Ash Pond at the critical section consists of 2.5H:1V slopes on both sides with a 20-foot wide top. The clay core that runs through the embankment has been built with 1H:12V side slopes, a 10-foot wide top, and a 20-foot wide base.
- Circular failure analysis and a block failure analysis were used for both Conditions.
- The water table was determined from onsite monitoring wells measured on 10/20/2015.
- The seismic stability analysis was conducted using a seismic coefficient equal to one-half of the predicted peak bedrock acceleration during an earthquake with a 2% probability of exceedance in 50 years, or  $\frac{1}{2}$  of 0.022g (0.011g) (Hynes-Griffin and Franklin 1984).
