Initial Safety Factor Assessment Scrubber Solids Pond No. 3 Sherburne County Generating Plant

This report presents the assessment and certification of the initial safety factor for Scrubber Solids Pond No. 3 (Pond 3) at the Sherburne County Generating Plant (Sherco) in Becker, Minnesota. Pond 3 is an “existing” surface impoundment comprised of two halves; Pond 3 North (Pond 3N) and Pond 3 South (Pond 3S). Both halves utilize a composite liner on the bottom and the west slope, and an inclined clay core supported by interior bottom ash and exterior common fill on the north, east and south dikes. The alignment of the dike elements of Pond 3N and 3S are the same, however, the starting elevation of the inclined clay core in the pond halves differ. As such, the critical sections of both Pond 3N and 3S were assessed.

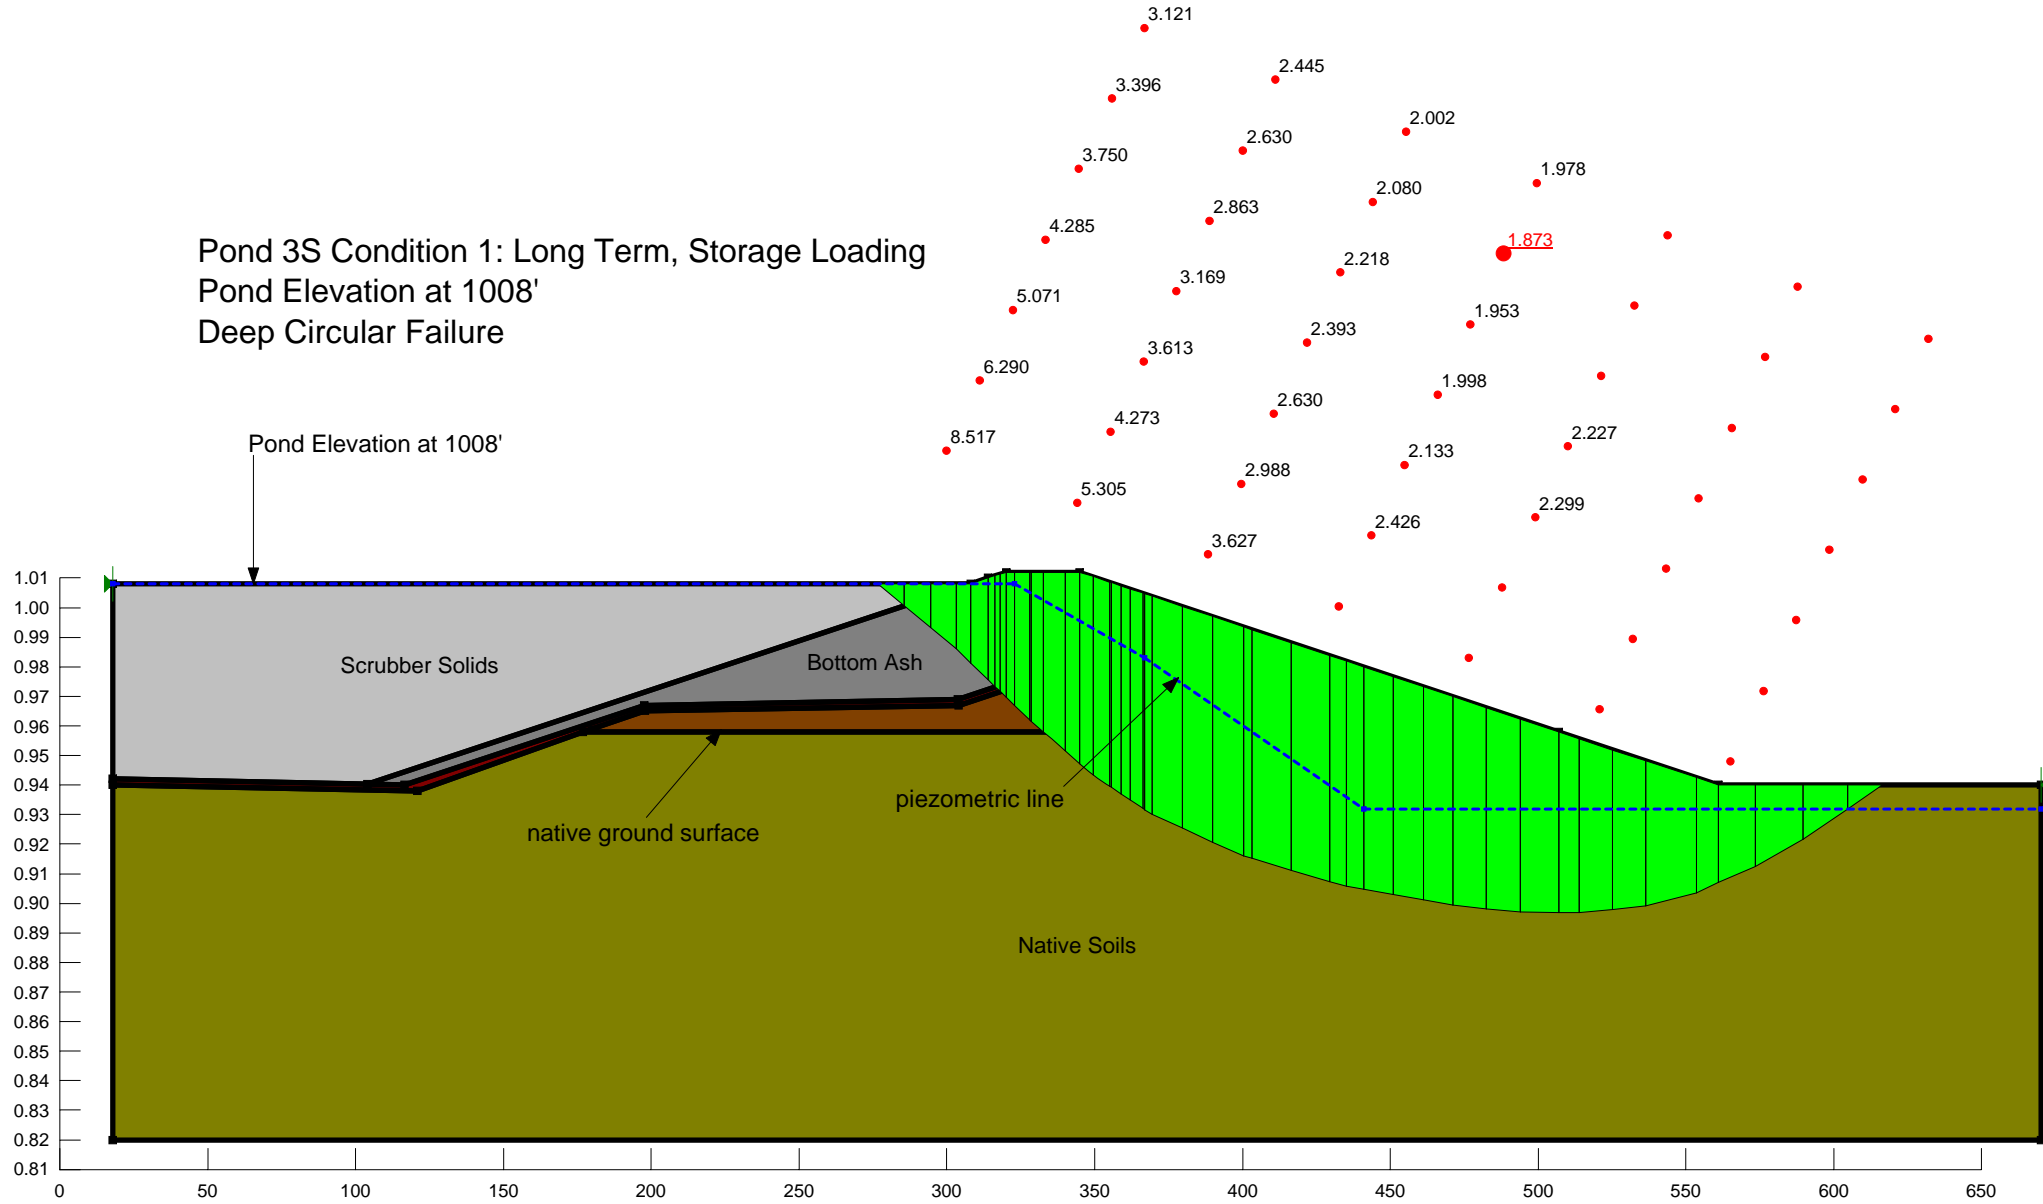
Pond 3S Condition 1: Long Term, Storage Loading
 Pond Elevation at 1008'
 Deep Circular Failure

Pond Elevation at 1008'

Scrubber Solids

Bottom Ash

native ground surface

piezometric line

Native Soils

Condition	Static FOS	Minimum Allowable FOS	Seismic FOS	Minimum Allowable FOS	Analysis Method
Condition 1 Long Term, Maximum Storage Pool Loading	1.87	1.50	1.79	1.00	Circular Failure
Condition 1 Long Term, Maximum Storage Pool Loading	1.83	1.50	1.77	1.00	Block Failure
Condition 2 Maximum Surcharge Loading	1.80	1.40	1.74	1.00	Circular Failure
Condition 2 Maximum Surcharge Loading	1.85	1.40	1.78	1.00	Block Failure

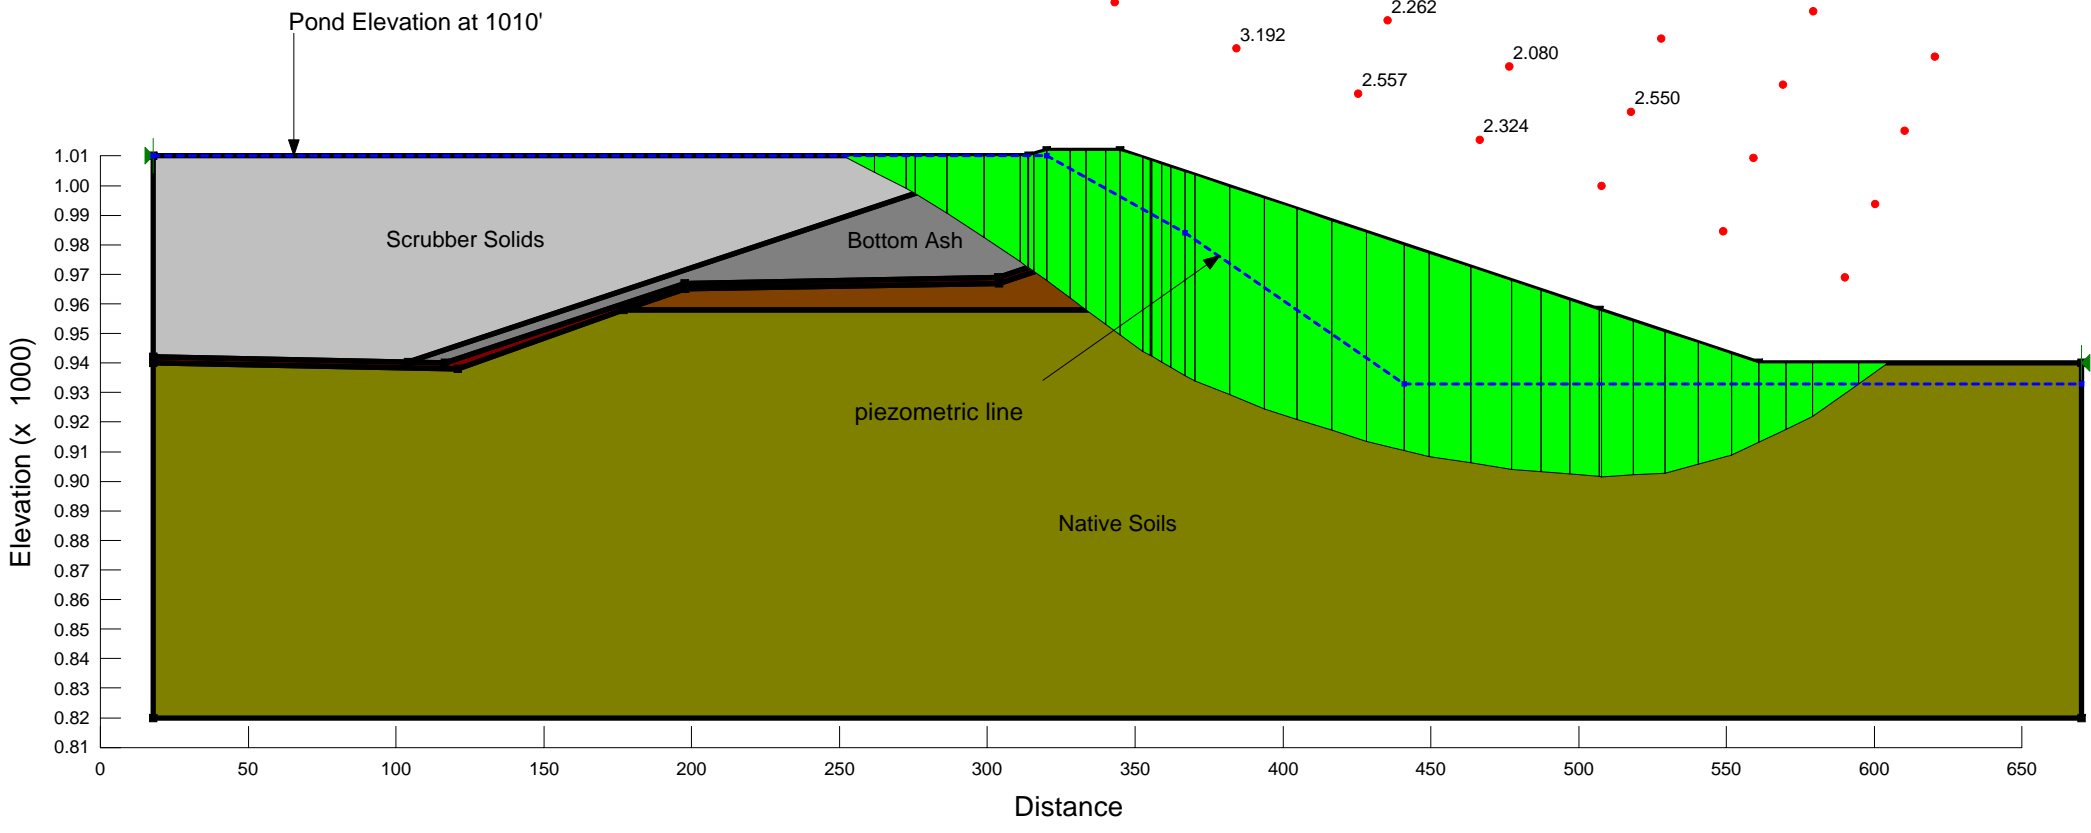
Pond 3S Condition 2: Maximum Surcharge Loading
 Pond Elevation at 1010'
 Deep Circular Failure

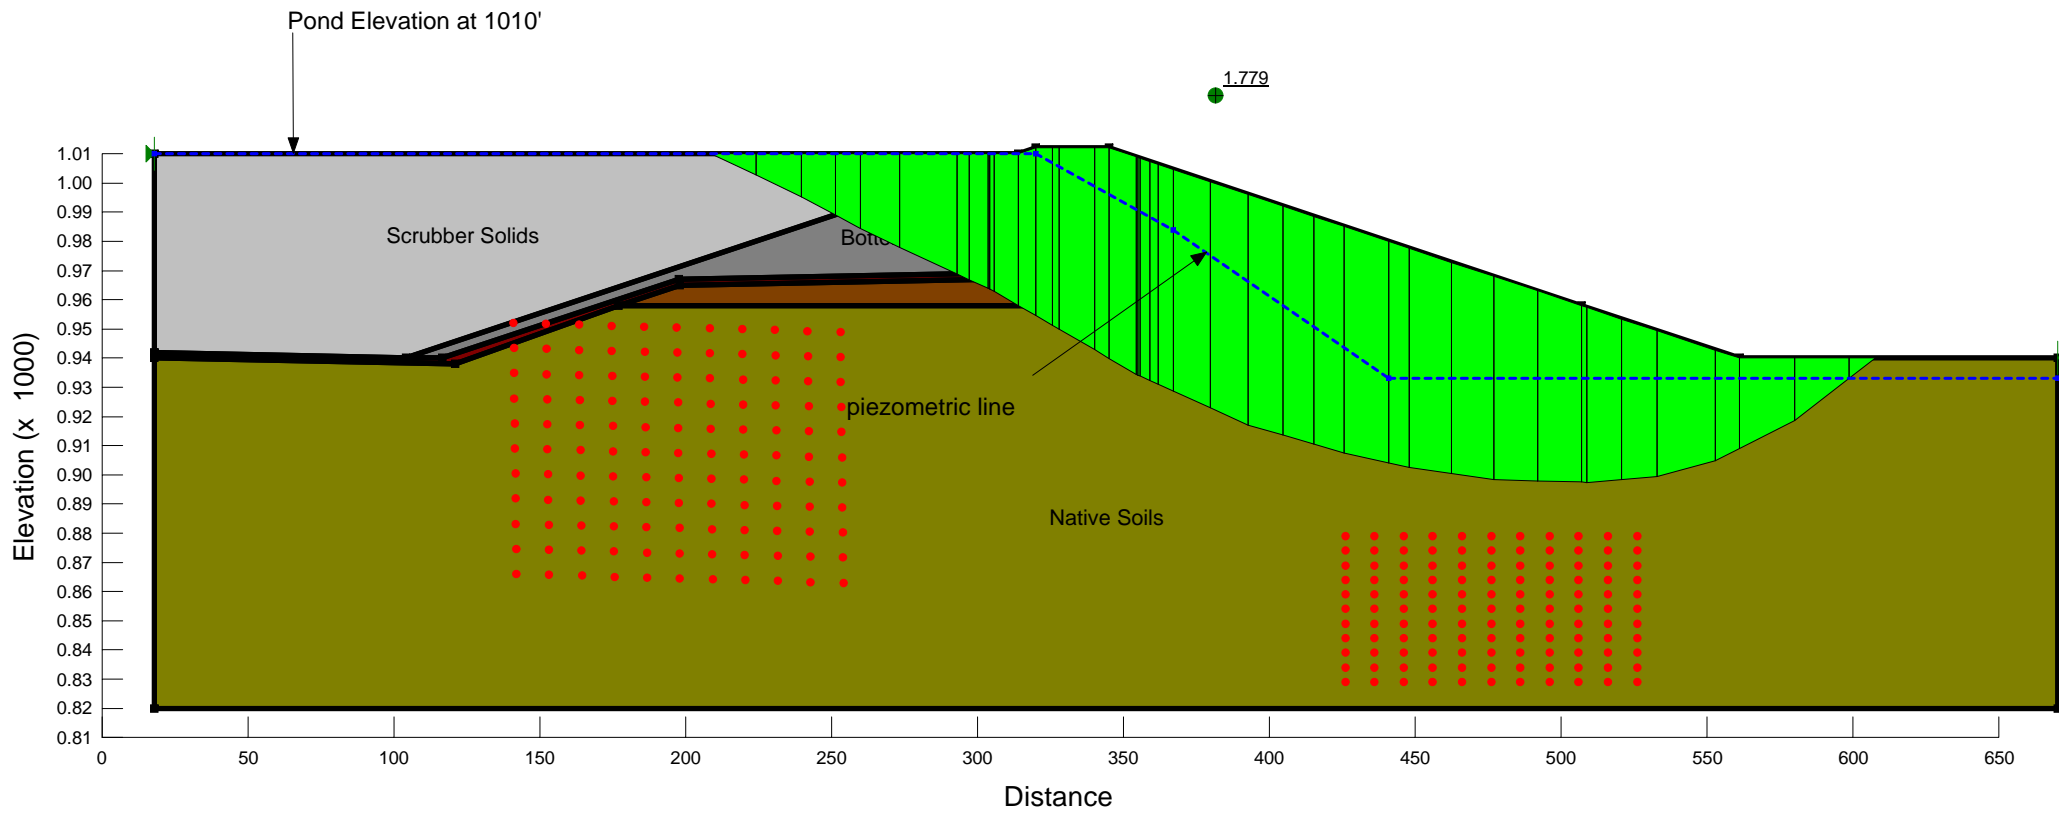
Pond 3S Condition 2: Maximum Surcharge Loading
Pond Elevation at 1010'
Block Failure
Seismic Analysis
