2019 Annual Inspection Report

for Compliance with the Coal
Combustion Residuals Rule
(40 CFR Part 257)

Hayden Station

January 18, 2020

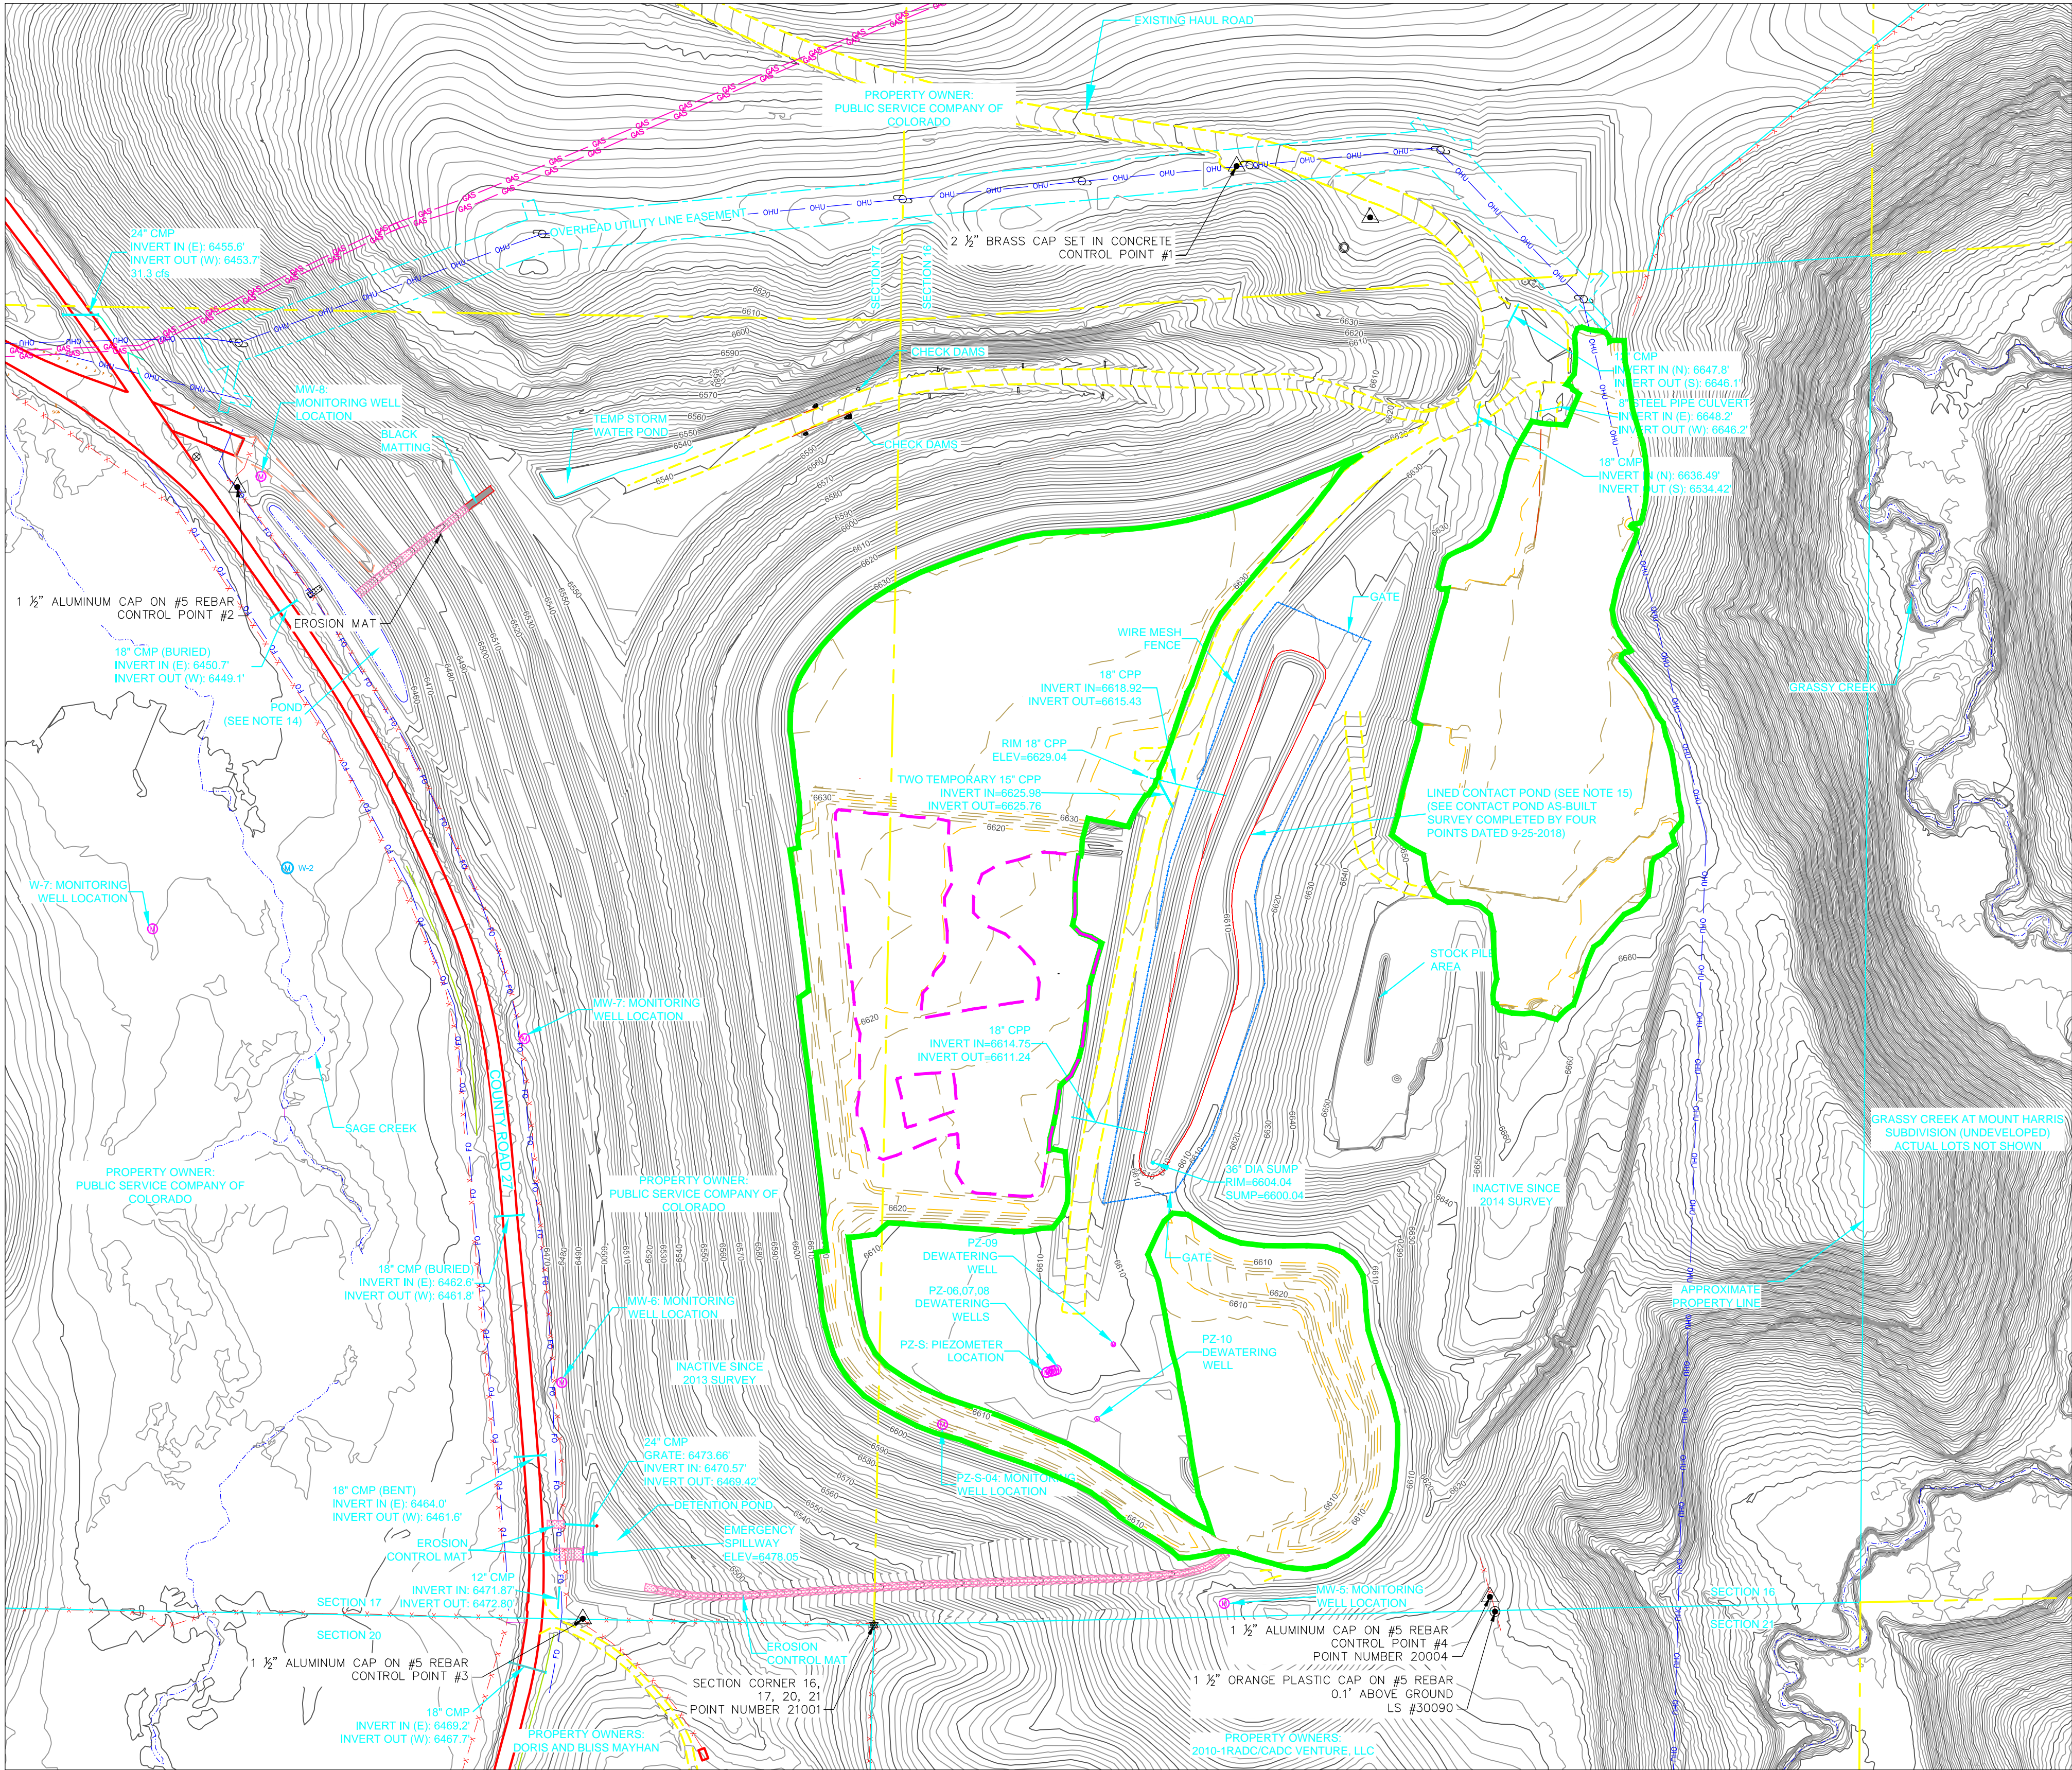
TOPOGRAPHIC EXHIBIT

LOCATED IN THE SOUTHEAST QUARTER OF SECTION 17 AND THE SOUTHWEST QUARTER OF SECTION 16, TOWNSHIP 6 NORTH , RANGE 87 WEST OF THE 6TH P.M.,
COUNTY OF ROUTT , STATE OF COLORADO
SHEET 1 OF 1

Appendix A: Landfill Site Map

4. Weekly CCR Landfill Inspection Forms (per Section 257.84(a)).
5. October 2019 As-Built Survey with updated topography; the survey field work was completed October 16 - 17, 2019, performed by Four Points Surveying and Engineering.
