## **Energy Performance Systems, Inc.**

**Project Title: Improving the Efficiency of Planting, Tending and Harvesting  
Farm Grown Trees for Energy**

### **MILESTONE 11 - SUMMARY REPORT**

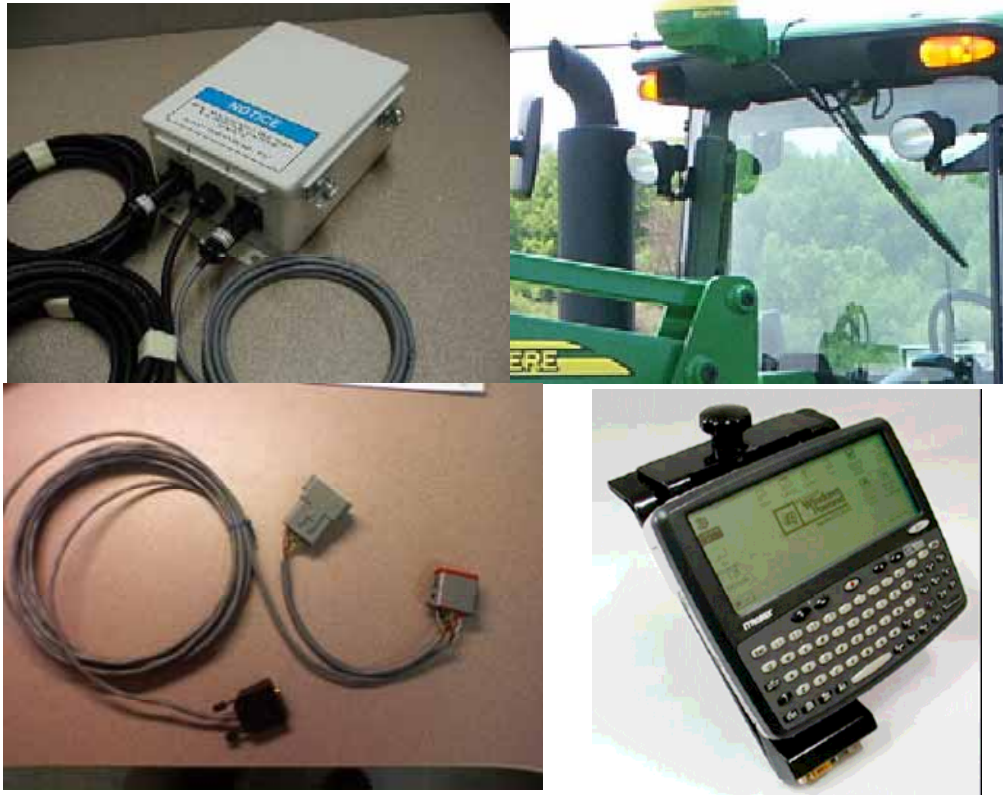
**Figure 1. Components of the SkyTrip system that triggers the planter.**

shows the SkyTrip components that were then wired to the planter to allow satellite triggering of the planter. EPS and ALMACO are talking about commercial terms for modification and the long-term use of their systems on EPS planters.

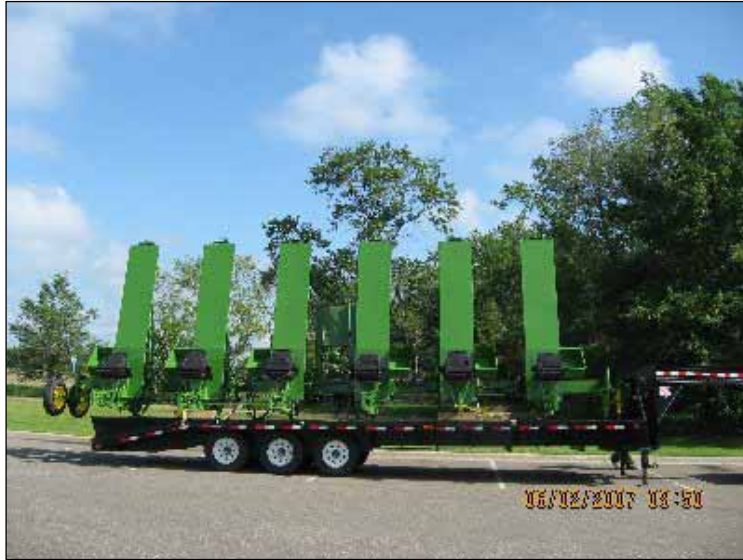
**Figure 2. The 10,000 pound planter loaded on trailer for hauling to the Graceville, MN planting site on June 2, 2007.**

The planter was moved to a farm near the 2<sup>nd</sup> planting site near Graceville, MN on Saturday June 2 on a 36 ft trailer and attached to the tractor (Fig. 2 & 3) for in-field testing of the automatic position control and all other planter operations. Hauling of the planter on the trailer posed no problems with respect to passing under bridges, stoplights and signs along the roads between Minneapolis and Graceville, MN.

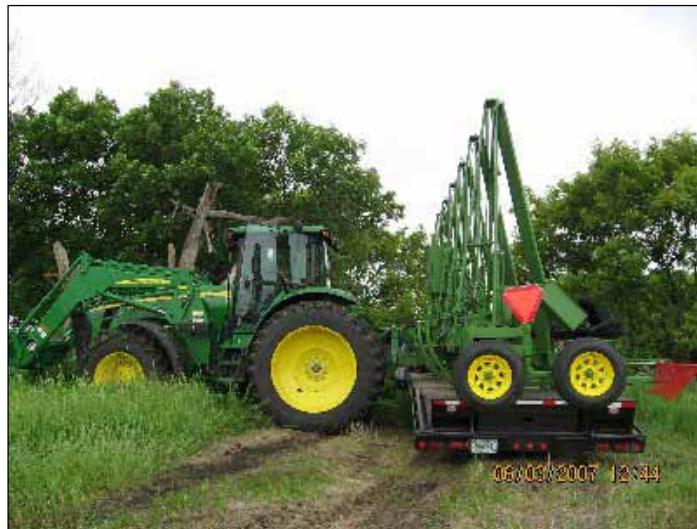
**Figure 3. Attachment of planter to tractor and off-loading from trailer.**

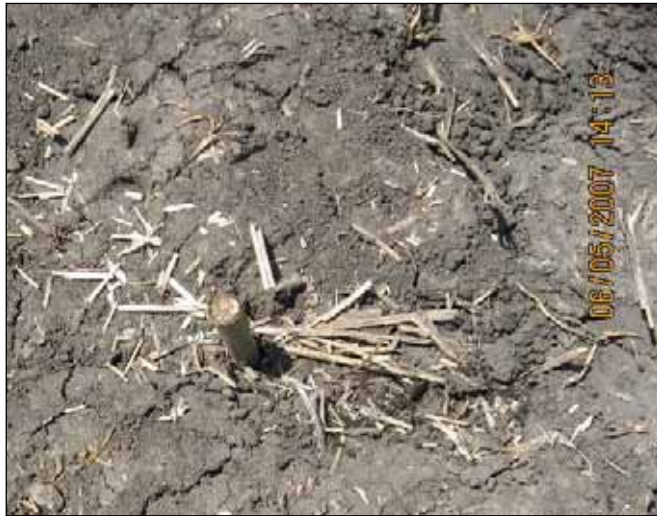
**Figure 4. Slip injected properly after firing of slip injection system into hard, dry soil.**

The first simultaneous firing of all six planter rams at the Graceville field site, was accomplished with mixed success. Three slips were injected deeply without damage and three slips were bent (Fig. 4).

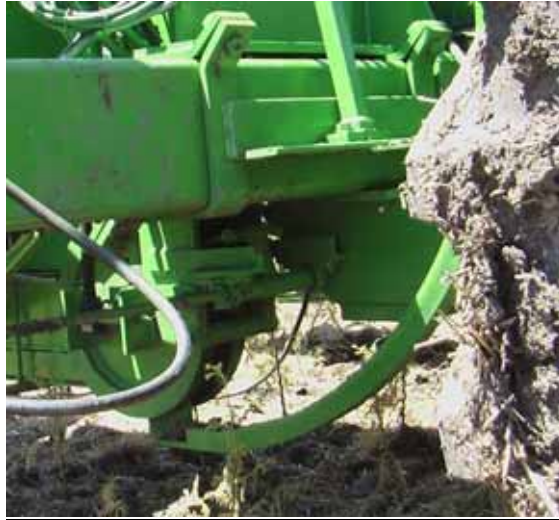
**Figure 5. Curved skid attached to bottom of injection slot. Mud on tractor tires shows field was too wet for planting on June 5, 2007.**

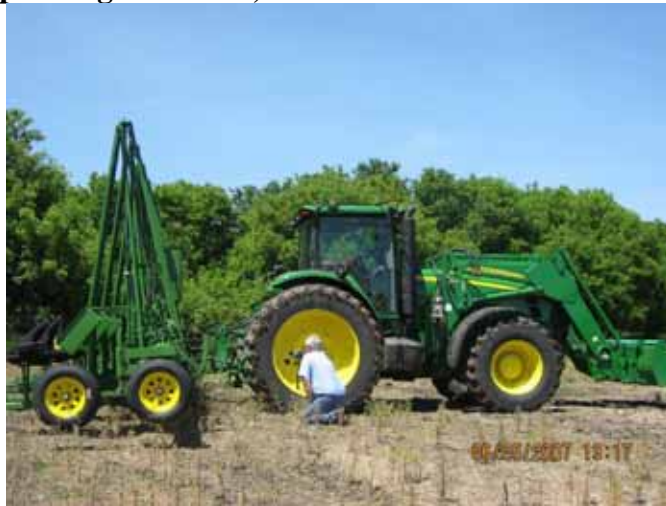
**Figure 6. Planter weight is balanced by front-end loader on tractor.**

- (7) Due to the high weight of the planter, 10,000 lbs and it's height (12 feet) there was some worry that the tractor would not be able to pick-up the planter (since the tractor was only rated for handling 8,000 lbs). However, that was not a problem and the front-end loader on the tractor helped to provide a counter balance (Fig 6).

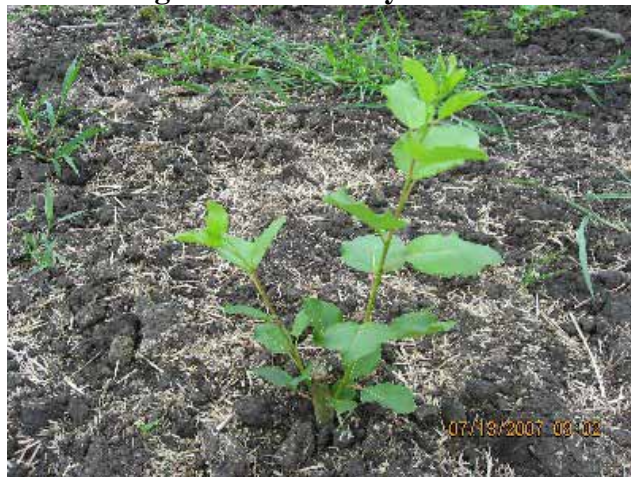
**Figure 7. Machine planted cutting showing deep planting and healthy sprouts.**

- (12) Most importantly, the great majority of the slips established with the planter were injected deeply, without breakage or end damage and were producing sprouts (Fig 7), to be further discussed in Milestone 12.
